Phase I – Environmental Site Assessment

Lakes Region Facility
1 Right Way Path
Laconia, New Hampshire

August 10, 2010

In Reference to:
Project No. 10001086

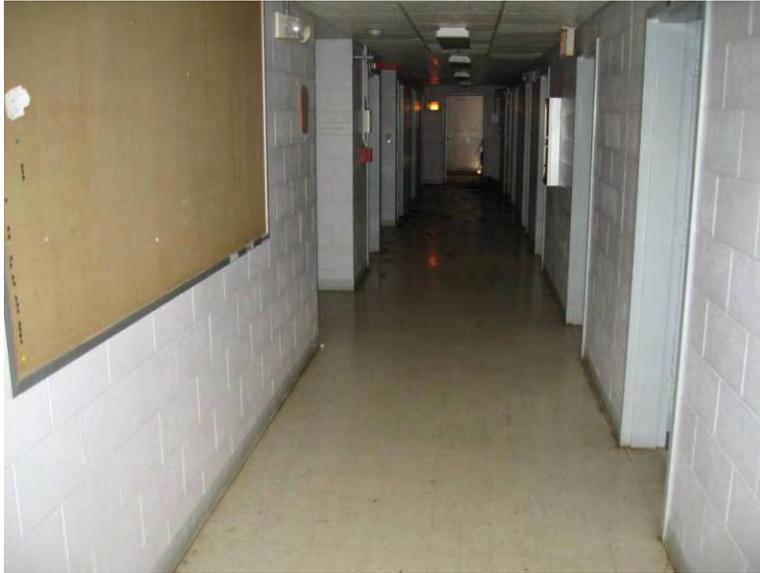
Picture 1.
Representative interior conditions of the basement of
Building 1—Administration

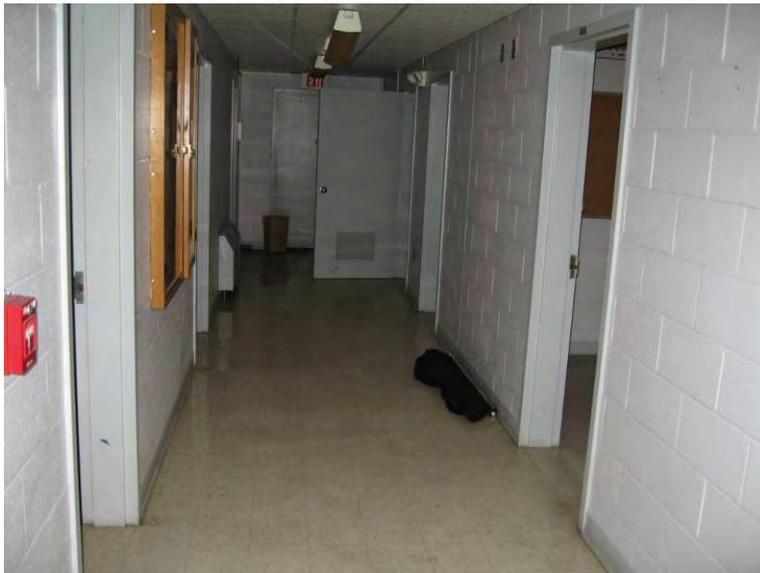
Picture 2.
Representative interior conditions of the first floor of
Building 1—Administration

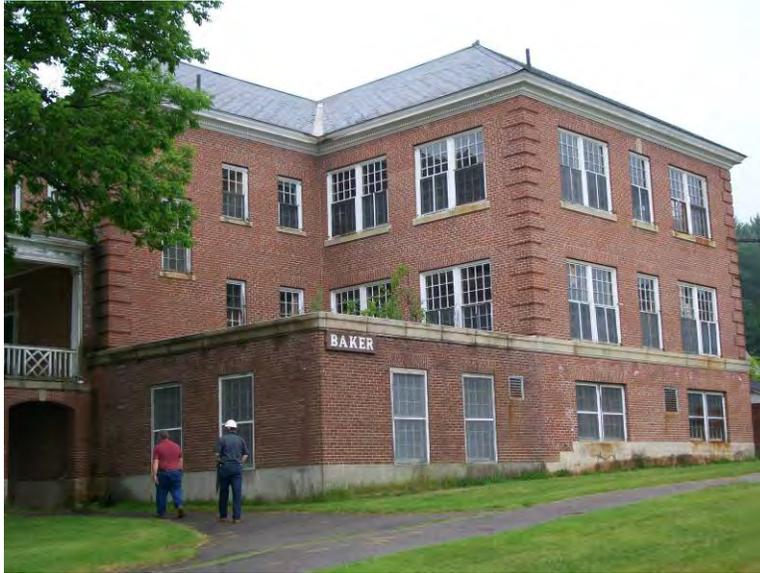
Picture 3.
Representative exterior conditions of
Building 2—Baker

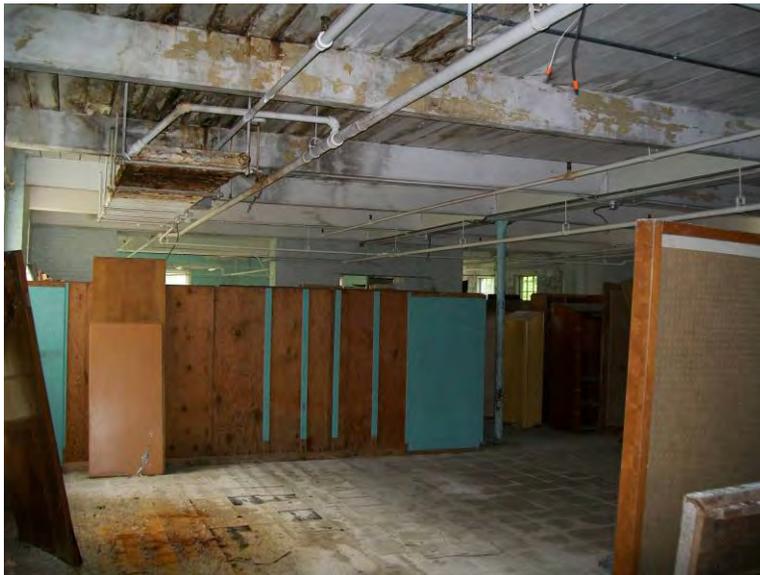
Picture 4.
Representative interior conditions of the basement of
Building 2—Baker. Note loose and peeling paint.

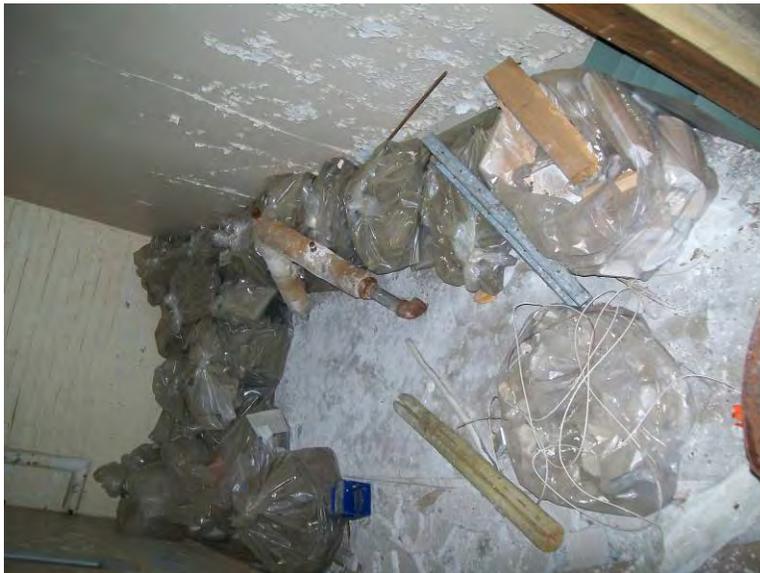
Picture 6.
Bagged fibrous waste observed on the first floor of
Building 2—Baker.

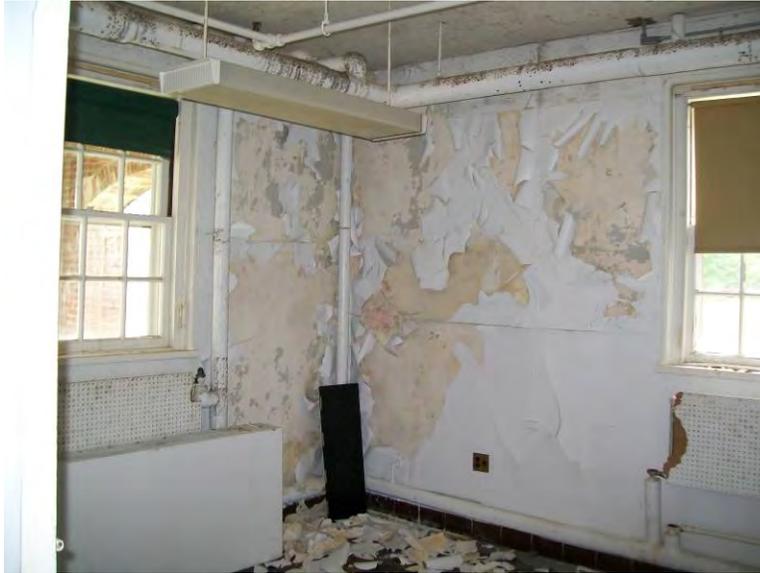
Picture 9.

Representative interior conditions of the second floor of Building 3—Blood. Note mold and loose and flaking paint

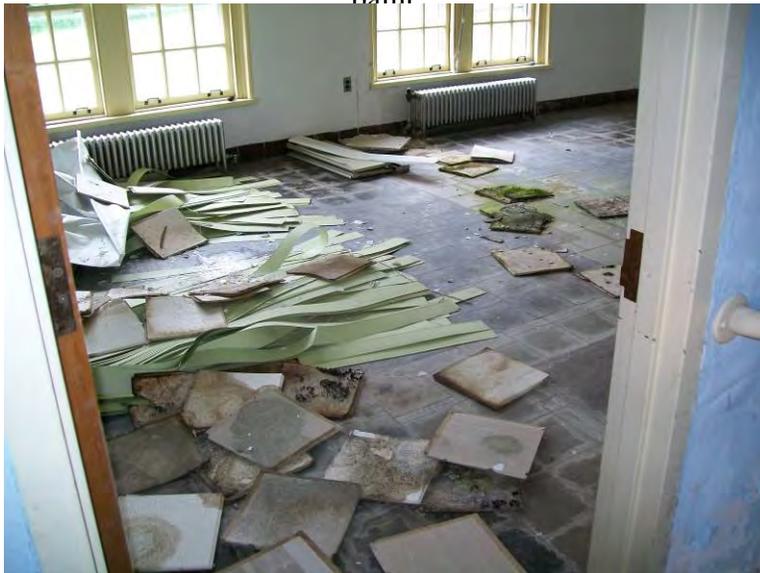
Picture 10. Representative interior conditions of the third floor of Building 3—Blood. Note mold and suspect ACM floor and ceiling tiles.

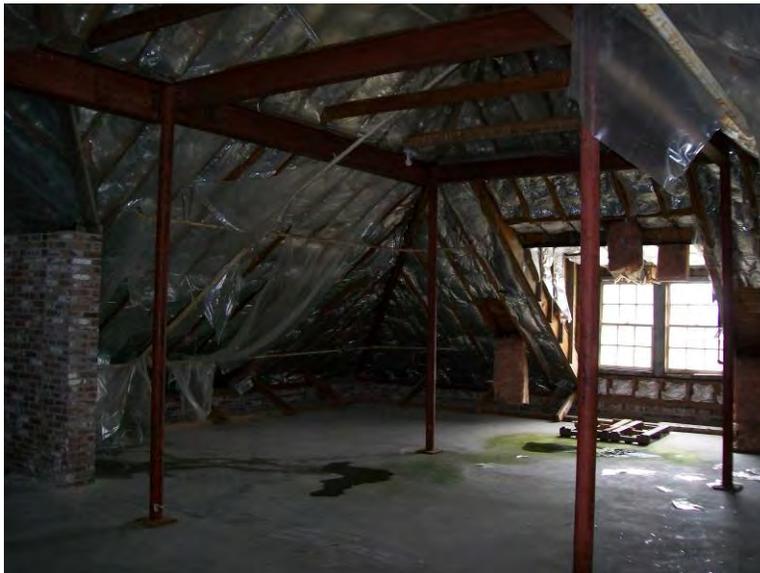
Picture 12.

Representative interior conditions of the fourth floor of Building 3—Blood. Note mold and water damage.

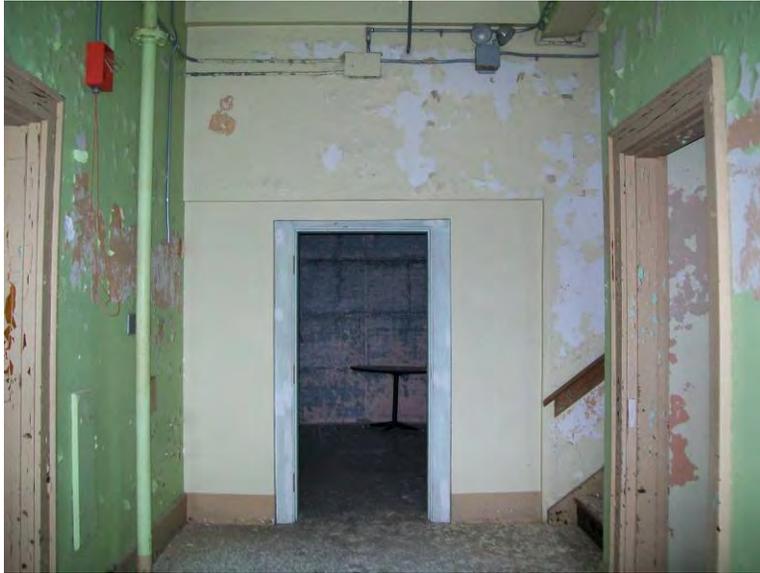
Picture 26.
Universal waste observed on the first floor of
Building 6—Felker.

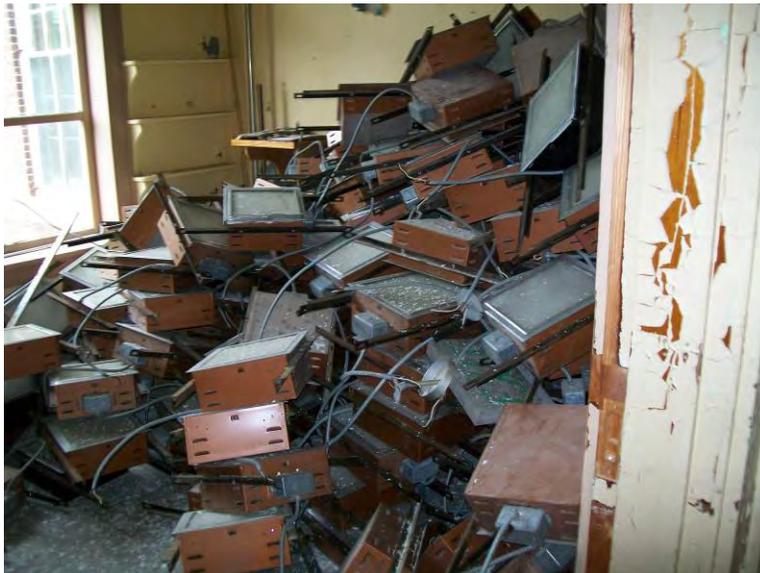
Picture 28.
Universal waste including potting material and ballasts observed on the second floor of Building 6—Felker.

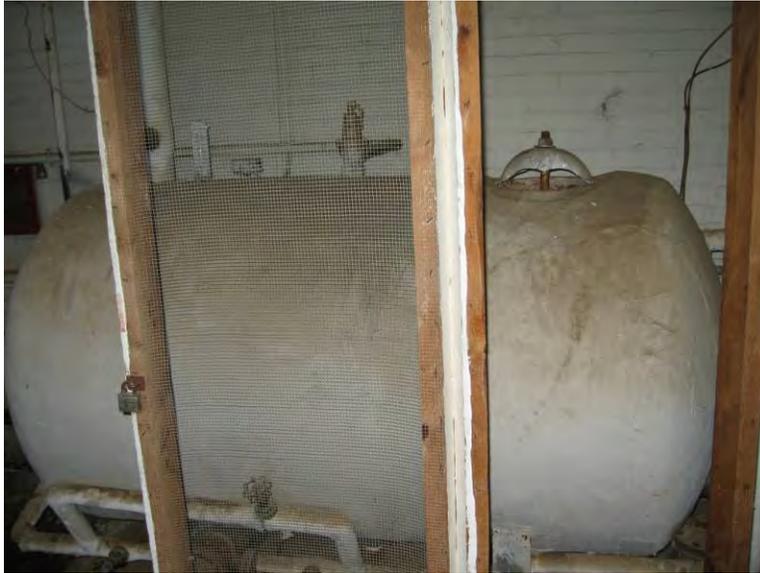
Picture 31.

Hot water tank and associated potential ACM observed within the basement of Building 7—Floyd.

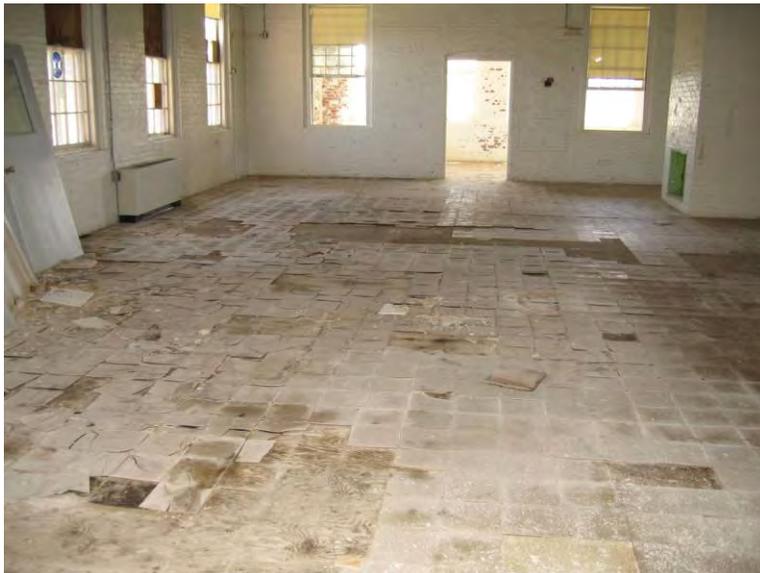
Picture 32.

Representative interior conditions of the first floor of Building 7—Floyd. Note: Suspect ACM floor tiles.

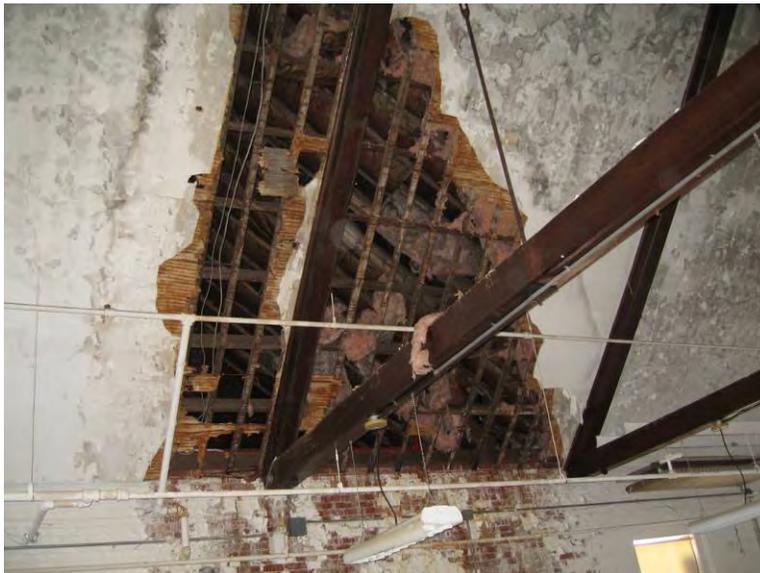
Picture 34.
Water damage on the second floor of
Building 7—Floyd.

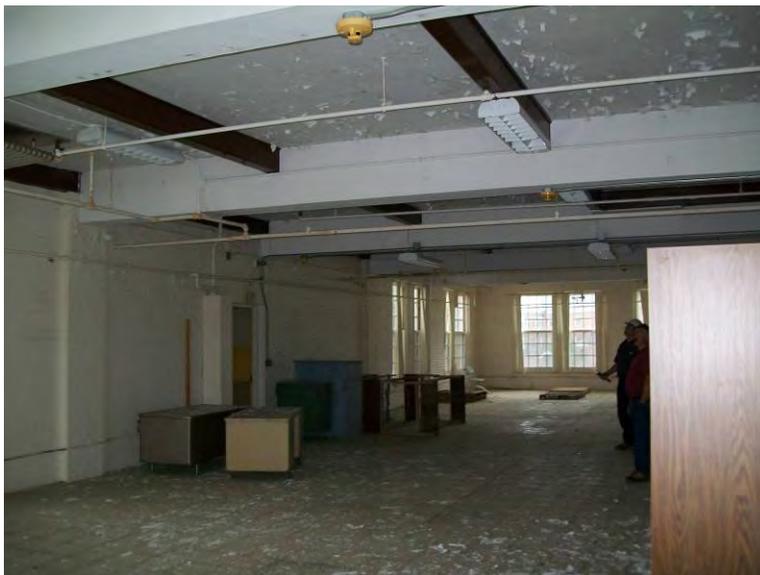
Picture 38. Representative interior conditions of the first floor of Building 8—Keys. Note: Suspect ACM floor tiles and loose and flaking paint.

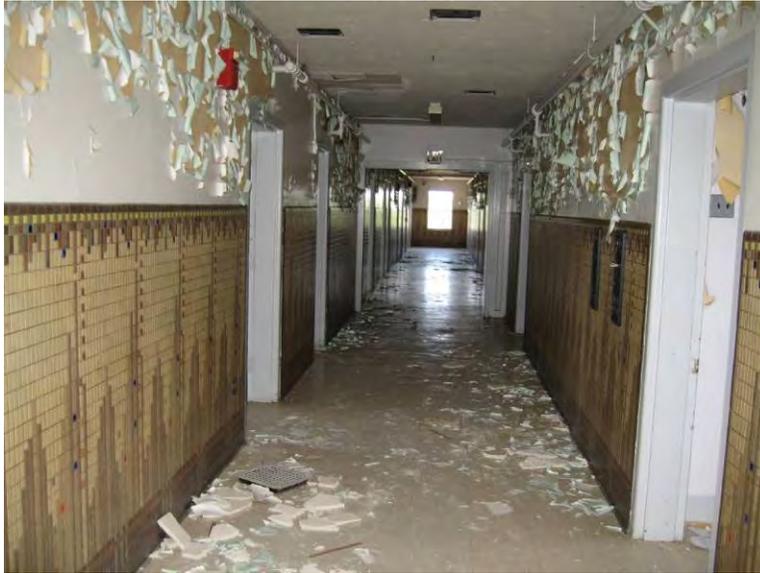
Picture 47. Representative interior conditions of the first and second floors of Building 10—Murphy. Note: Suspect ACM floor tiles and loose and flaking paint.

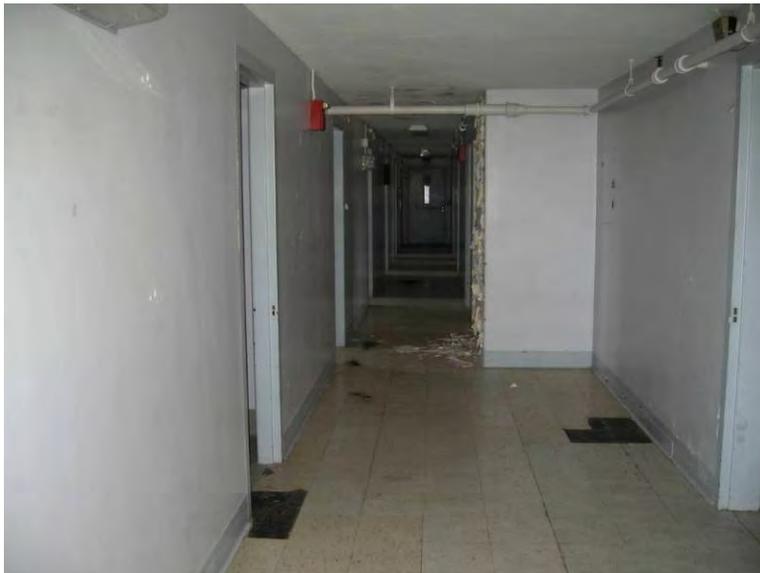
Picture 48. Representative interior conditions of the third floor of Building 10—Murphy. Note: Suspect ACM floor tiles and loose and flaking paint.

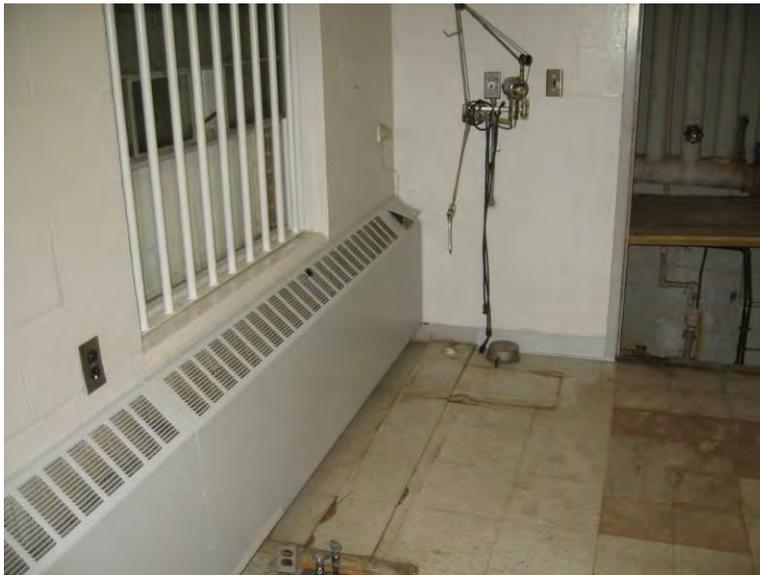
Picture 50. Representative interior conditions of the
dental care area on first floor of Building 11—Murphy
Wing. Note: Suspect ACM floor tiles.

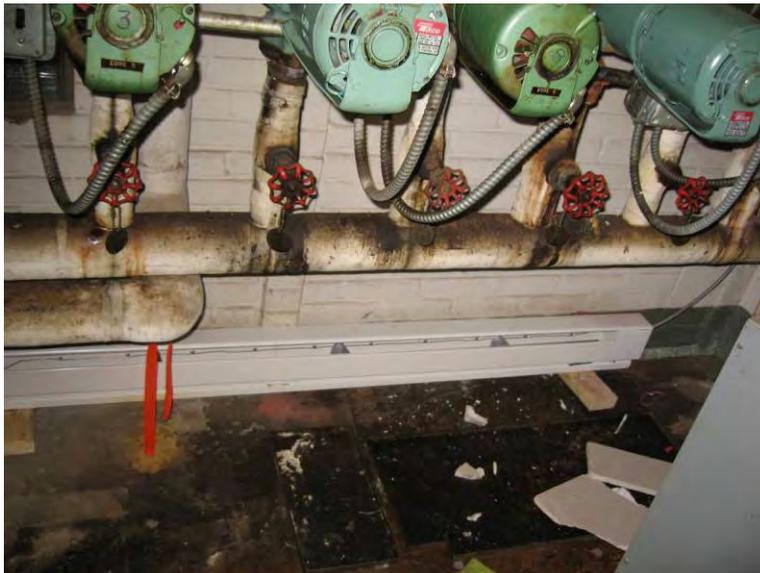
Picture 52.

Staining of the floor within the mechanical room in the basement of Building 11—Murphy Wing.

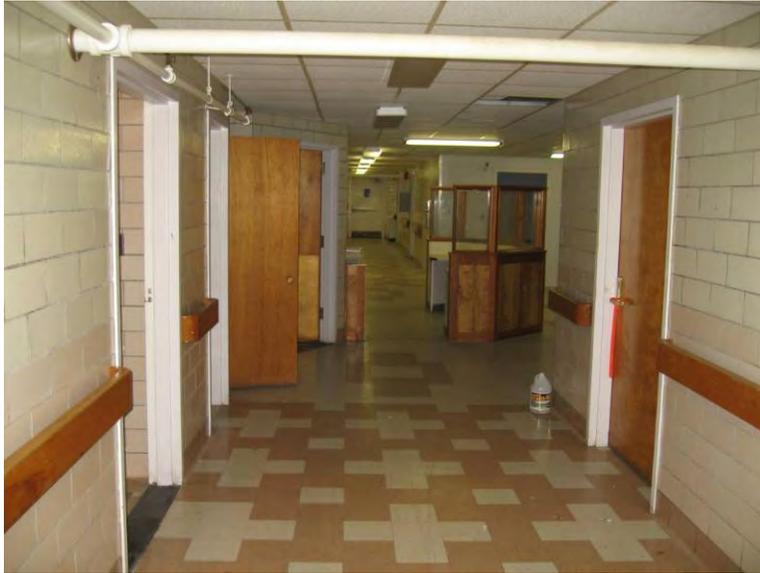
Picture 53. Representative conditions of the first floor of Building 11—Murphy Wing.
Note: Suspect ACM floor tiles.

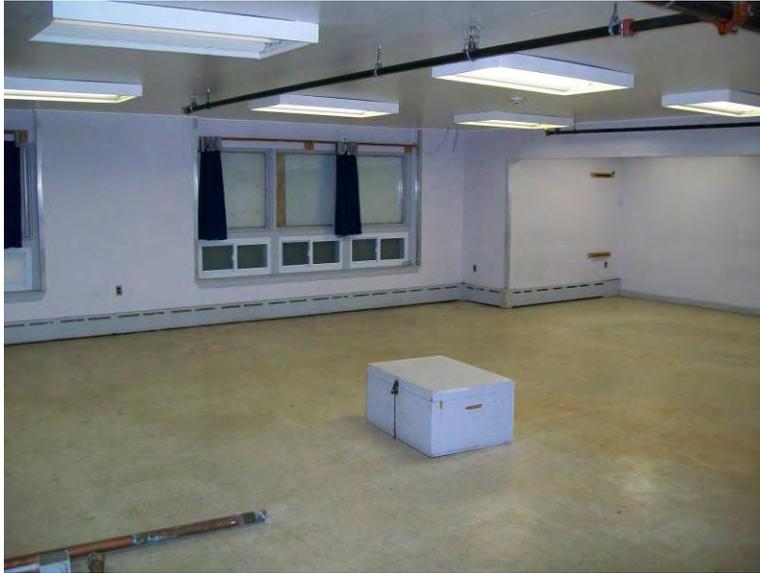
Picture 55.

Representative conditions of the first floor of Building 12—Peterson. Note: Suspect ACM floor tiles

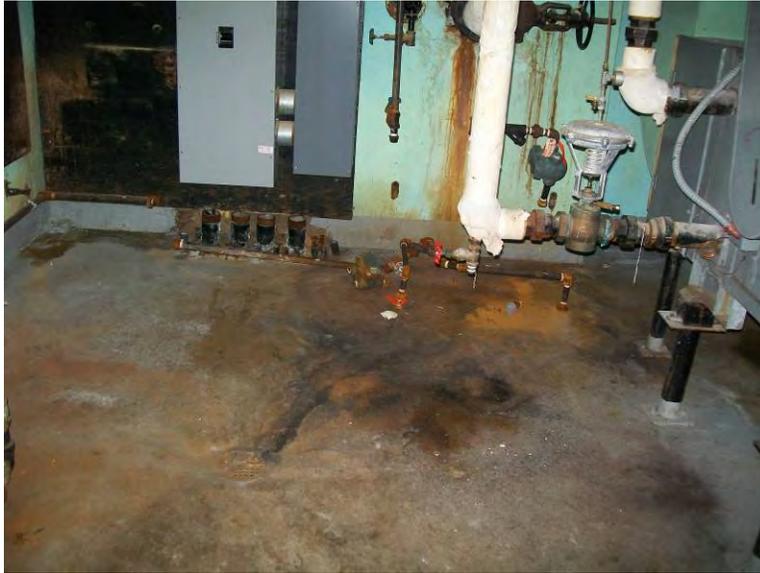
Picture 63.

Suspect ACM pipe insulation and floor staining located in the sub-basement of Building 14—Powell.

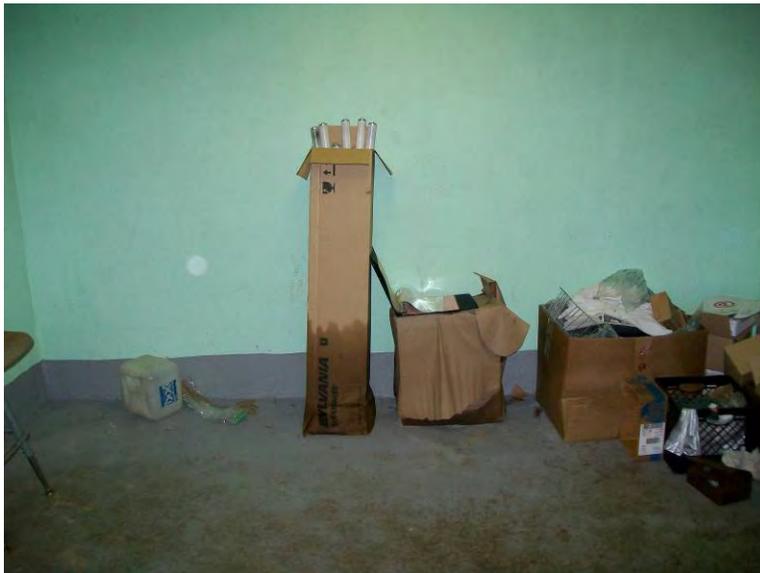
Picture 64.

Universal waste located in the sub-basement of Building 14—Powell.

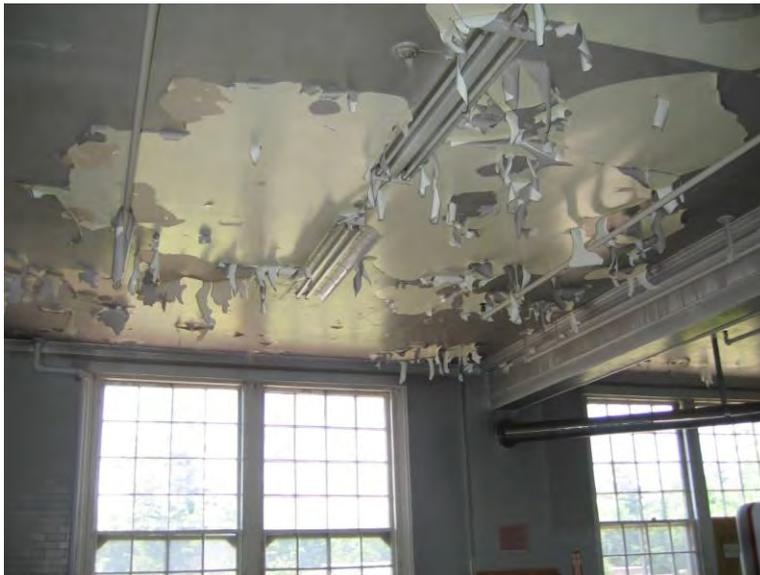
Picture 70.
Representative conditions on the first floor of
Building 15—Quinby. Note: Loose and flaking paint.

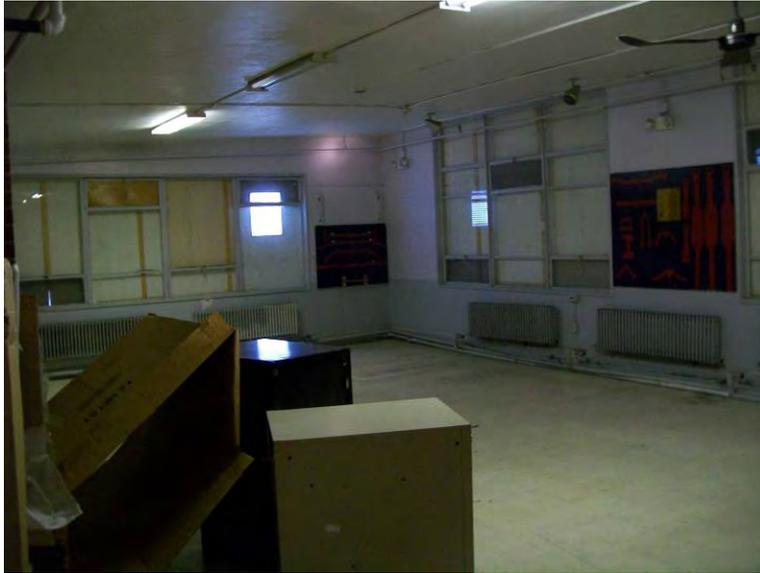
Picture 75.

Representative interior conditions of the first floor of Building 16—Rice. Note: Suspect ACM floor tiles.

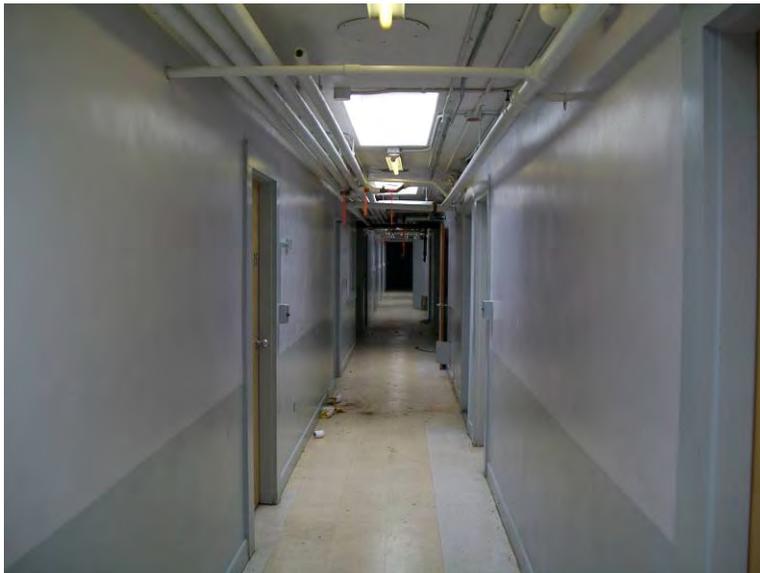
Picture 76.

Representative interior conditions of the first floor of Building 16—Rice. Note: Suspect ACM floor tiles.

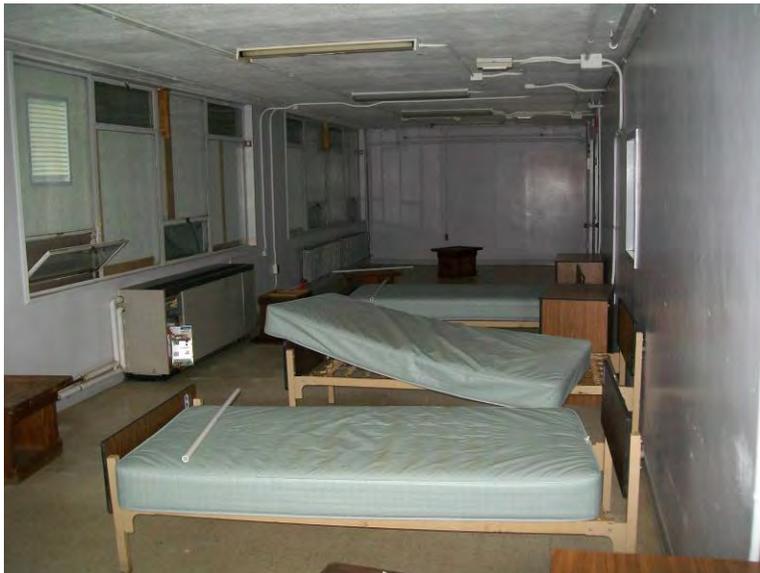
Picture 86.

Representative conditions of the first floor of Building 18—Speare. Note: Suspect ACM floor tiles.

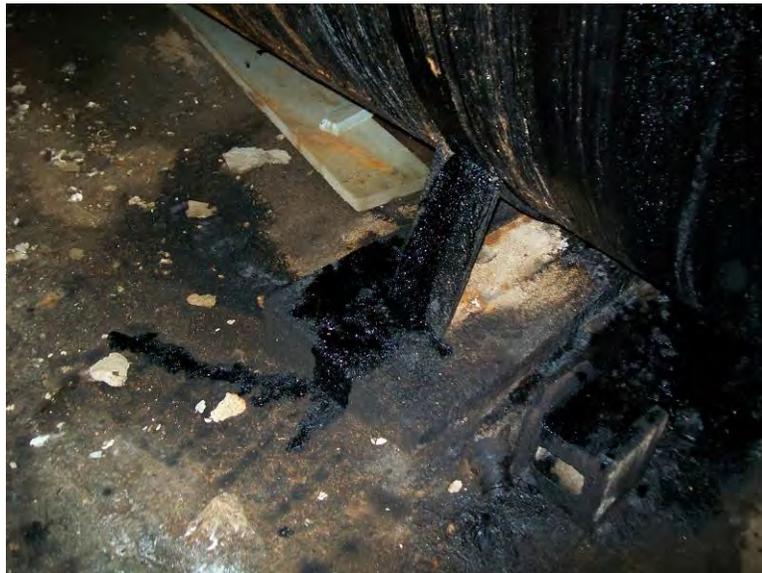
Picture 118. Representative staining observed below the two empty 12,000 gallon ASTs and throughout the Fuel Bunker section of Building 22—Boiler House.

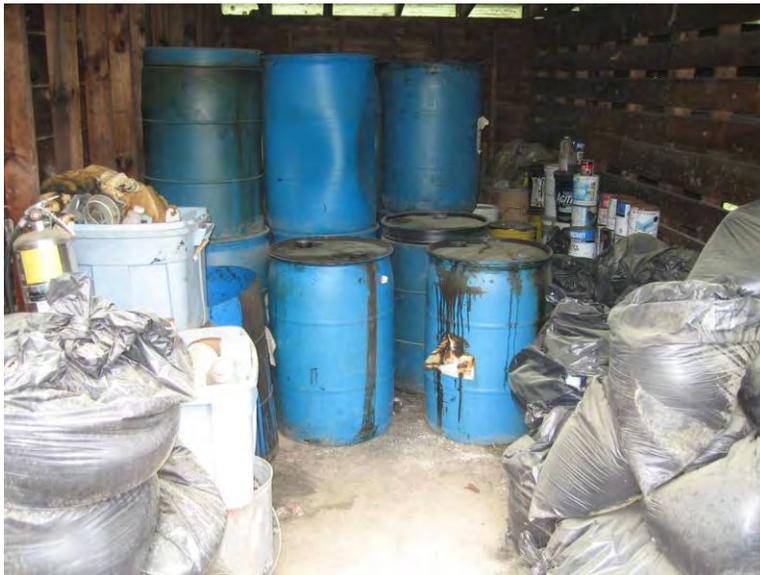
Picture 148.
Representative waste items observed within
Building 26—Lumber Storage.

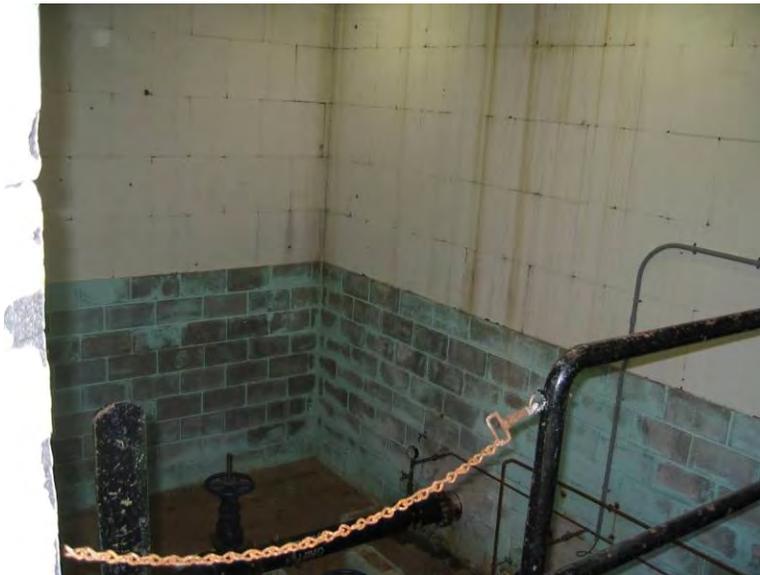
Picture 166. Interior conditions of the control
structure of Building 29—Water Towers.
Note: Suspect ACM paneling and mold.
