APPENDIX B

PROBLEM CULVERT IDENTIFICATION

Jewett Brook Stream Crossing Assessments
Data collection by Bear Creek Environmental, LLC
Assessment Conducted during August 2010

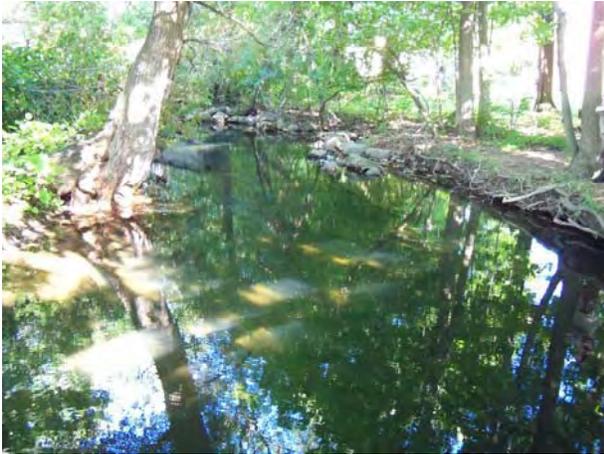
Channel above inlet

Erosion and Armoring – hard bank armoring not associated with bridge is failing above structure; bank erosion is low upstream and downstream of bridge.

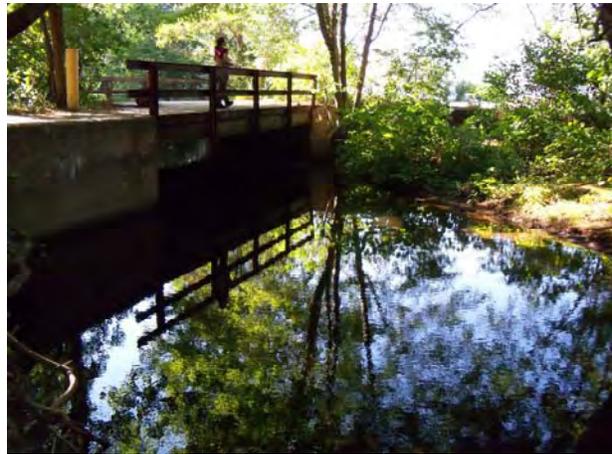
Inlet

Additional problems noted: Upstream alignment is poor; water hits the wing wall above the structure at the south side.

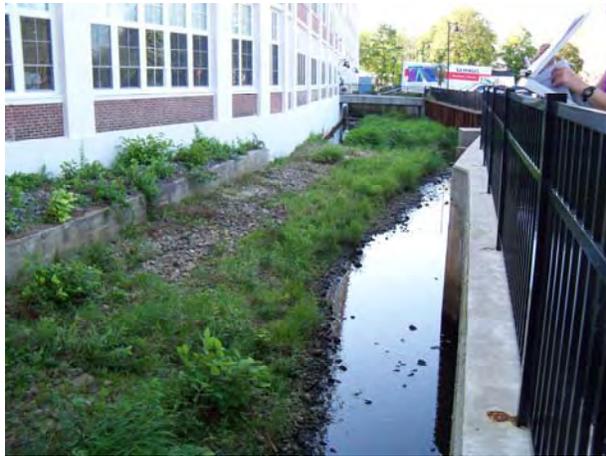
Side bar above Davis Street Bridge

Sediment Continuity – Elevation of sediment deposits (side bars) upstream is greater than 1/2 bankfull elevation

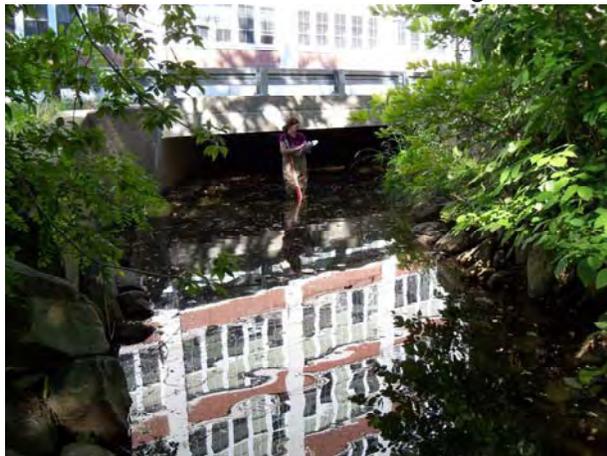
Outlet

Notes: Scour below structure

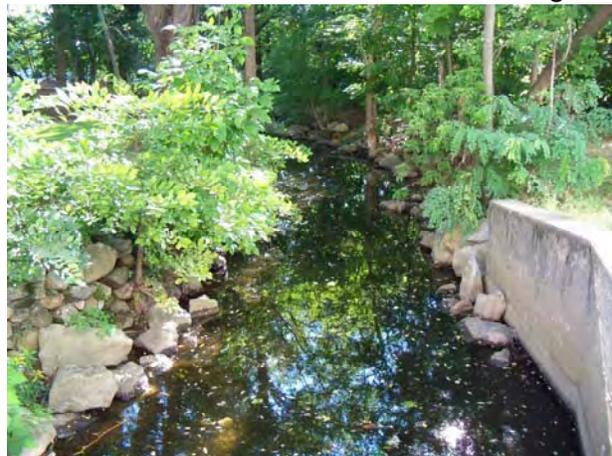
Channel below Davis Street

Erosion and Armoring – Armoring intact upstream and failing downstream; bank erosion low in channel below bridge.

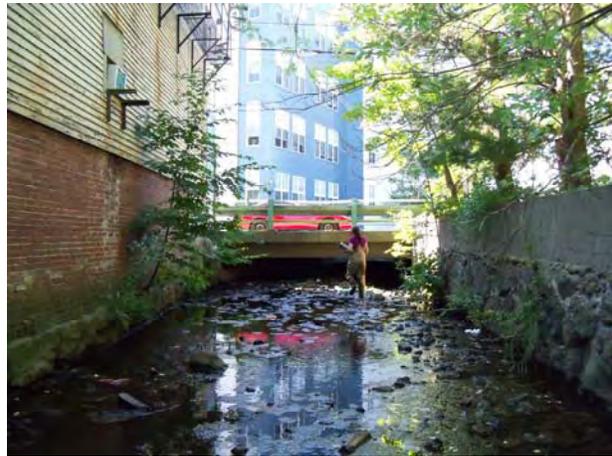
Inlet

Sediment Continuity – Mid- channel bar upstream of bridge and within the structure; sediment deposits are not greater than ½ bankfull.

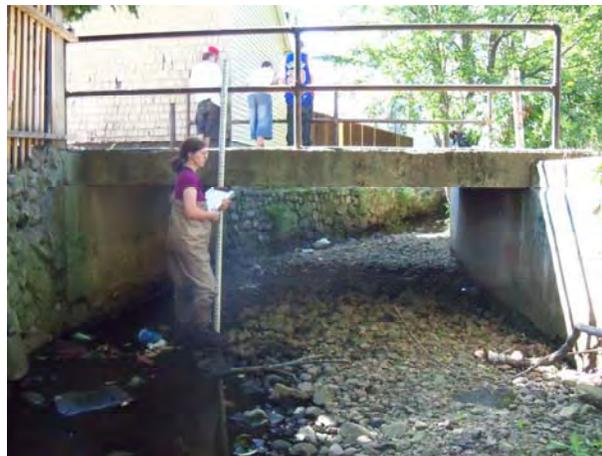
Inlet

Erosion and Armoring – Hard bank armoring failing above and below structure; streambed scour undermining abutments at both upstream and downstream ends.

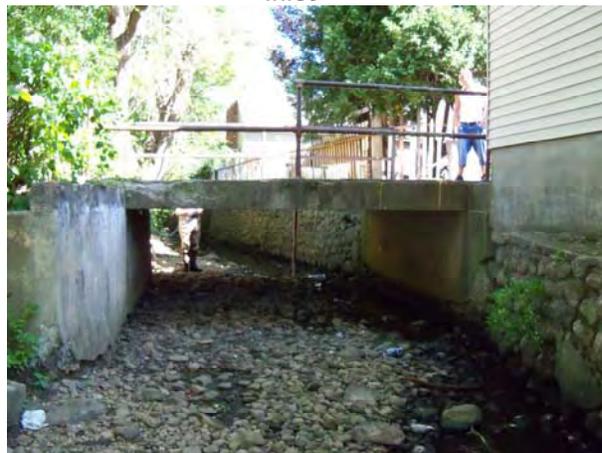
Outlet

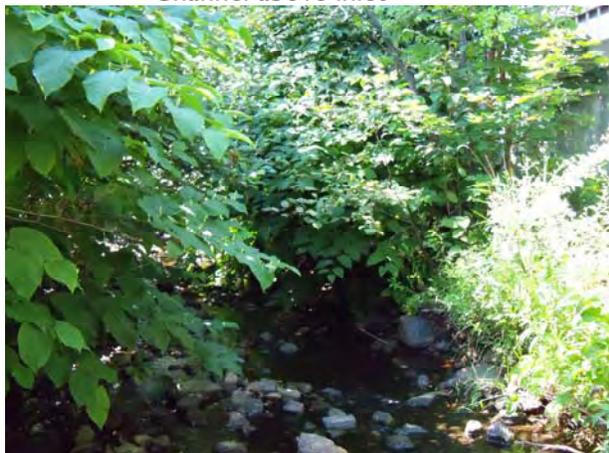
Chanel below Outlet

Sediment Continuity – High side bars (greater than ½ bankfull) on both sides below bridge

Notes: Structure looks relatively new. No major problems noted other than significant deposition below the bridge. Japanese knotweed (invasive plant) is growing on bars.

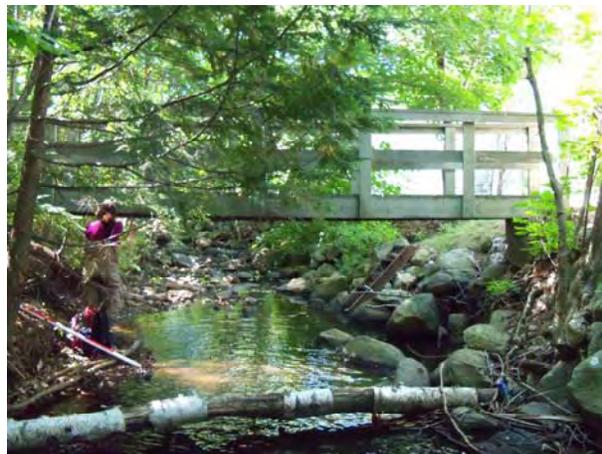
Inlet

Erosion and Armoring – Hard bank armoring failing above and below structure; high bank erosion upstream and downstream; scour causing undermining around/under structure at upstream end.

Notes: Some scour on north bank under abutment; slight scour above bridge. Bridge is a not a floodprone constriction.

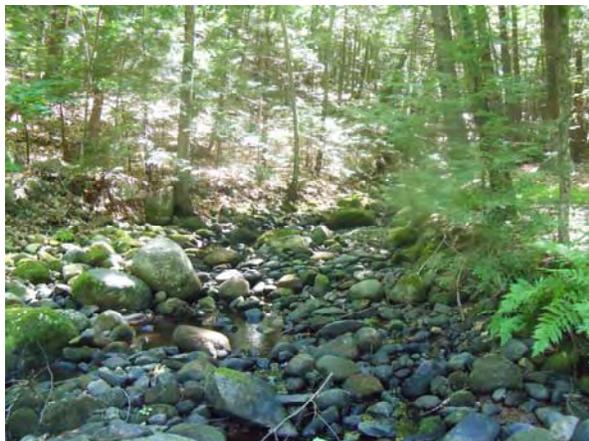
Channel above inlet

Sediment Continuity – Steep riffle upstream of twin culverts indicating structure is undersized

Notes: Debris and sediment at upstream end of structure. Riprap on north bank is failing – severe bank erosion. Riprap is slightly blocking the south outlet.

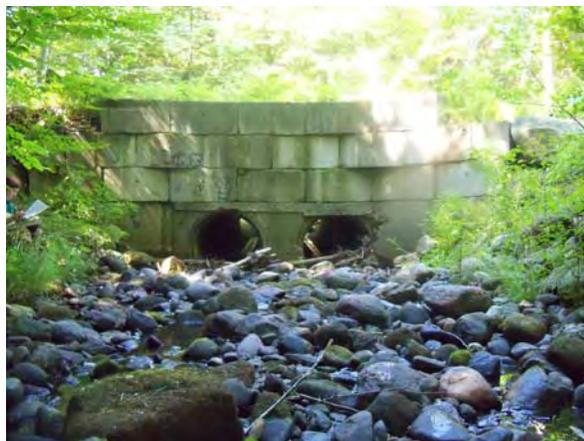
Inlet

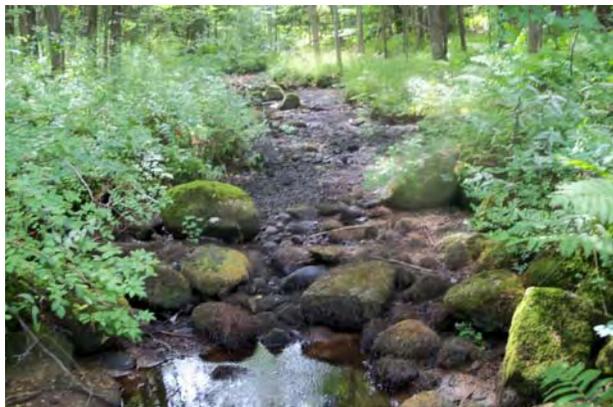
Channel above inlet

Erosion and Armoring – Low bank erosion above and below box culvert; streambed scouring causing undermining around/under culvert and footer at upstream end and wing walls at downstream end.

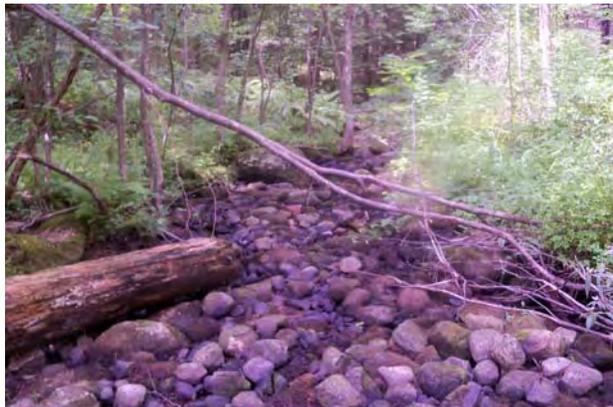
Channel below Outlet

Notes: Culvert appears to be old; concrete is deteriorating on bottom. Significant scouring of wingwalls at downstream end.

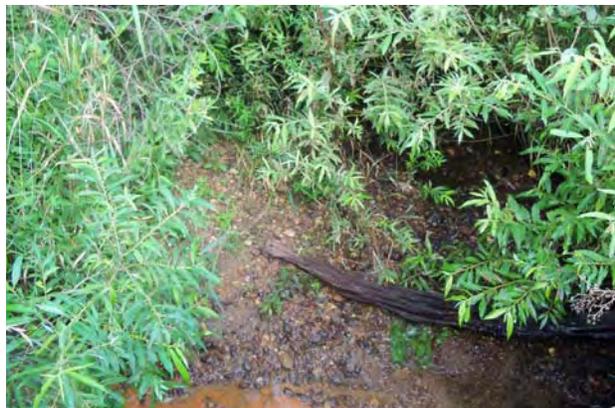
Channel above inlet

Sediment Continuity – Side bar greater than 1/2 bankfull elevation above structure.

Notes: Culvert is in good condition, but is very undersized. Significant aggradation at upstream end (with sediment obstructing the inlet) and scour below structure.

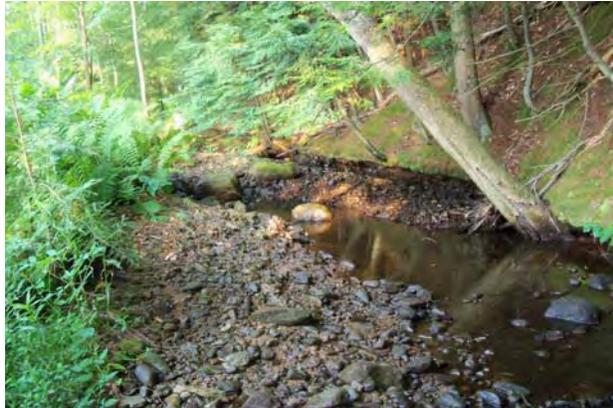
Channel above inlet

Sediment Continuity – Side bar and mid-channel bar upstream of bridge have sediment deposits greater than ½ bankfull elevation. Sharp bend appears to be contributing to deposition.

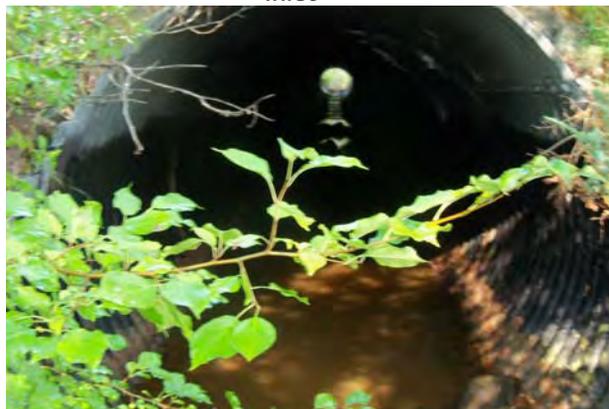
Outlet

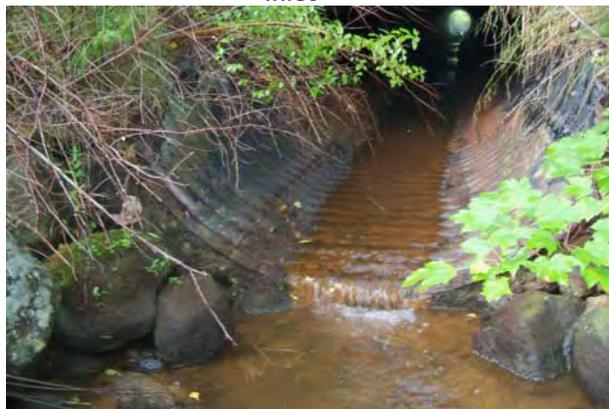
Outlet

Notes: Very long culvert. Stormwater drainage at downstream end is causing scour around culvert.

Water depth in culvert is 0.1 feet. Culvert is free fall and perch is 0.3 feet.

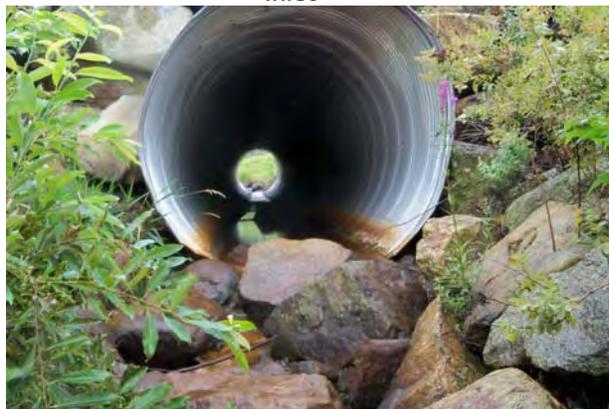
Outlet

Notes: Culvert is becoming deformed by weight of riprap cemented around it. Two overflow pipes are associated with the structure. Crossing is channelized with extensive riprap.

Water depth in culvert is 0.4 feet. Outlet is cascade with estimated drop of two feet.

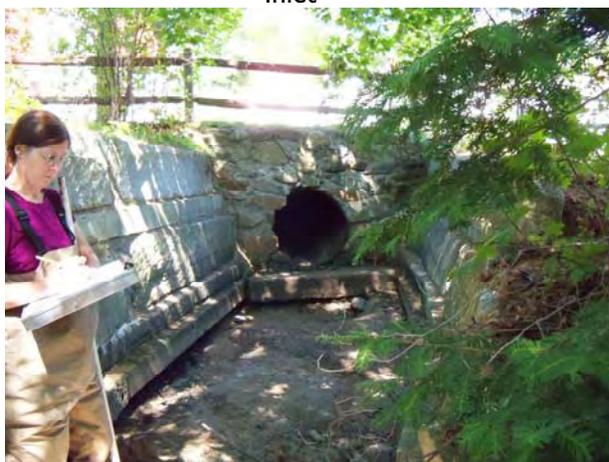
Outlet

Erosion and Armoring –High bank erosion above and below culvert; upstream hard bank armoring failing; streambed scouring around culvert upstream and around wing walls downstream.

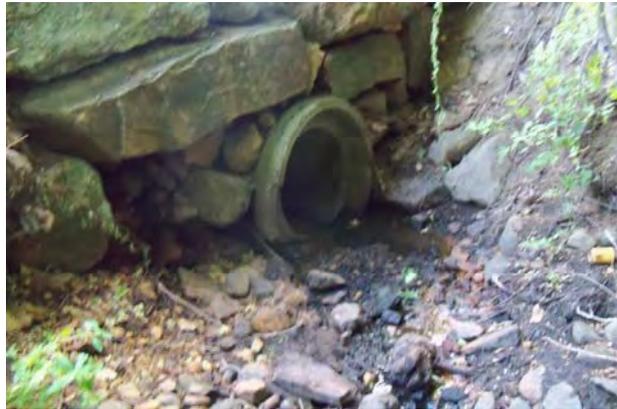
Inlet

Erosion and Armoring –High bank erosion upstream and low erosion downstream; hard bank armoring is failing; streambed scour causing undermining around/under culvert at upstream end.
