Jewett Brook Watershed Stream Geomorphic Assessment Laconia and Gilford, New Hampshire May 30, 2011

Prepared by:
Bear Creek Environmental, LLC
297 East Bear Swamp Road
Middlesex, Vermont 05602

Prepared for:
New England District, U.S. Army Corps of Engineers
696 Virginia Road
Concord, MA 01742-2751

1.0 EXECUTIVE SUMMARY

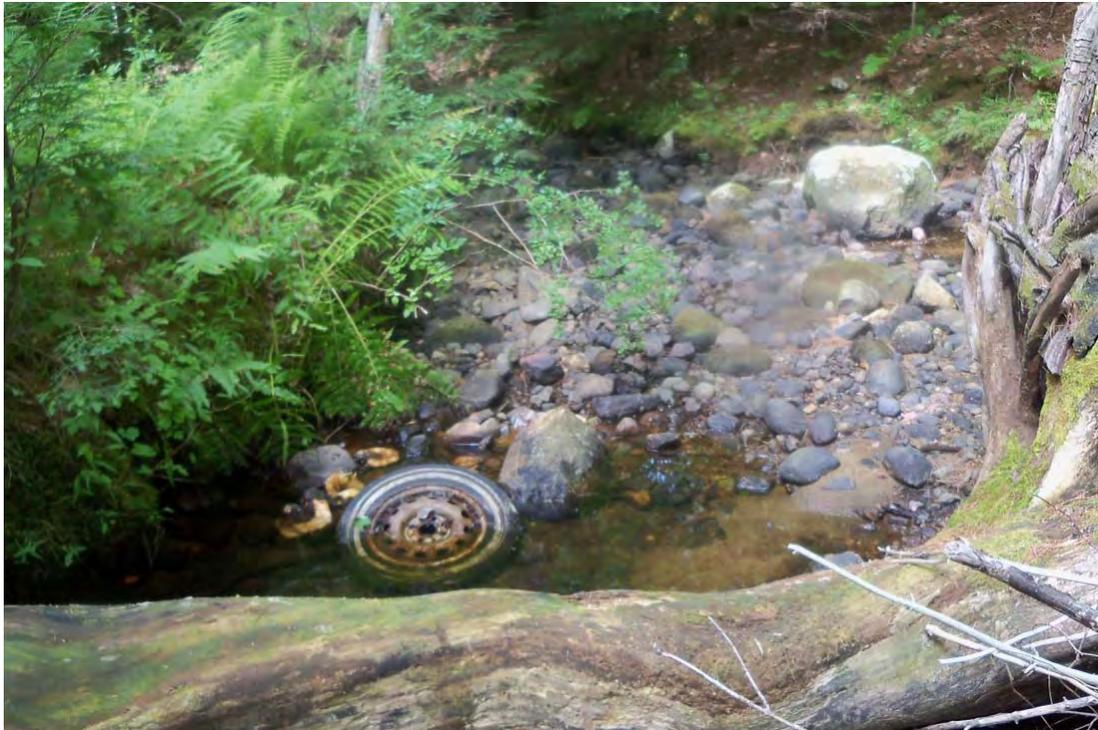
Discarded tires and other trash were common in stream channels within the Jewett Brook watershed. A significant number of tires were observed even in the upper reaches of the main stem (Figure 8.1). Towns and community groups have the opportunity to sponsor stream cleanup days to remove trash from Jewett Brook and tributaries. This cleanup effort improves water quality and offers a connection between local citizens and the stream that runs through their community.

Figure 8.1 Tire in Reach M05

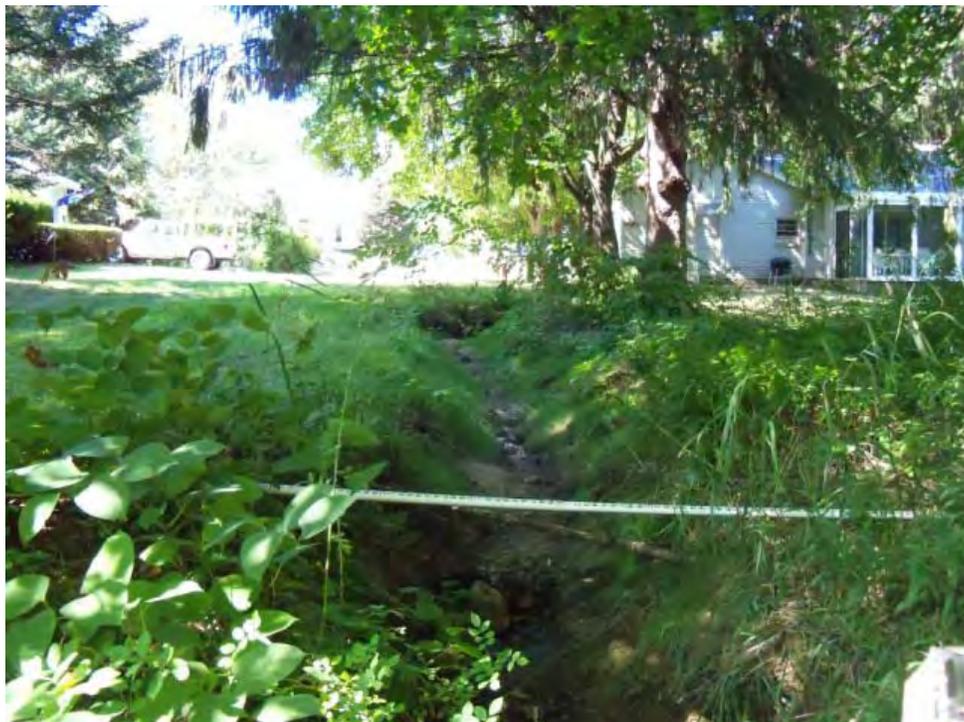
Figure 8.2. Gully erosion on north bank downstream of Highland Street

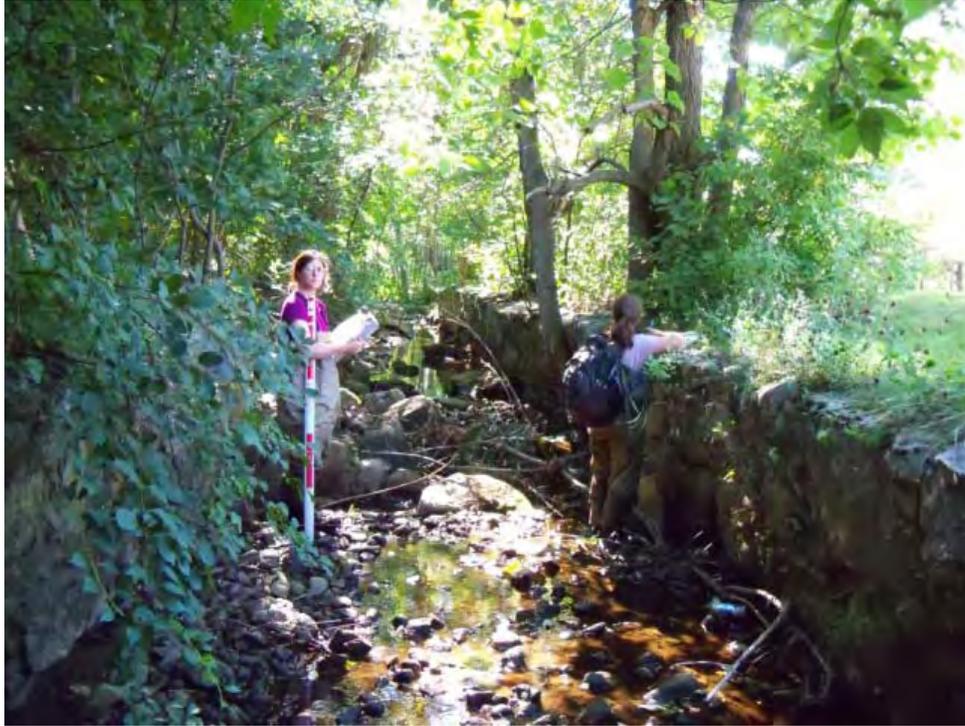
The rock wall banks of Jewett Brook near the TD Bank North Parking lot is deteriorating in places (Figure 8.3). An alternatives analysis is recommended (Project #4 on Page I of Appendix C) for removing, replacing or repairing the bank. Over 80 percent of each bank has buffers that are less than 25 feet in width. Near bank vegetation and vegetation within the buffer is dominated by herbaceous plants, such as grass. In many locations the buffer is narrow or lacking due to the close proximity of development. Buffers less than 25 feet are common in backyards that abut Jewett Brook, such as the yard shown in Figure 8.4, which is located downstream of Highland Street.

Figure 8.3. Rock wall (armored banks) near TD Bank North Parking Lot

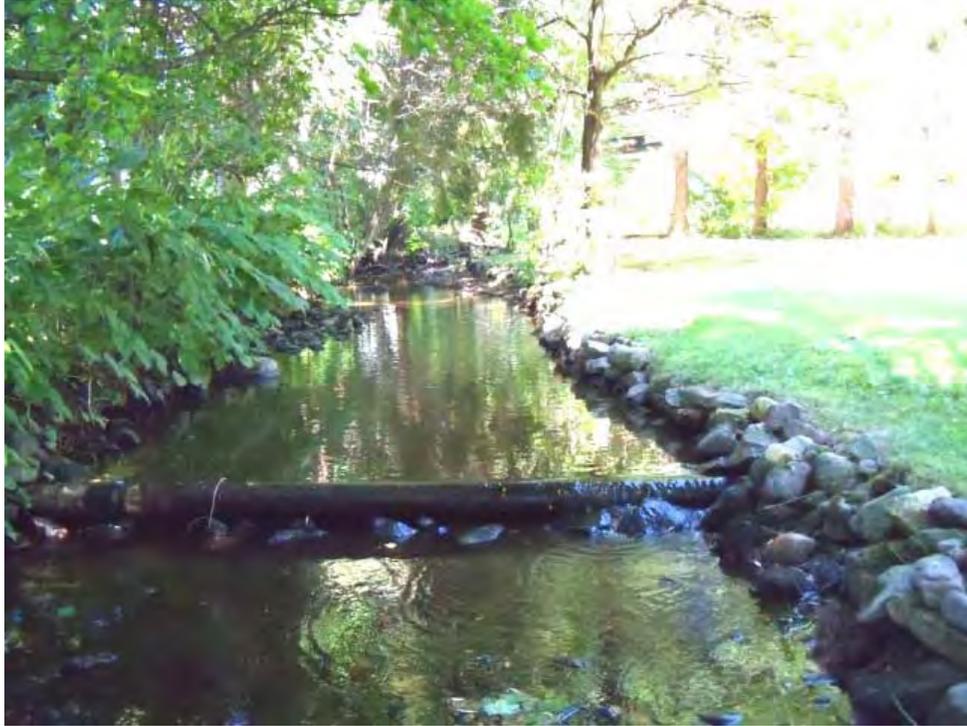
Floodplain access (i.e. incision) is variable within the reach. The yard shown in Figure 8.4 has good floodplain access. It is recommended that locations with good floodplain access and no existing encroachments within the river corridor be protected to provide flood and sediment attenuation within the reach through the adoption of fluvial erosion hazard (FEH) zones or corridor easements (Project #7 on Page I of Appendix C). Floodplain access is poor in other sections of this reach, such as at the top of the reach (Figure 8.5). A cross section was measured between Highland Street and Union Street that represents an average reach condition for incision. The incision ratio of the cross section (1.43) reflects Jewett Brook in M01 being moderately incised.

Figure 8.4. Buffer less than 25 feet and good floodplain access downstream of Highland Street

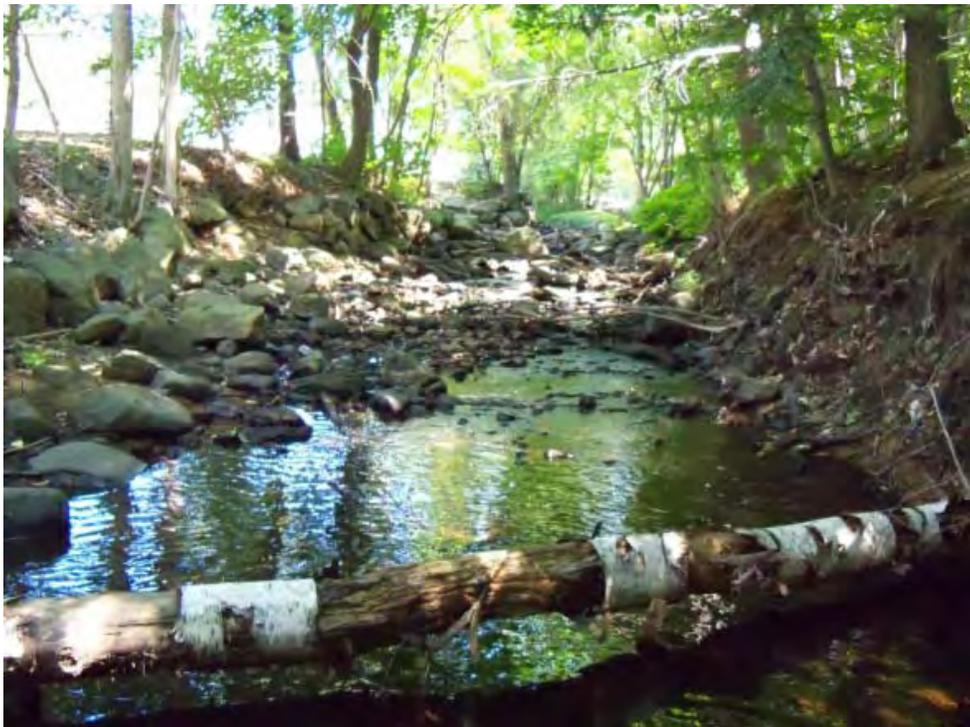
Figure 8.5. Incised channel with poor floodplain access at top of reach M01

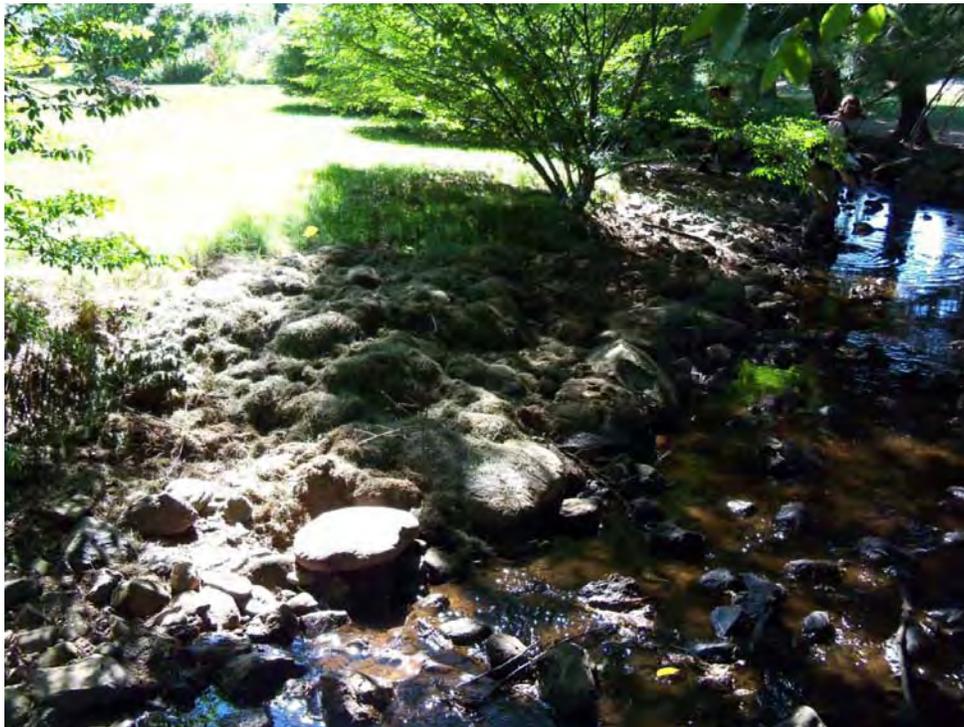
Figure 8.6. Grass clippings on the stream bank are contributing to nutrient enrichment in Reach M01.

Dense algae were noted along much of the reach. Reach M01 would benefit from a landowner education program to better manage yard waste, such as grass clippings (Figure 8.6), pet waste, etc. (Project #5 on Page I of Appendix C). The landowner education program could also provide landowners information regarding the benefits of riparian buffers. Riparian buffers provide many benefits. Some of these benefits are protecting and enhancing water quality, providing fish and wildlife habitat, providing streamside shading, and providing root structure to prevent bank erosion.

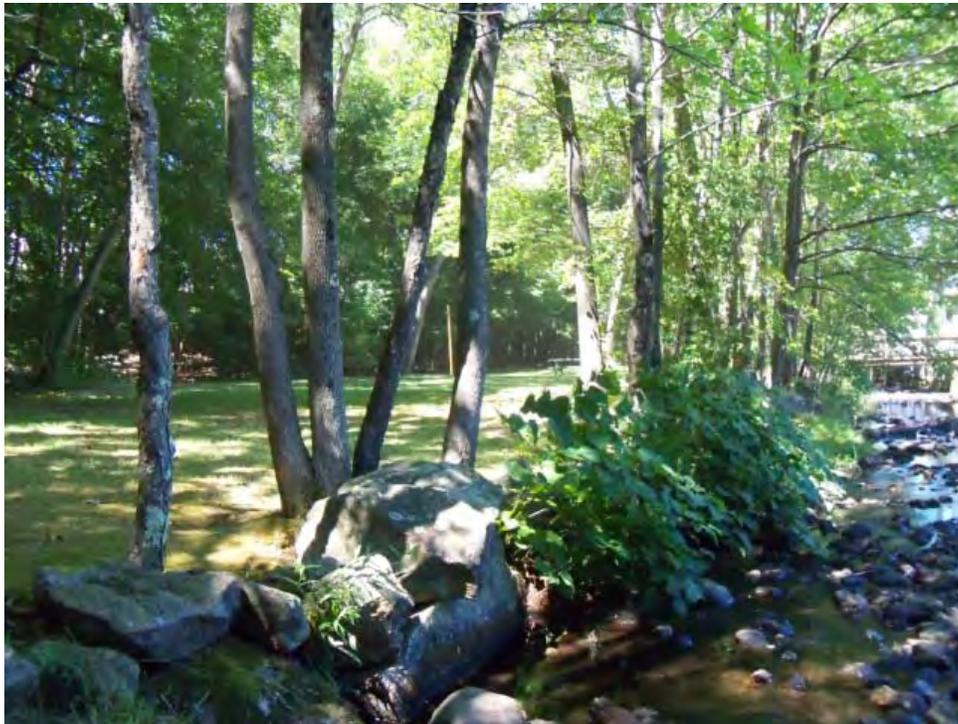
Figure 8.7. Narrow buffer on south bank at Tardiff Park

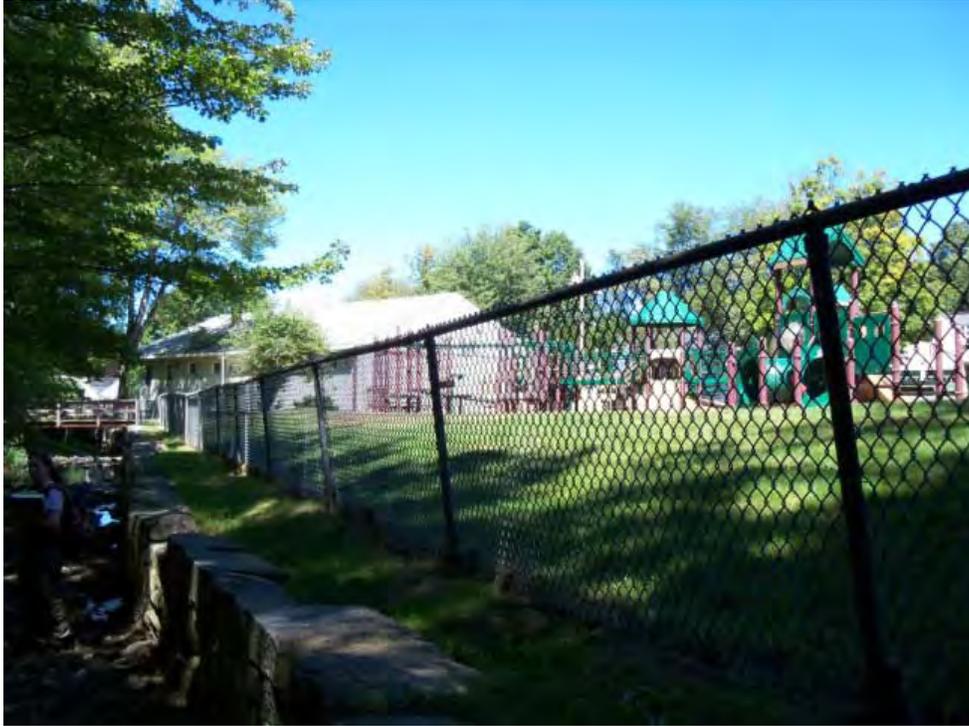
Figure 8.8. Lack of buffer on north bank at Tardiff Park

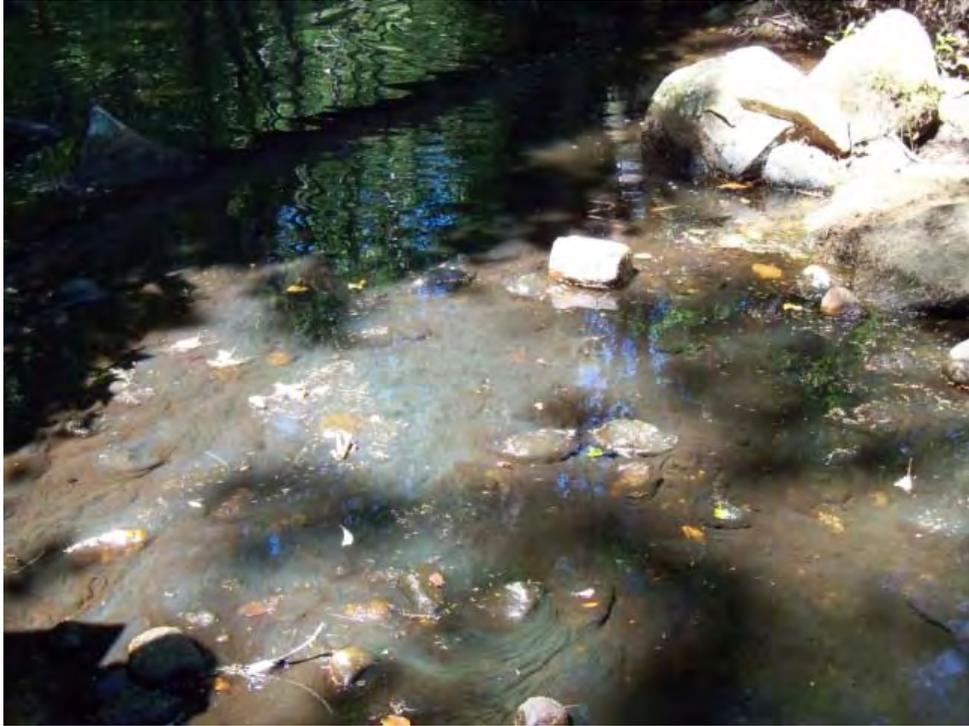
Upstream of Tardiff Park, grass clippings were in the channel and along the bank. A major algal bloom was observed (Figure 8.9). Similar to Reach M01, segment M02-A would benefit from a landowner education program that targets improving the water quality of Jewett Brook (Project #2 on Page 2 of Appendix C). Nutrient (phosphorus) loading to Jewett Brook could be reduced by disposing of grass clippings and pet waste properly. Grass clippings could be composted or left on the grass as a natural fertilizer. Pesticides and fertilizer should be used sparingly adjacent to the brook, and riparian buffers are recommended to filter stormwater, provide shade and stabilize the soil on the banks. In the vicinity of Brook Street and Paul Avenue, there is significant bank erosion and the rock riprap along the bank has deteriorated (Figure 8.10). Project #3 (Page 2 of Appendix C) has been recommended to evaluate solutions for addressing this erosion. There are a number of stormwater inputs in segment M02-A, and improved stormwater management is suggested as Project #4 (Page 4 of Appendix C).

Figure 8.9. Algal bloom upstream of Tardiff Park

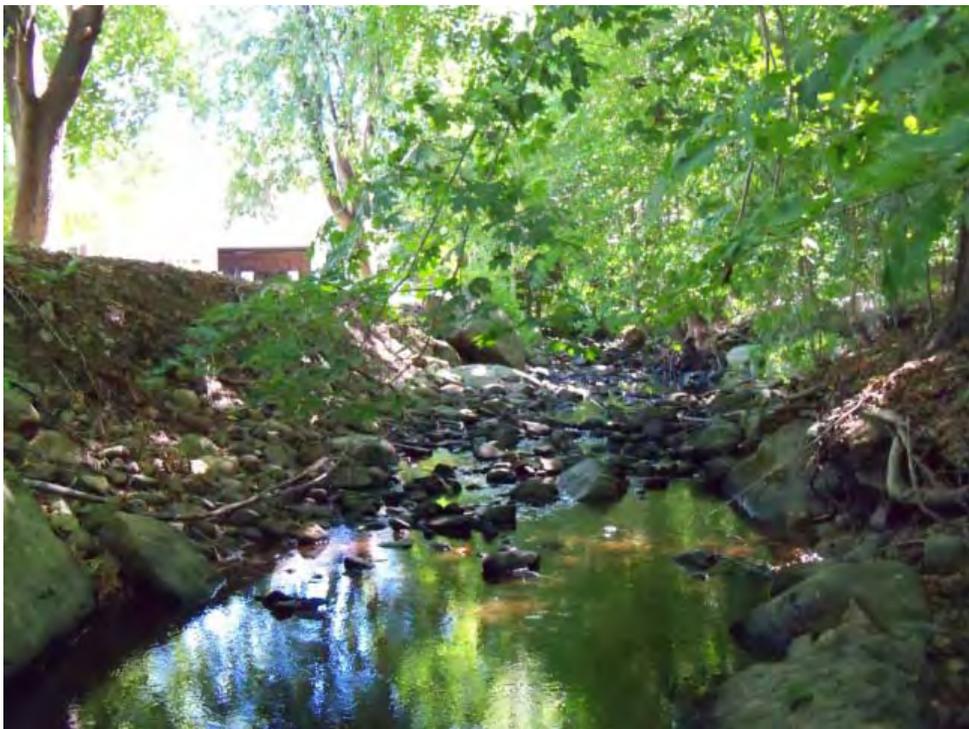
Figure 8.10. Bank erosion and failed riprap in the vicinity of Paul Avenue and Brook Street (see Project #3)

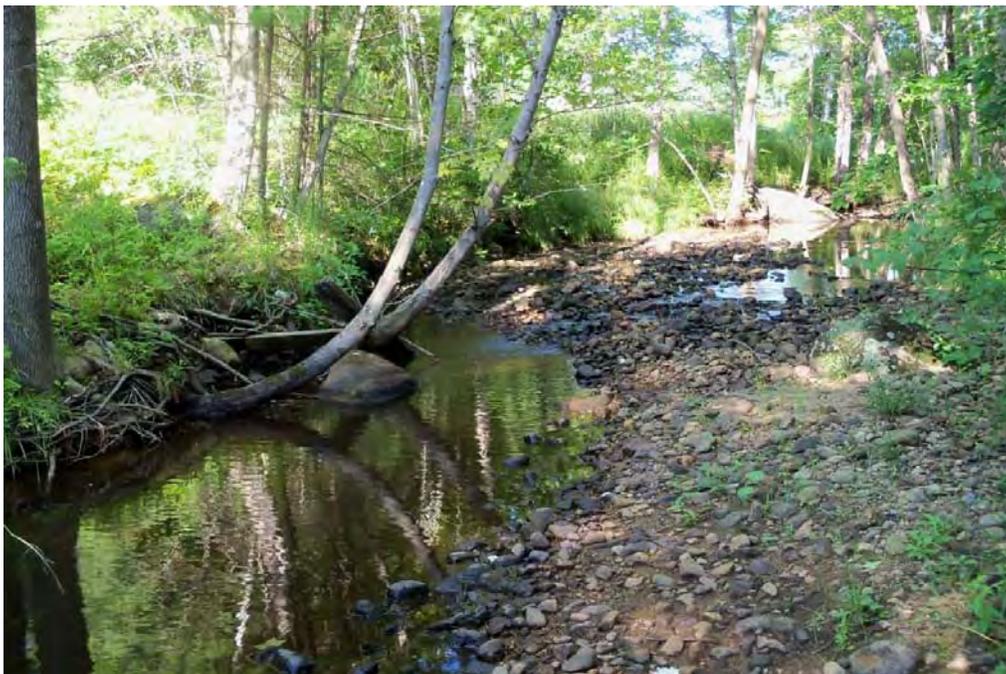
Figure 8.11. Segment M02-B is an important attenuation reach. A large diagonal bar is shown upstream of a pool. This section of channel has a high quality wooded corridor and excellent floodplain access.

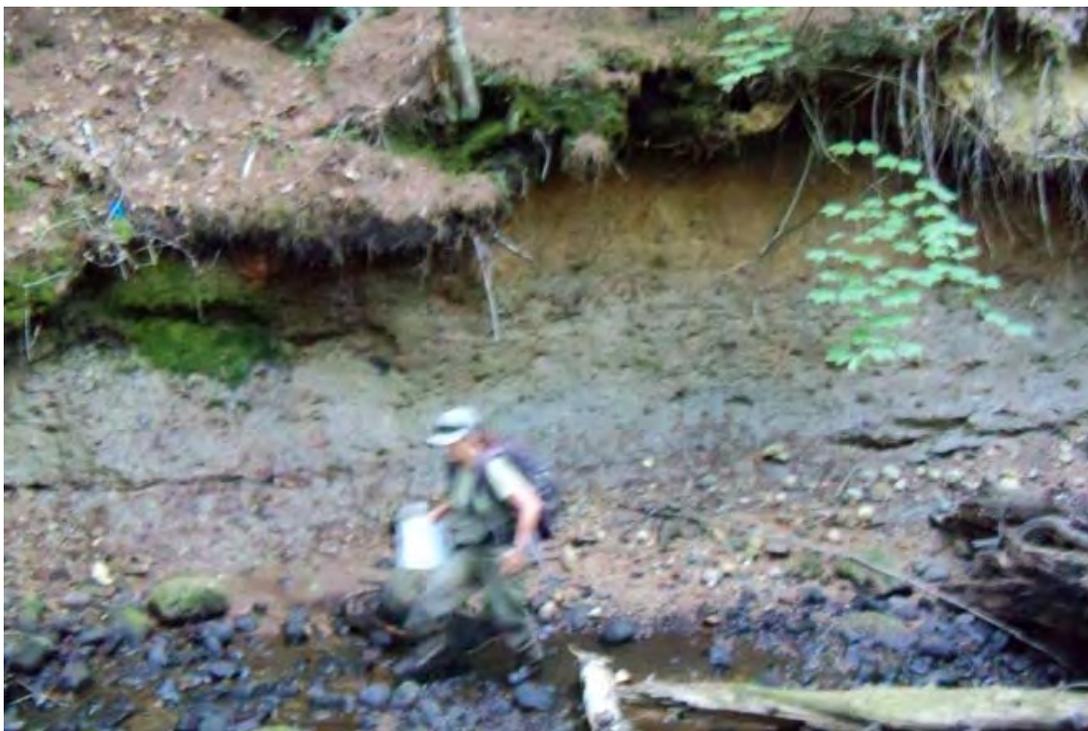
Segment M03-A has a riffle-pool bedform with sedimented (i.e., diagonal) riffles. A mass failure about 12 feet high and 50 feet long is located approximately 750 feet downstream of the outlet of the Route 3 & 11 culvert (Figure 8.12). Active planform adjustment, as evidenced by flood chutes, is occurring downstream of the Route 3 & 11 crossing (Figure 8.13). Bank erosion was noted to be moderate. The bank erosion and planform adjustment may be attributed to impacts from this significantly undersized structure. Although the structure is in good to fair condition, a culvert replacement project is recommended to provide improved sediment transport (Project #3 on page 3 of Appendix C). A significant iron seep is located in the vicinity of the Route 3 & 11 structure (Figure 8.14). If the culvert is replaced, consideration should be given to remediate this active iron seep, which enters from the north side of the channel (Project #2 on page 3 of Appendix C). Iron precipitate often occurs in areas where the soil has been disturbed. This can result in a decrease in available food and habitat for aquatic insects.

Figure 8.12. Mass failure 12 feet high by 50 feet long in M03-A

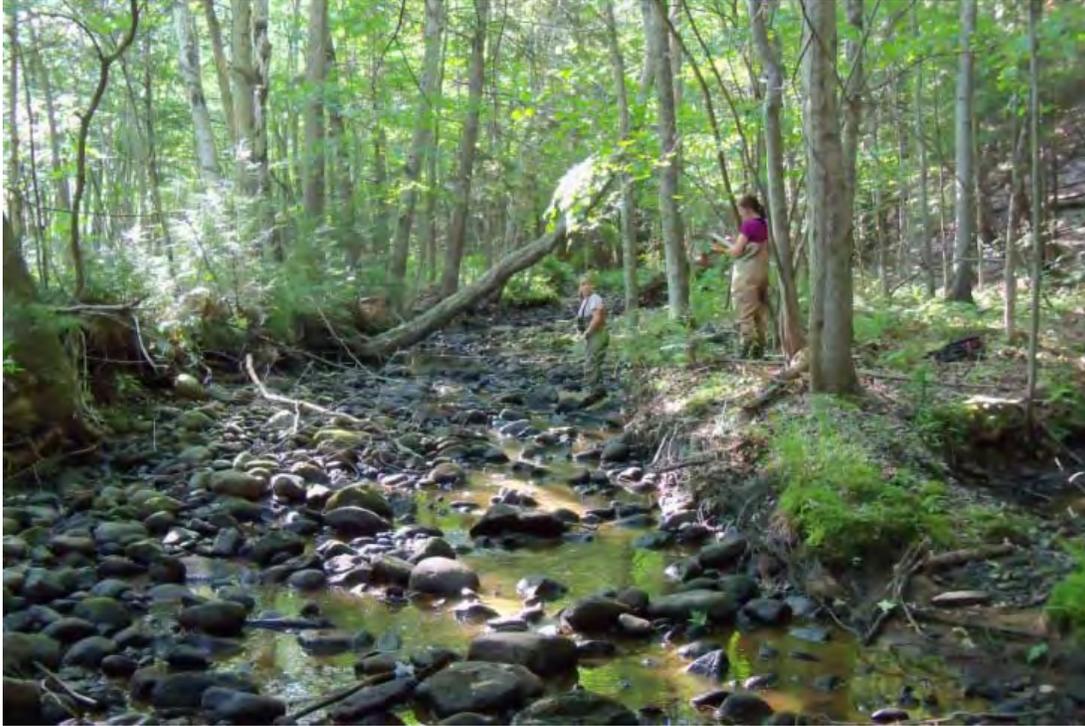
Figure 8.13. Typical channel with flood chutes in M03-A downstream of Route 3 & II culvert. Segment M03-A has relatively good floodplain access.

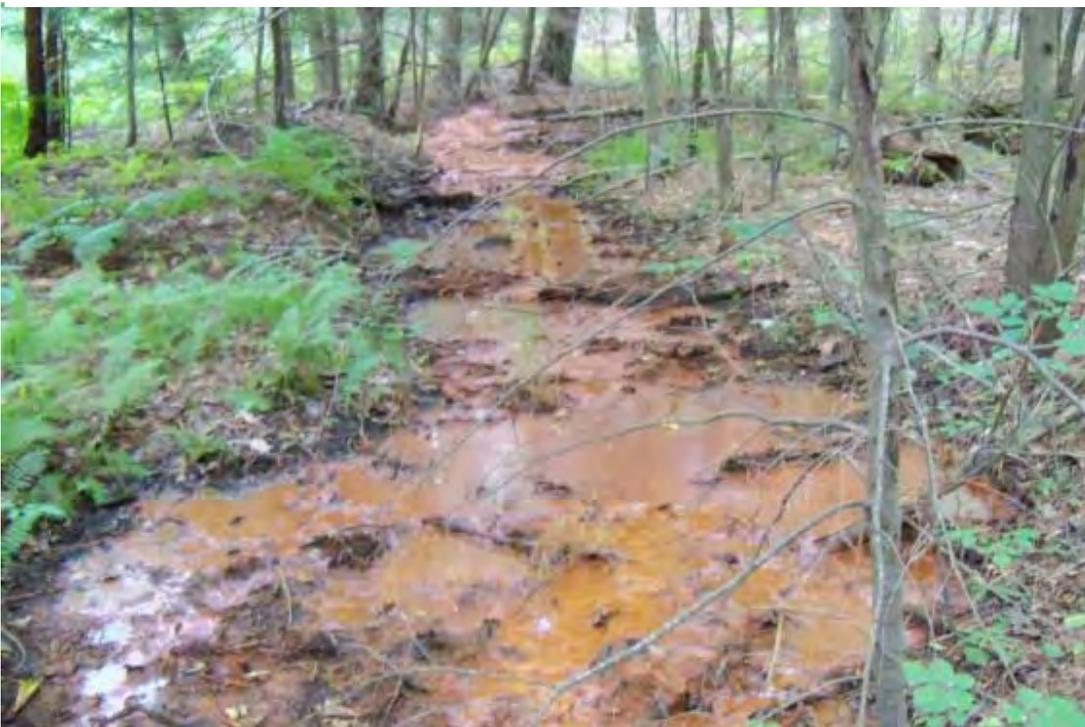
Figure 8.14. Swale entering below Route 3 & II crossing with iron precipitate

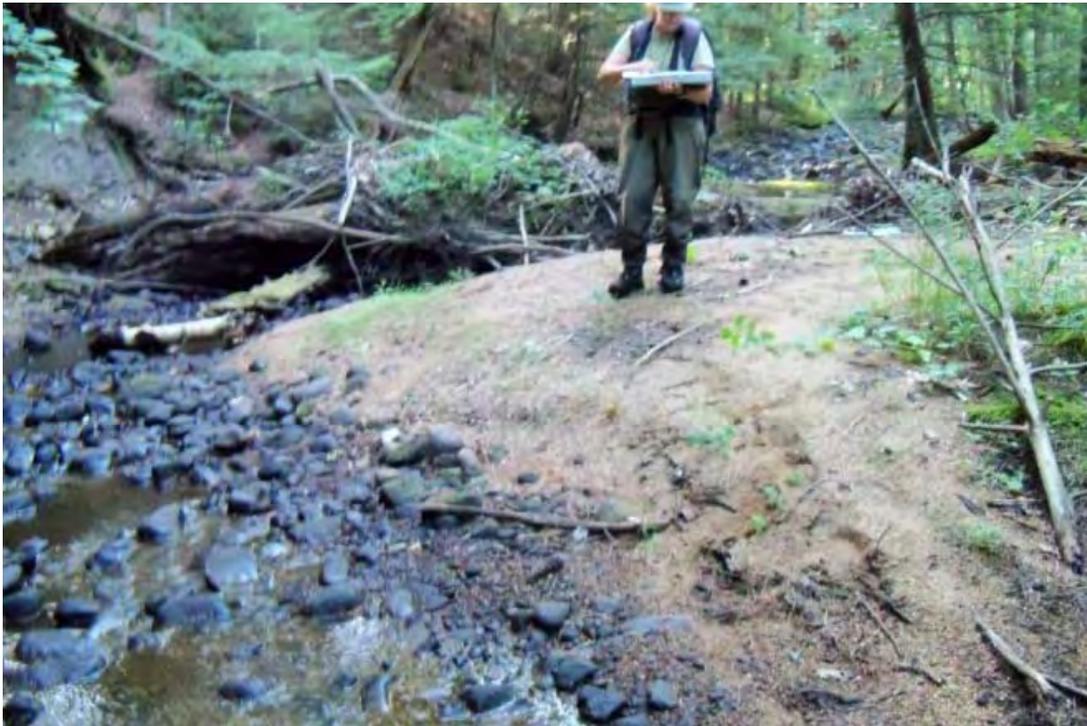
Figure 8.15. Debris jam and high depositional side bar in M03-A

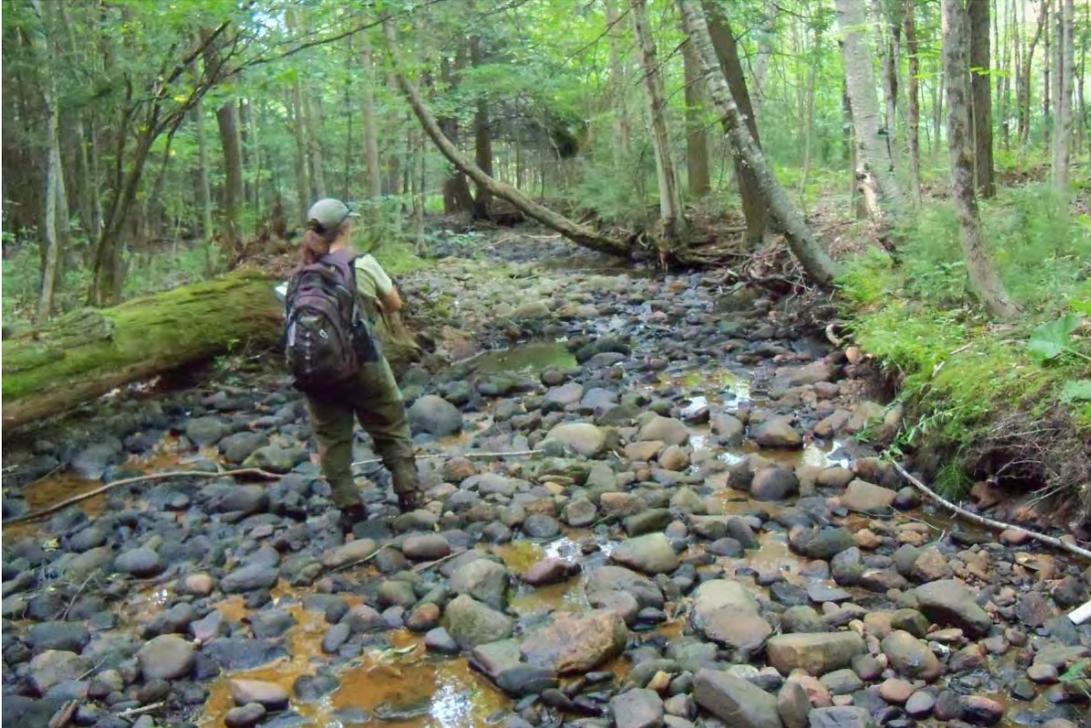
M03-A was difficult to assess because flow conditions at the time of the assessment were low and very little water was in the channel (Figure 8.16). Consistent with the geomorphic condition rating, the habitat condition also scored “fair”. Most of the habitat parameters scored in the good (minor) or fair (major) range. Hydrologic characteristics scored in the poor (severe) category because exposed substrate was greater than 60 percent and runoff characteristics are completely altered due to stormwater influence. The number of pools per mile fell in the good category; however, pool cover for fish was only fair. Most of the pools were shallow with the exception of the large scour pool located below the outlet of the Route 3 & 11 culvert.

Figure 8.16. High percentage of exposed substrate in Segment M03-A

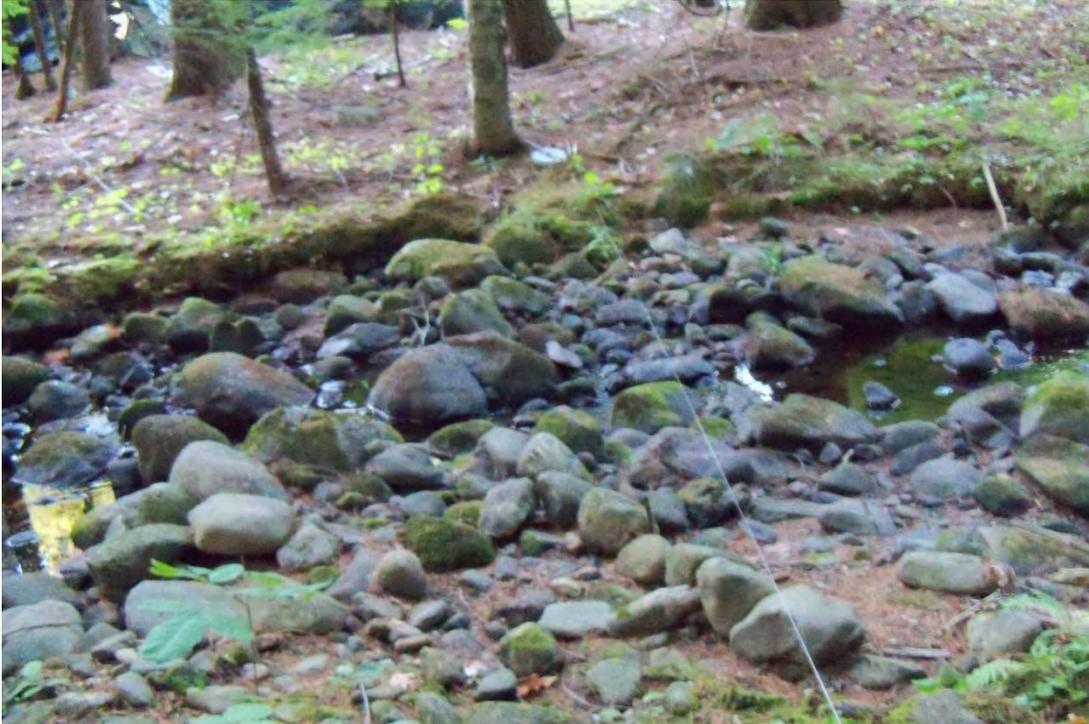
Figure 8.17. Channel with good floodplain access in Segment M03-B.

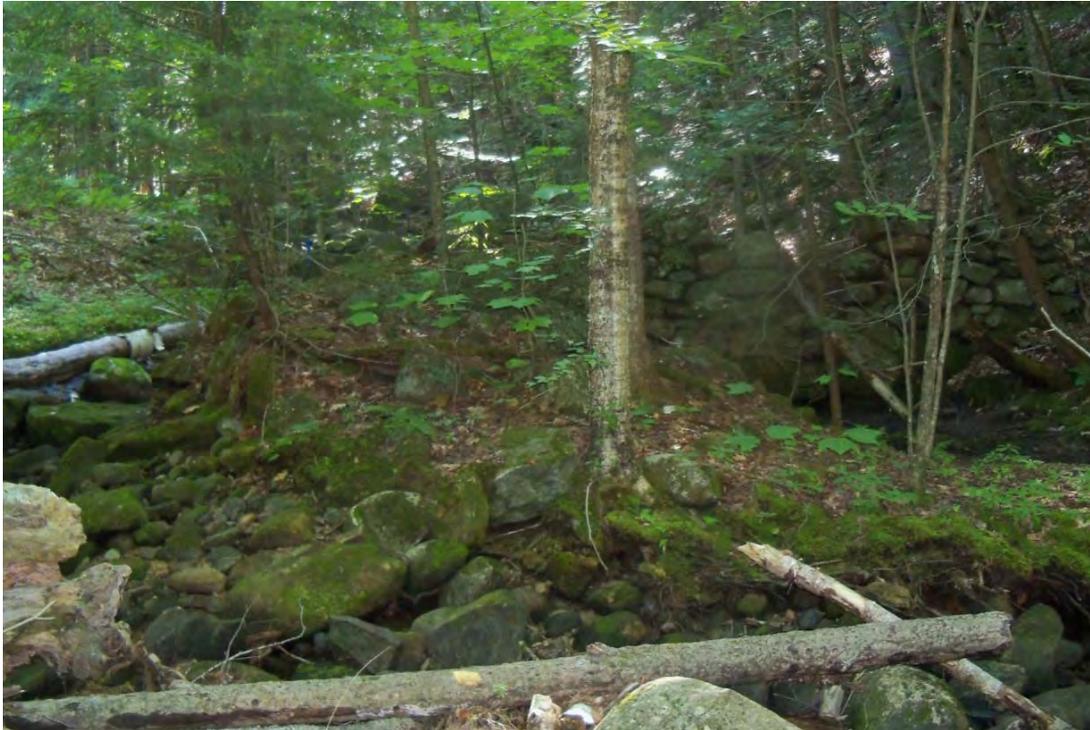
M04-A is gravel dominated and has a dominant bedform of step-pool. The bedform is planebed in areas where the slope is lower. The Country Club Road crossing is the only road crossing within segment M04-A. The twin culverts at Country Club Road are mostly incompatible in terms of geomorphic stability and were flagged as no aquatic organism passage including adult salmonids using the Vermont AOP screening tool. The structure is significantly undersized and is recommended for replacement (Project # 1 on Page 4 of Appendix C). An old rock wall, at the upstream end of M04-A is another channel constriction that is causing localized geomorphic incompatibility (Figure 8.18). The rock wall may be a remnant structure from a former mill, where streamflow was once diverted. An island has formed in this location and there are flood chutes downstream of the rock wall indicating major planform adjustment. An alternatives analysis is recommended to evaluate the planform issues at the former mill site and determine if it makes sense to remove the rock wall and a berm located downstream of the rock wall (Project #2 on Page 4 of Appendix C).

Figure 8.18. An old Rock wall has caused geomorphic instability within segment M04-A. The rock wall may be a remnant structure from an old mill site.

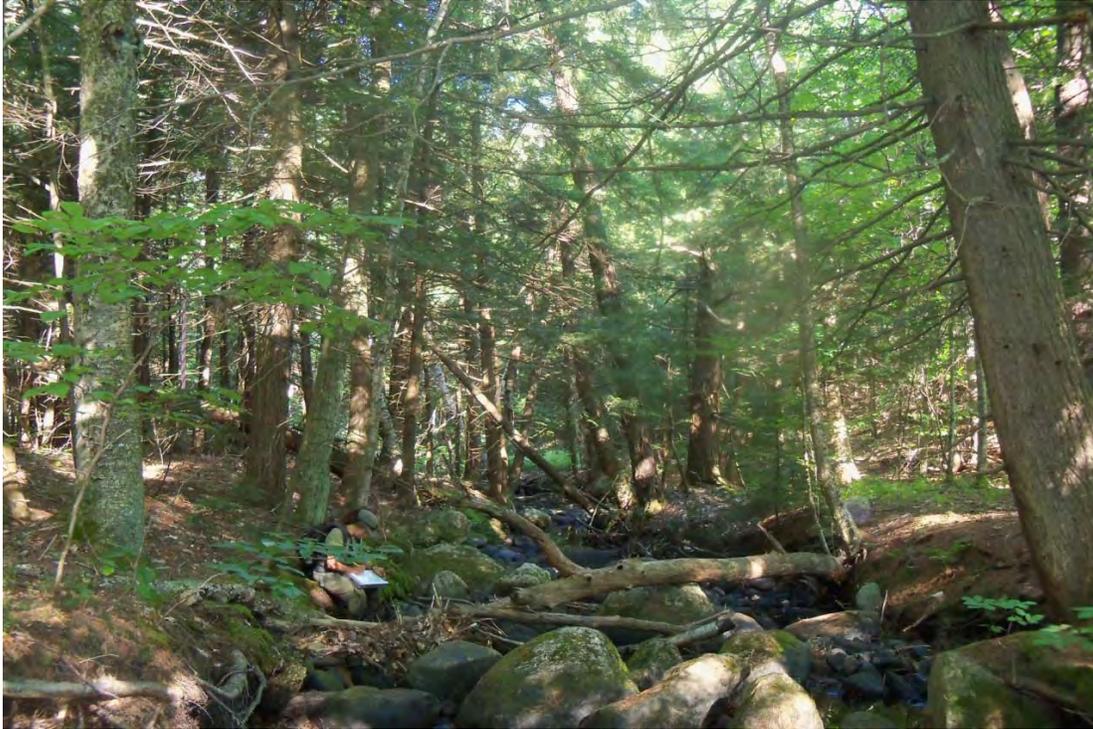
Figure 8.19. High quality banks and riparian corridor in Segment M04-B

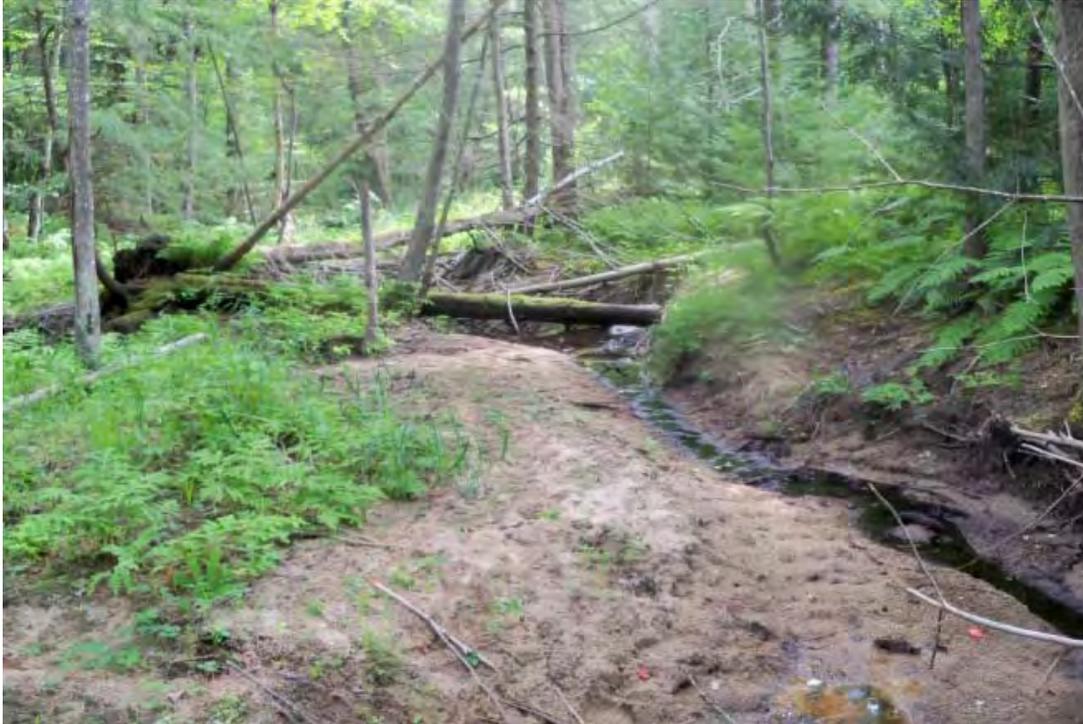
Figure 8.20. Sand dominated channel at top of Reach M05

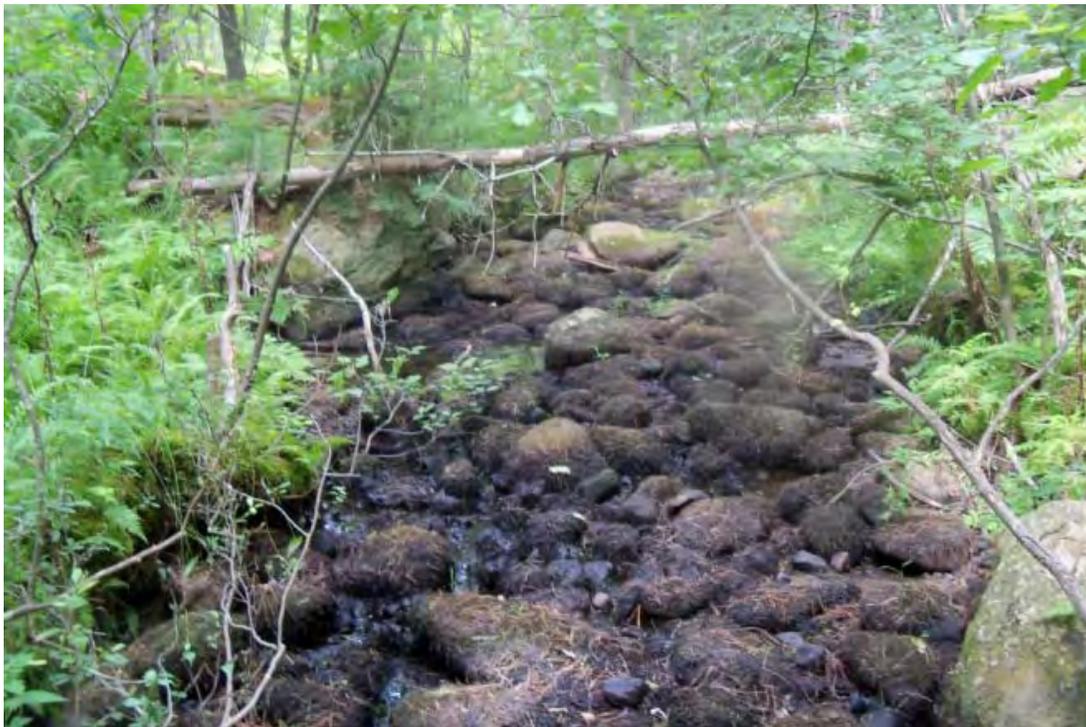
Figure 8.21. Gravel dominated channel with high width to depth ratio and dense moss above Swain Road crossing

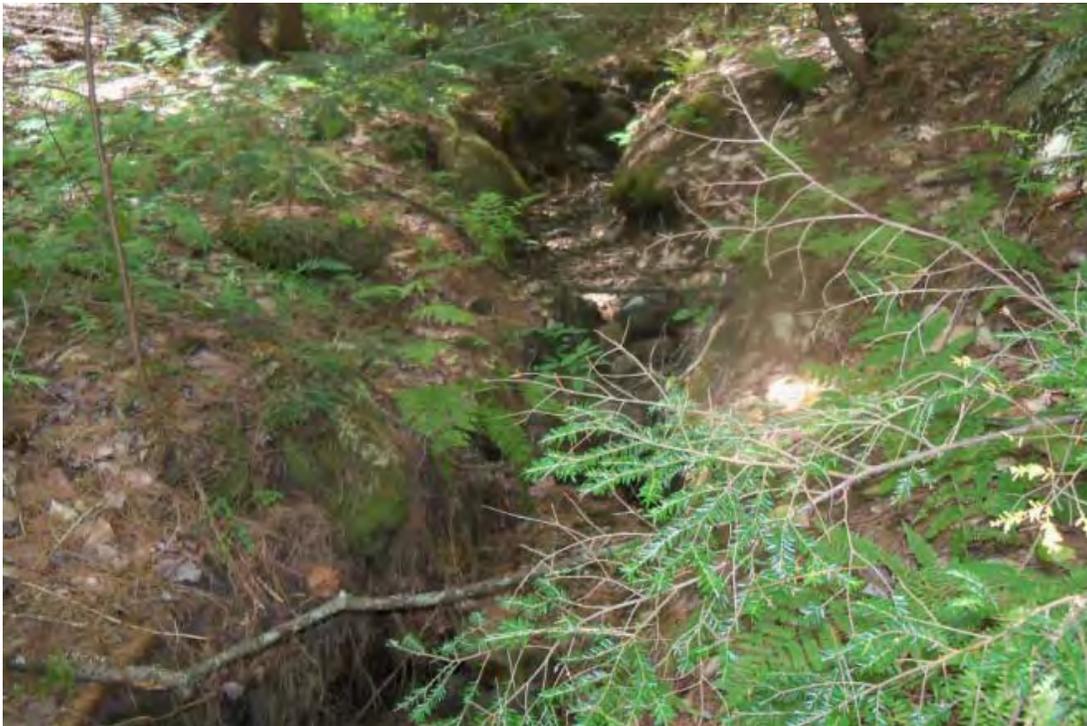
As shown in Figure 8.22, an incised tributary (swale) enters Jewett Brook from the west side about 300 feet downstream of Swain Road. It is recommended that the source of this incision be investigated and possible remediation measures be developed to reduce sediment entering Jewett Brook (Project # 3 on Page 5 of Appendix C). Bank erosion mapped in the field indicates Reach M05 has moderate erosion (about 25 percent of the banks are eroded). This erosion may have been overestimated due to lack of water in the channel. Much of the mapped erosion was at the upper end of the reach below Swain Road. In some locations there was dense moss cover along the banks (Figure 8.23).

Figure 8.22. An incised tributary (swale) enters Jewett Brook from the west about 300 feet below Swain Road

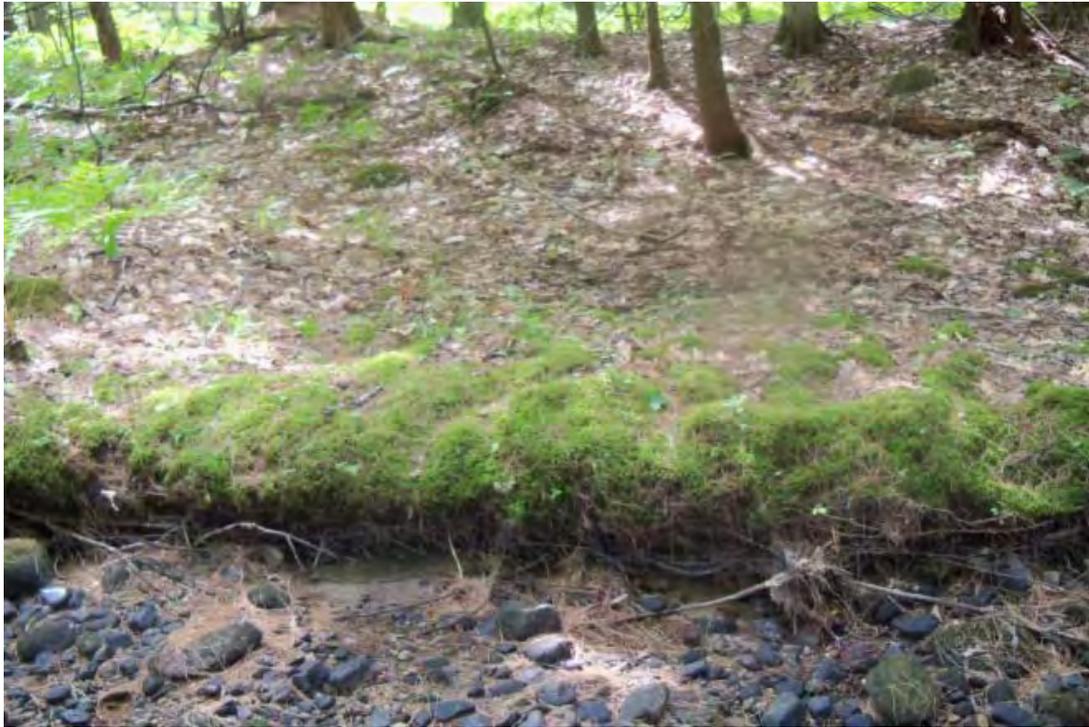
Figure 8.23. Dense moss cover on stable bank about 1100 feet below Swain Road

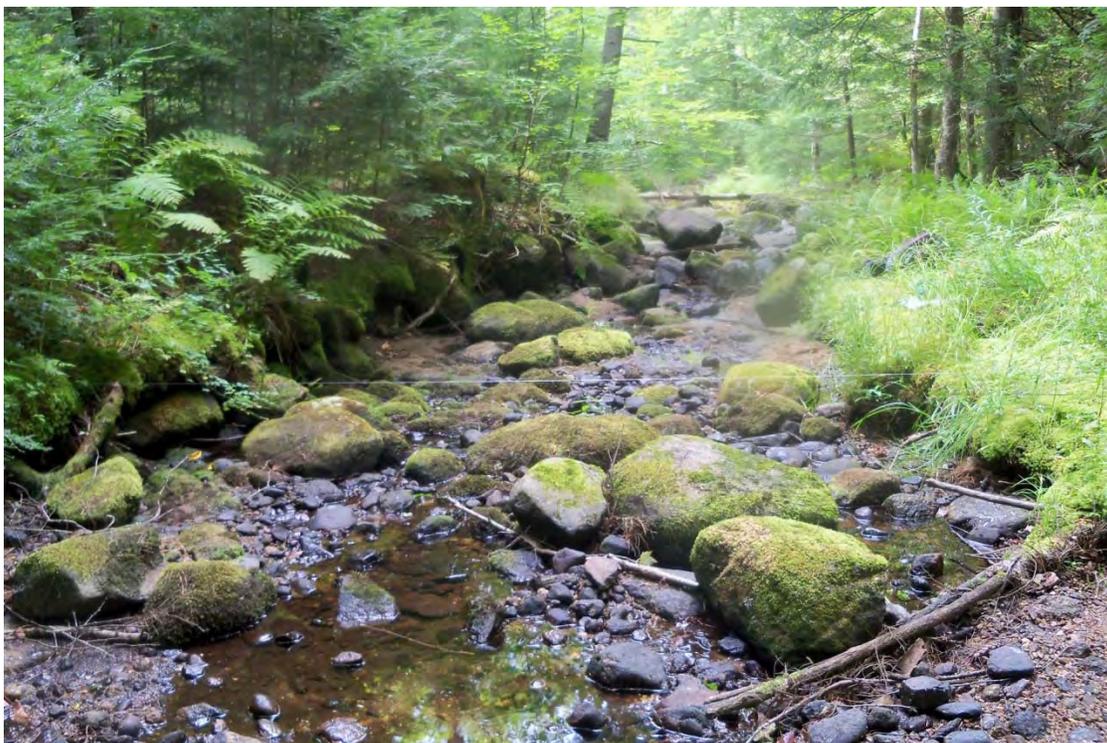
Figure 8.24. Typical channel in Reach M05

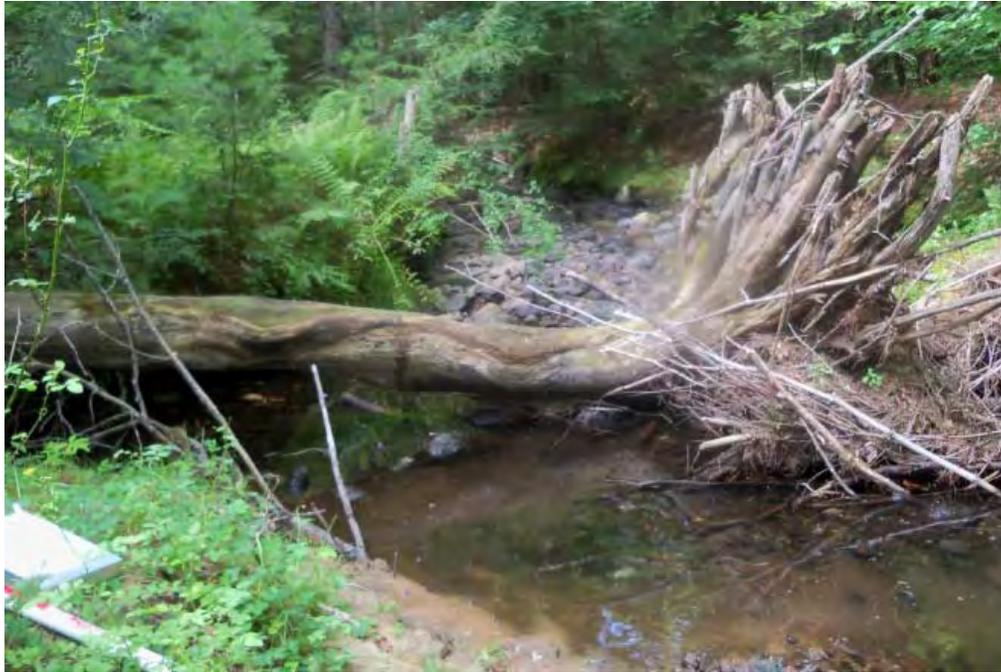
Figure 8.25. Root wad creating small pool

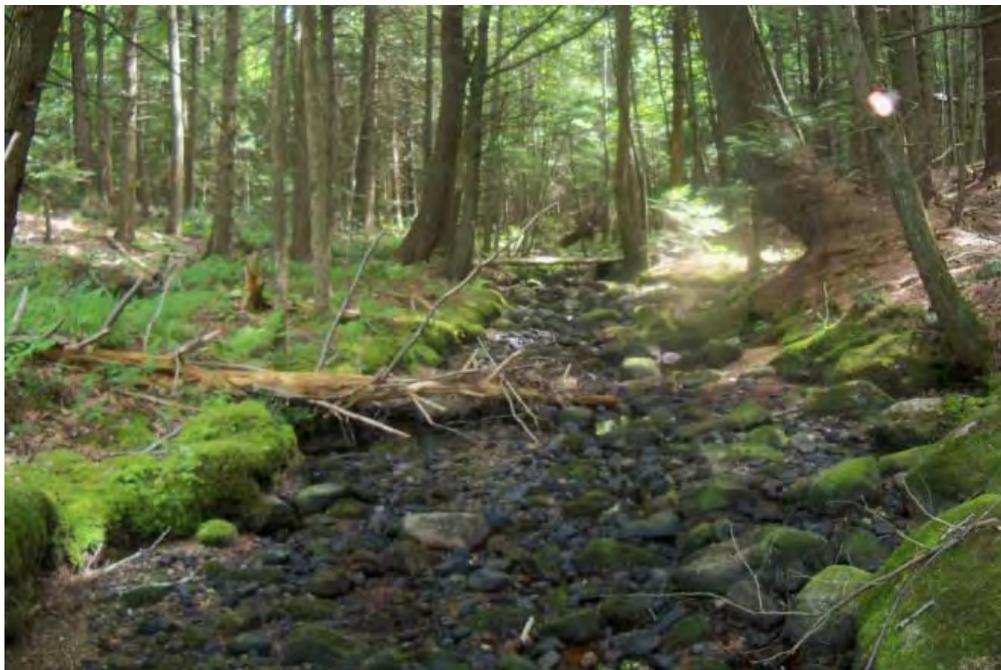
The habitat condition scored at the high end of the “fair” range. The lack of water in the channel greatly impacted the habitat condition. While pools per mile were frequent, very few pools provided deep habitat (over 2 feet in depth). There were few bank undercuts due to shallow water and exposed substrate was estimated to be ninety percent. The riparian area was close to reference condition, with wide buffers (greater than 150 feet), diverse native vegetation to provide canopy cover and the absence of river corridor development (Figure 8.26).

Figure 8.26. High quality buffer and riparian zone in reach M05

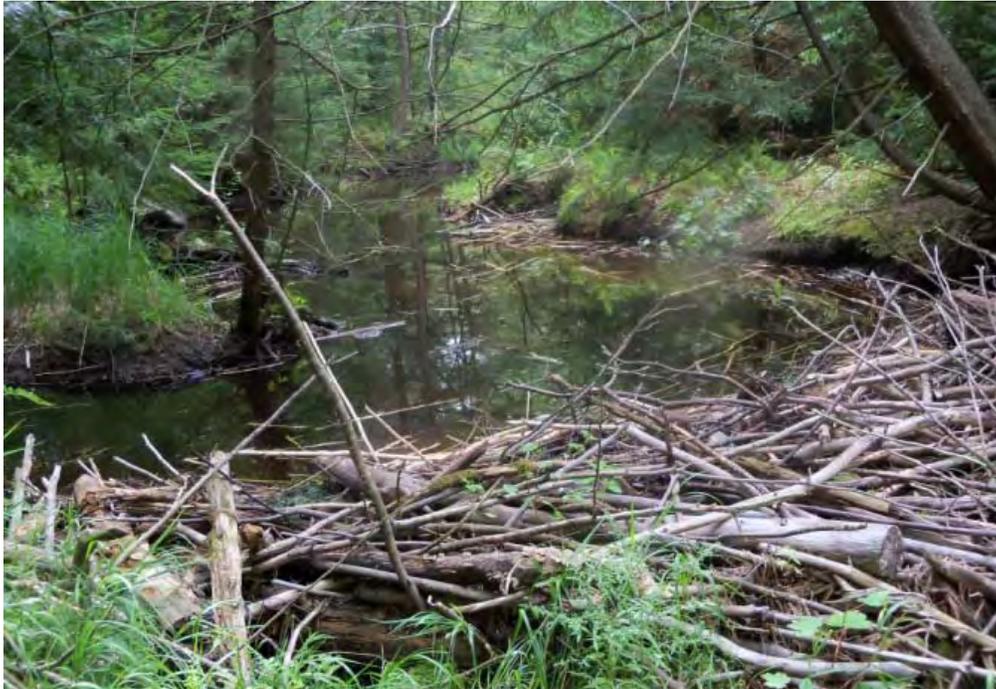
Figure 8.28. Upper extent of impact of beaver dam impoundment. Dominant tree species are white pine and maples
