Jewett Brook Watershed Stream Geomorphic Assessment Laconia and Gilford, New Hampshire May 30, 2011

Prepared by:
Bear Creek Environmental, LLC
297 East Bear Swamp Road
Middlesex, Vermont 05602

Prepared for:
New England District, U.S. Army Corps of Engineers
696 Virginia Road
Concord, MA 01742-2751

1.0 EXECUTIVE SUMMARY

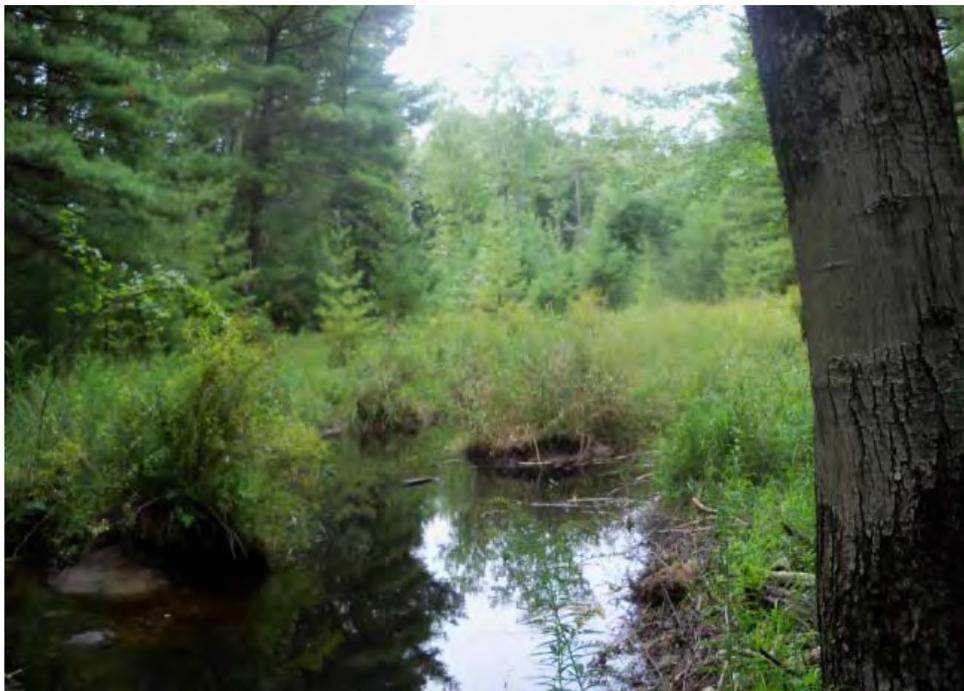
Figure 8.27. Beaver dam on reach break between M05 and M06

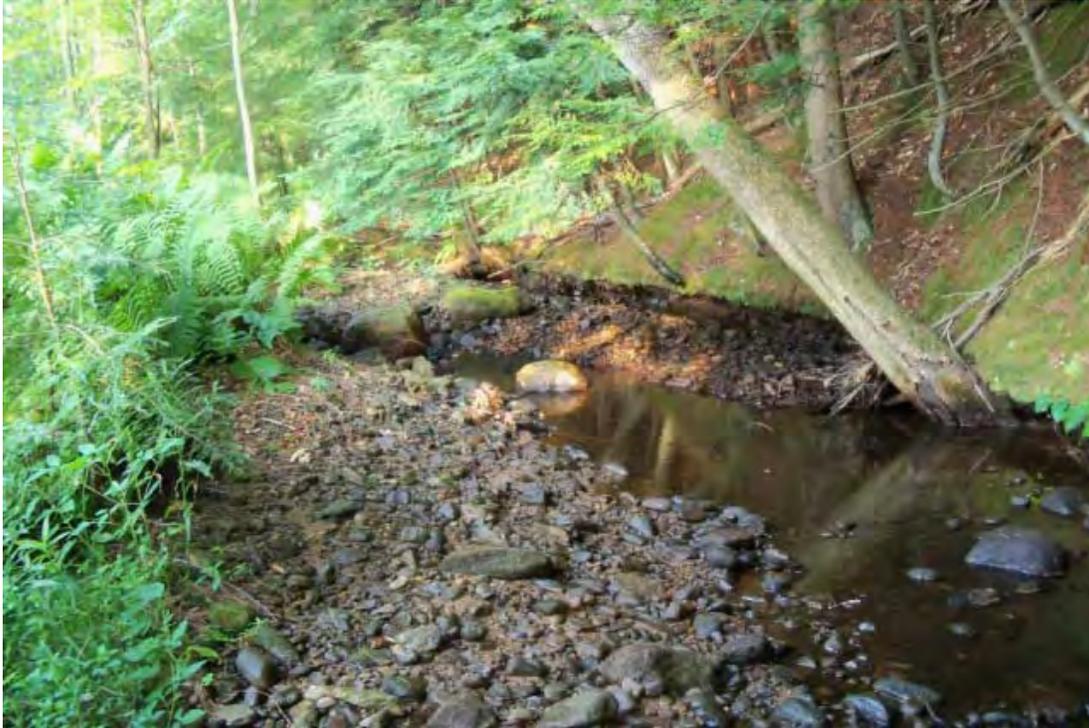
Figure 8.29. Large depositional feature in M02T1.01-A caused by upstream sediment transport

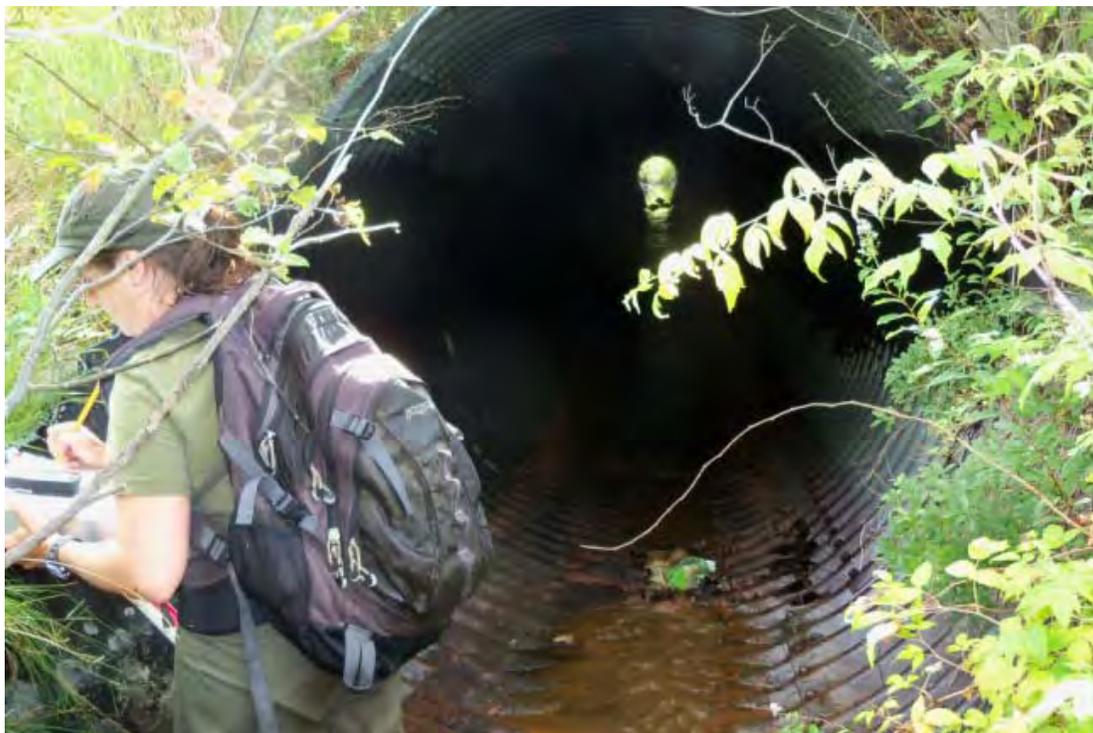
Figure 8.30. Long culvert in M02T1.01-B

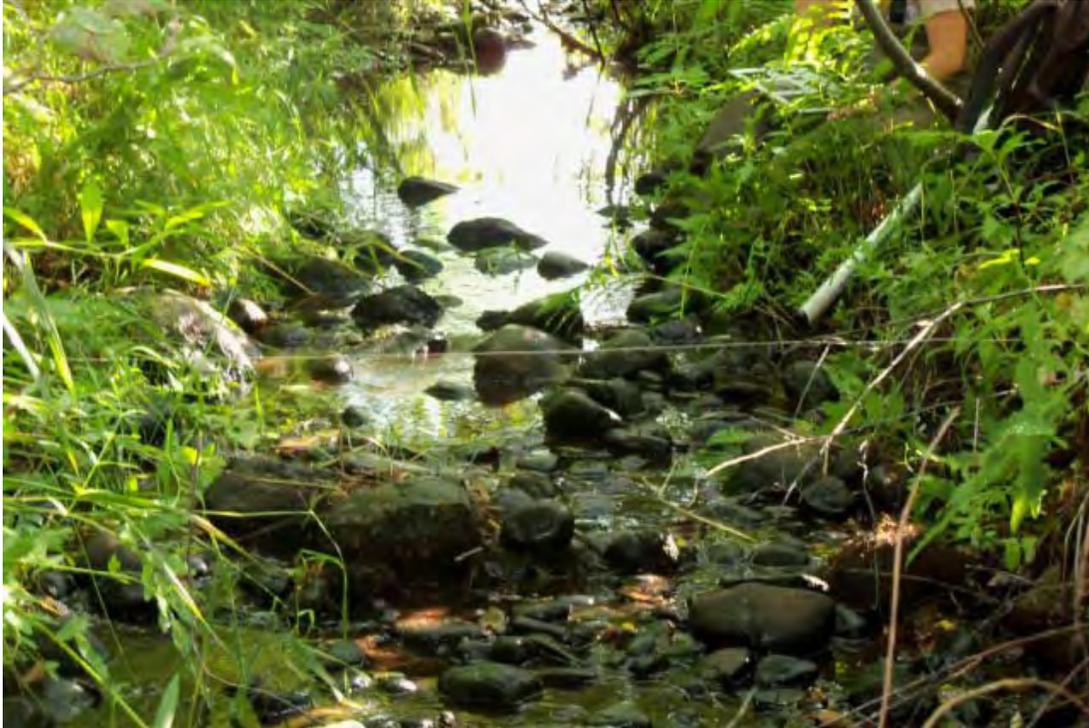
Figure 8.31. Typical channel of Segment M02T1.01-C

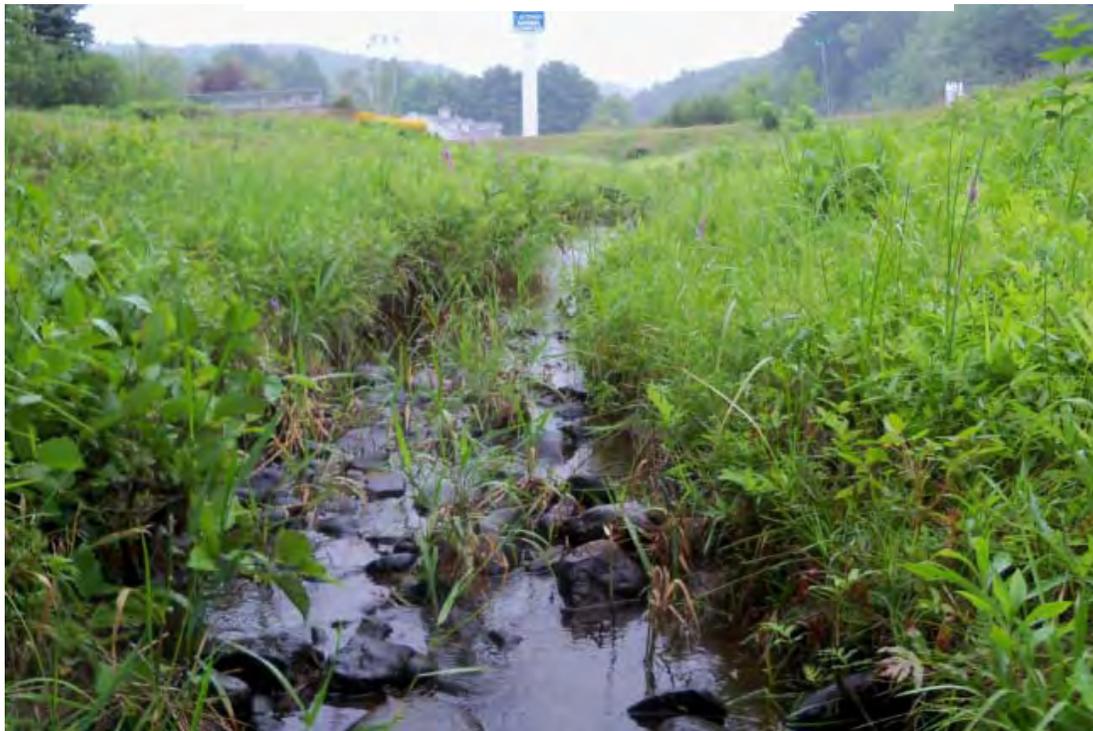
Figure 8.32. Channelized stream in previous wetland of M02T1.01-D

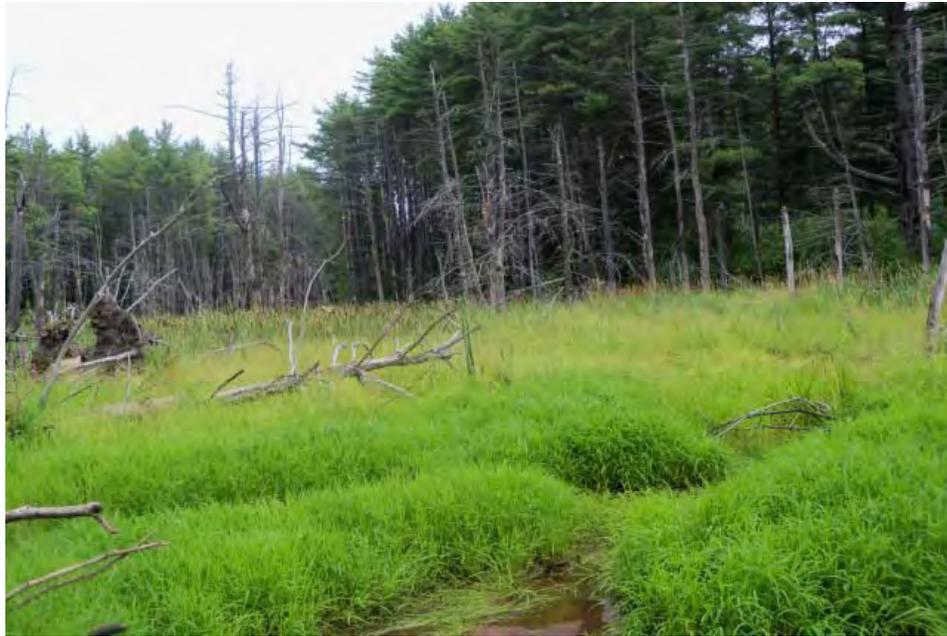
Figure 8.33. Wetland in Segment M02T1.01-E

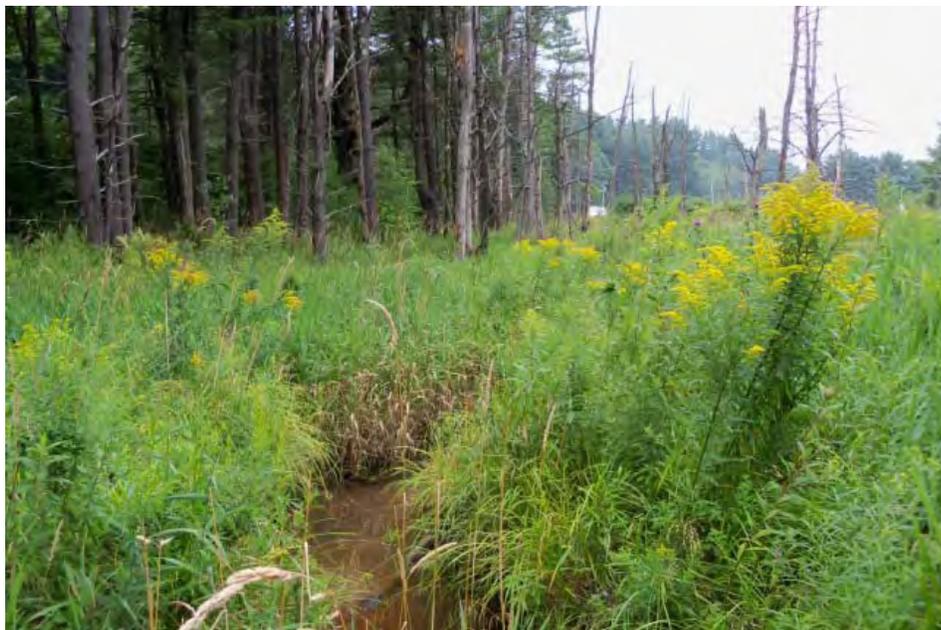
Reach M02T1.02 is 653 feet long and is a wetland channel that primarily contains herbaceous vegetation in both its buffers and near its banks (Figure 8.34). In contrast to the downstream reach, it has not been straightened and is not incised. The stream type is a gravel dominated “E” channel. Channel aggradation and planform adjustment are minor and incision and widening were scored in the reference range. Therefore, the RGA was scored as “good”. The RHA was also scored as “good” due to the high quality habitat conditions especially substrate cover and channel morphology. Since M02T1.02 has not incised, it is in Stage F-I of the channel evolution model.

Figure 8.34. Wetland channel in Segment M02T1.02
