**PHASE I ENVIRONMENTAL SITE ASSESSMENT**  
 New England Yard  
 a.k.a DPW New England Yard  
 210 Messer Street  
 Laconia, New Hampshire  
 NHDES#200911005

May 2, 2011

**Subject: Phase I Environmental Site Assessment  
New England Yard (a.k.a. DPW New England Yard)  
210 Messer Street, Laconia, New Hampshire**

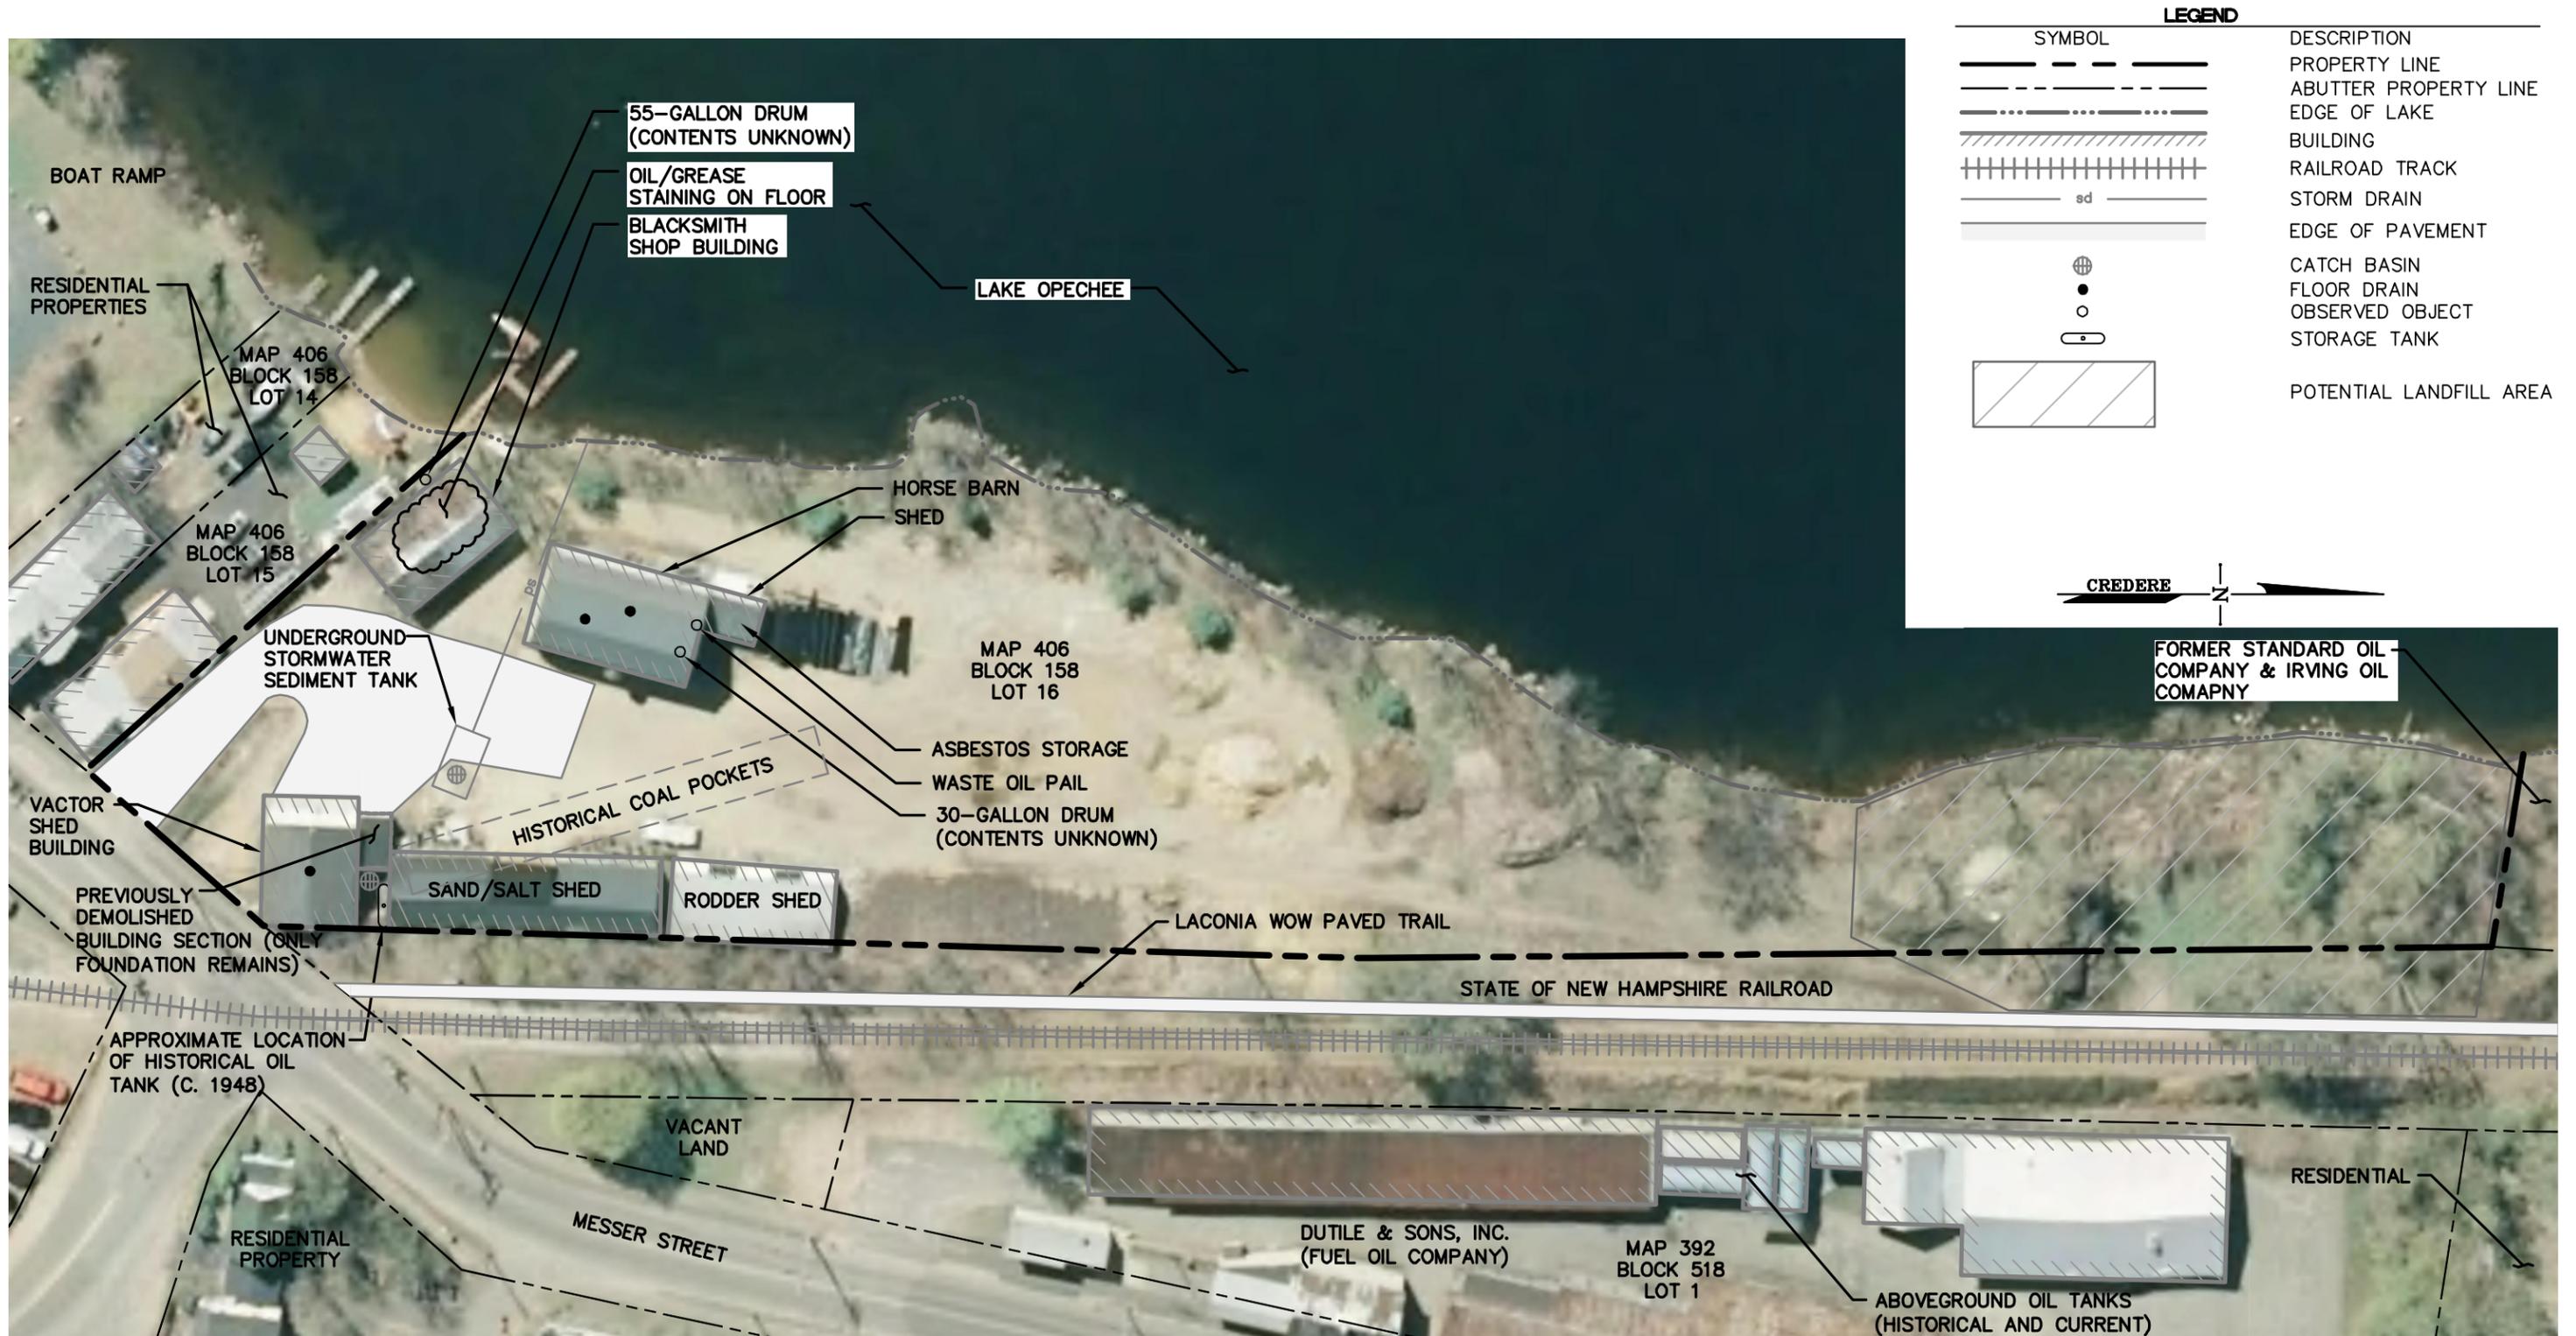
The exterior of the subject property was observed by walking the perimeter of the subject property; by observing the subject property from Messer Street and the Laconia WOW Paved Trail; by walking the perimeter of the buildings; and by walking the undeveloped portions of the subject property in several transects. Pertinent subject property features are depicted on **Figure 2**.

NOTE: INFORMATION SHOWN ON THIS PLAN IS FROM INFORMATION PROVIDED ON THE CITY OF LACONIA "MAPS ONLINE" AND FROM FIELD OBSERVATIONS ON DECEMBER 7, 2010.

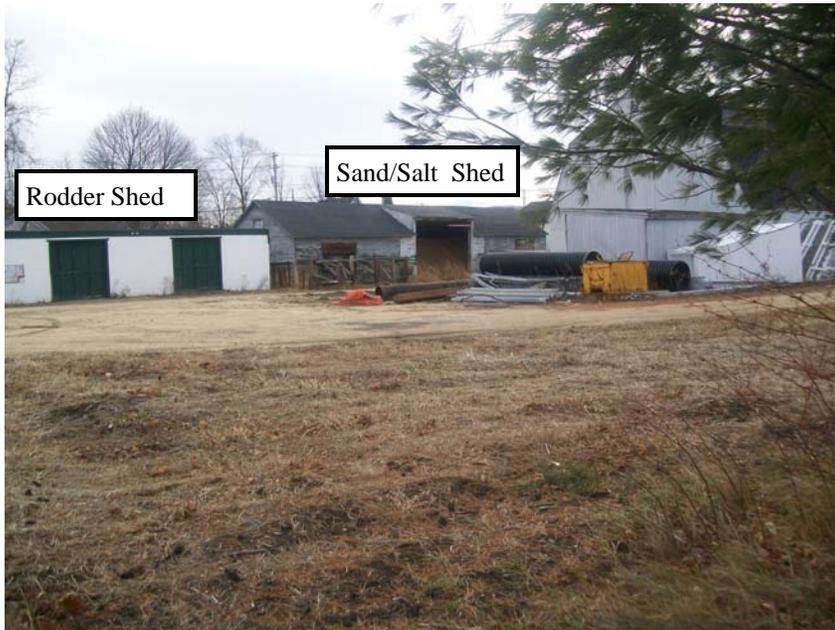
**Picture 5**

View of the Rodder Shed building and the Sand/Salt Shed building looking southeast.

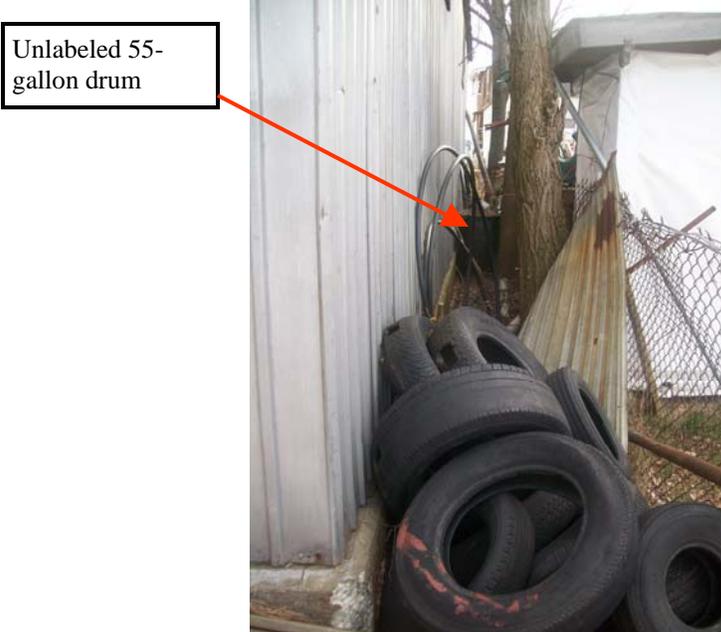
**Picture 6**

- REC-7 – The open pail of waste oil and approximately 30-gallon drum of unknown contents observed in the Horse Barn building and 55-gallon drum of unknown contents observed outside the Blacksmith Shop building represent a REC because these items are improperly stored and labeled and represent a material threat of release.

Items stored in exterior portions of the subject property include pipes, tires, guardrails, metal equipment, and wooden items. One (1) unlabeled 55-gallon plastic drum was observed outside and south of the Blacksmith Shop (**Picture 6** and **Figure 2**). No other evidence of petroleum or hazardous materials storage was observed in exterior portions of the subject property. However, one (1) unlabeled 55-gallon steel drum was observed on the south adjoining property, and several large ASTs were observed on the Dutile & Sons, Inc. property, which adjoins the subject property to the east.

View of the area south of the Blacksmith Shop building and the unlabeled 55-gallon drum looking southeast.

- Phase II ESA activities are recommended to confirm or dismiss the identified RECs that may have impacted the subject property.
- The waste oil pail and 30-gallon drum observed in the Horse Barn, and the 55-gallon drum observed outside the Blacksmith Shop should be properly managed and/or disposed in accordance with state and/or federal guidelines.
- The waste asbestos piping stored in the Horse Barn shed should be properly disposed in accordance with NHDES Env-SW-900 guidelines.
- Consistent with the redevelopment plans for the subject property, asbestos, lead-based paint, and PCB building materials surveys should be completed to confirm or dismiss the presence, and/or delineate the extent of hazardous building materials on or within the buildings.

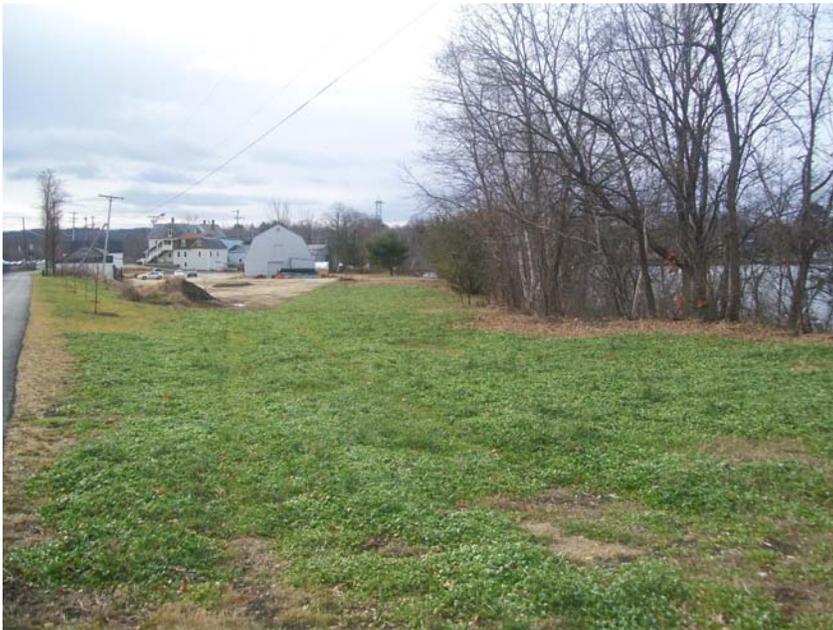
### **Picture 7**

The previous Phase I ESA noted that the northern portion of the subject property may have been used for landfilling (**Section 4**). The northern portion of the subject property (**Picture 7**) is higher in elevation than the subject property's gravel lot and the surrounding properties. It appears to have potentially been filled to level the area with the raised railroad bed and Laconia WOW Paved Trail. Although no solid waste was visible, inert materials such as concrete and granite blocks were visible protruding from the banks of this area.

View of the suspected landfill area in northern portion of subject property looking south.

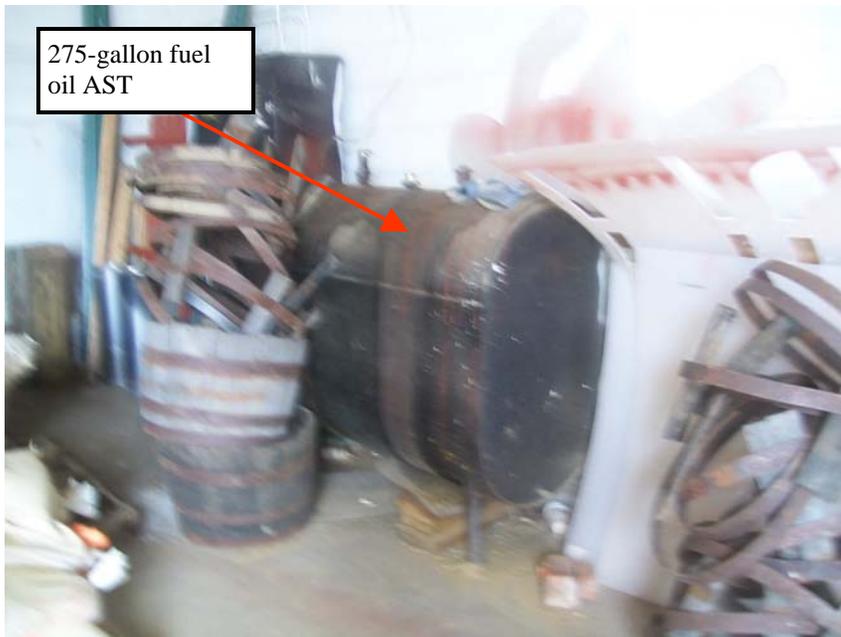
### **Picture 8**

View of the 275-gallon fuel oil AST within the Vactor Shed.

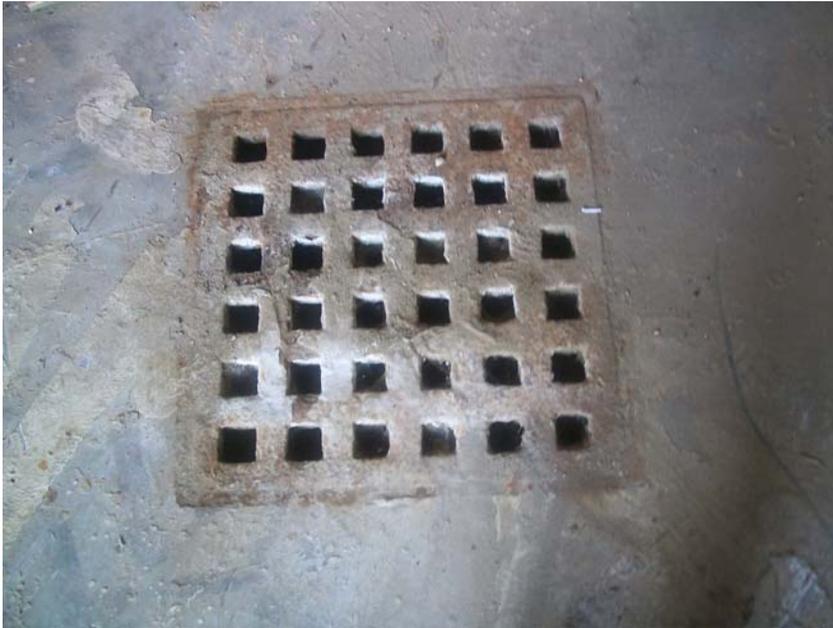
### **Picture 9**

- REC-6 – The floor drain located within the Vactor Shed building represents a REC because evidence of dumping was observed around the drain (i.e. paint covered grate and floor) that may have resulted in releases to the environment.

View of the floor drain in the Vector Shed building. Note the paint coated grate and floor around the drain.

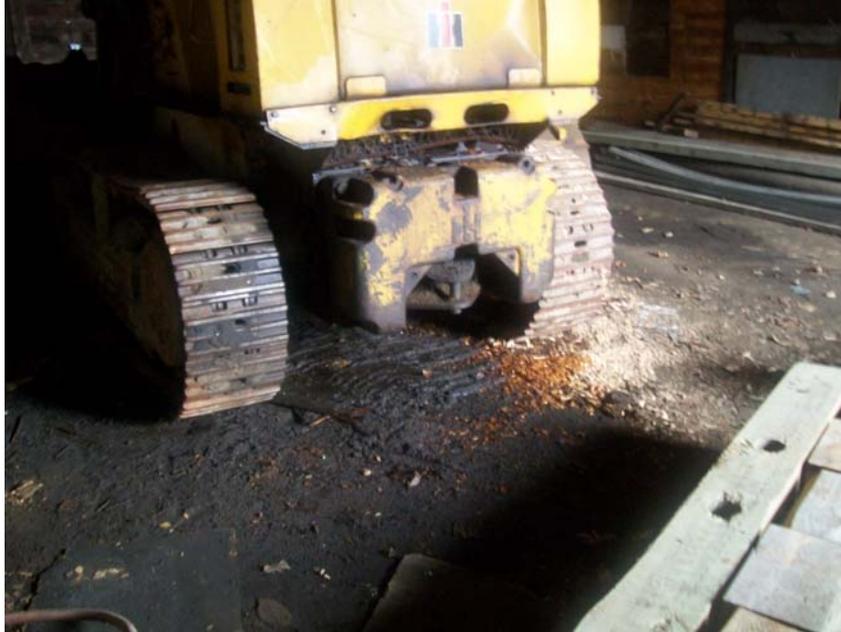
### **Picture 10**

- REC-2 – Oil stained soil observed within the Blacksmith Shop represents a REC because it is indicative of a release of oil and/or hazardous substances, which may have affected soil and/or groundwater at the subject property.

View of the oil stained floor within the Blacksmith Shop building.

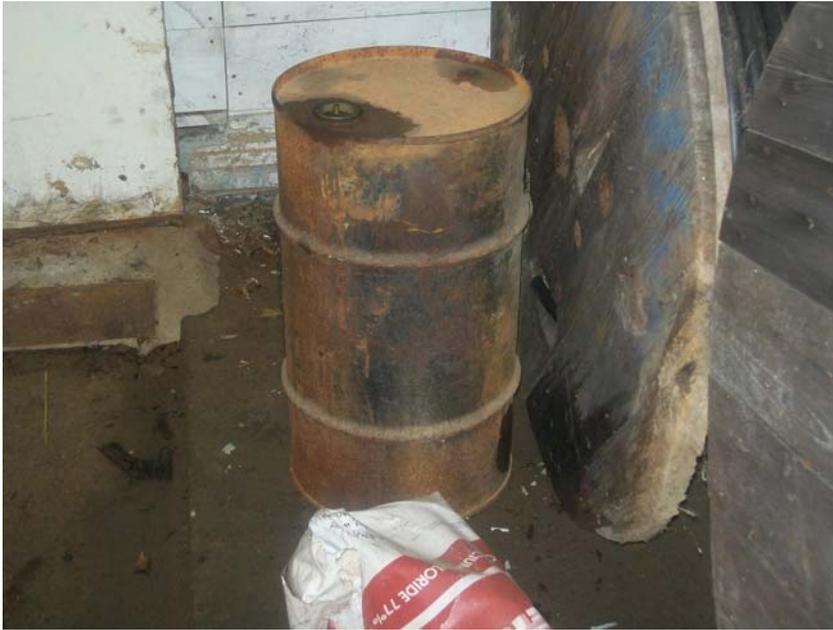
**Picture 11**  
View of 30-gallon  
drum of unknown  
liquid with the  
Horse Barn build-  
ing.

Two (2) pallets of calcium chloride were observed on the first floor that are reportedly used for dust control on other City of Laconia properties. One partially full approximately 30-gallon steel drum of an unknown liquid was observed next to the pallets (**Picture 11**). No visual evidence of leaks or spills was observed around the drum. One partially full pail of what appeared to be waste oil and a small gasoline can were observed in the northwest corner of the ground floor (**Picture 12**). No evidence of leaks or spills was observed in this area. Two (2) floor drains were observed in the concrete floor. Both drains appeared blocked with dirt. No evidence of staining or dumping was observed around the drains. No other evidence of petroleum or hazardous materials storage was observed on the first floor.

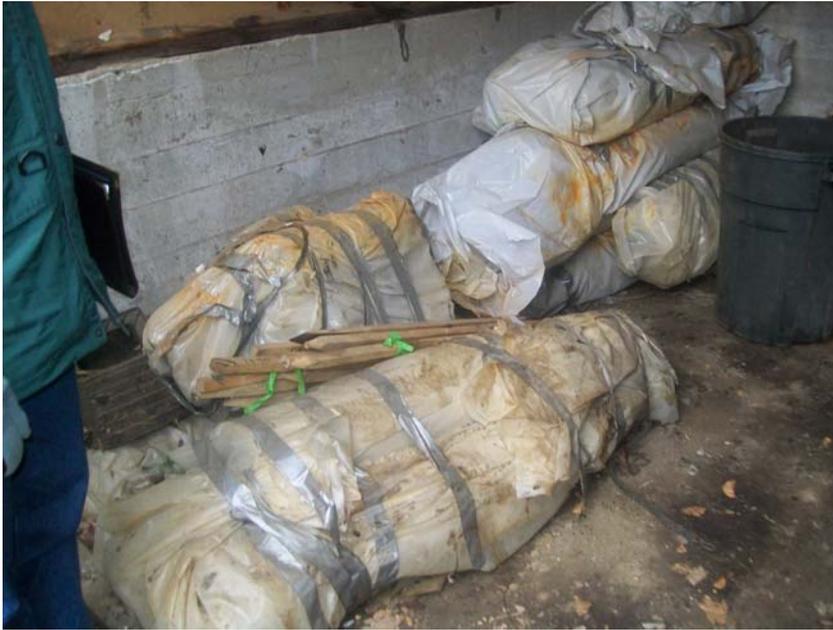
**Picture 13**

- DMEC-1 –Waste asbestos piping that was observed to be stored in the locked Horse Barn shed.

View of baled asbestos pipe observed in the Horse Barn building attached shed.

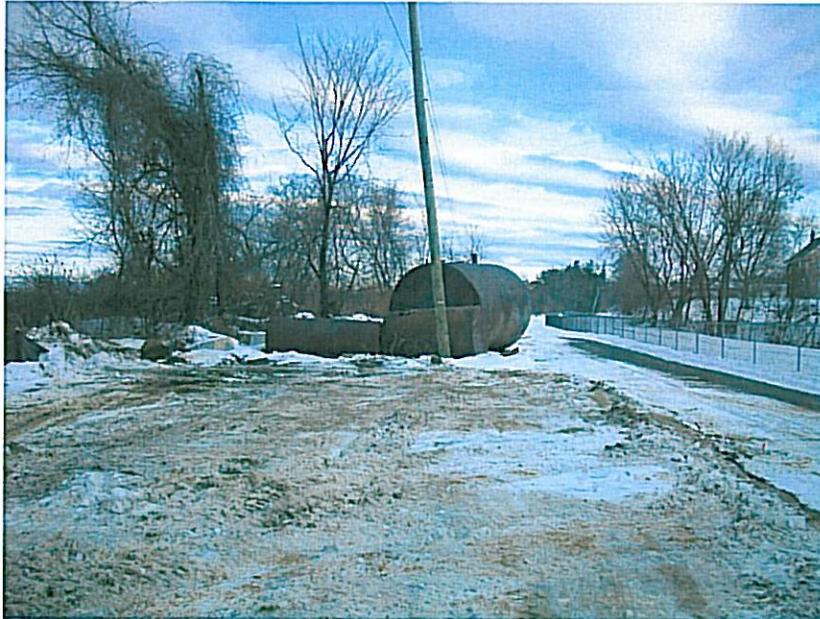
1. View looking to the north of the three aboveground storage tanks (ASTs) prior to removal activities on January 12, 2010.

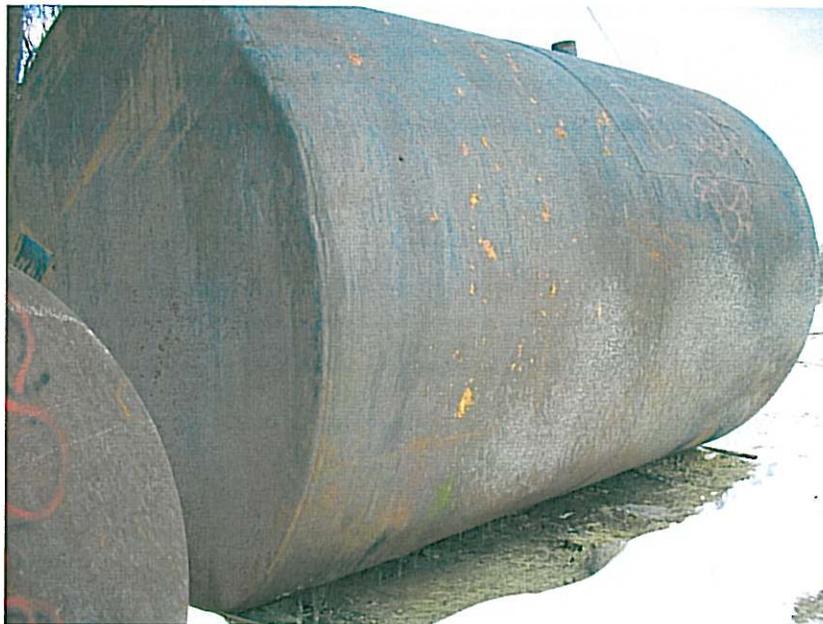
2. View looking to the north of the 9,400-gallon No. 6 fuel oil AST prior to removal activities on January 12, 2010.

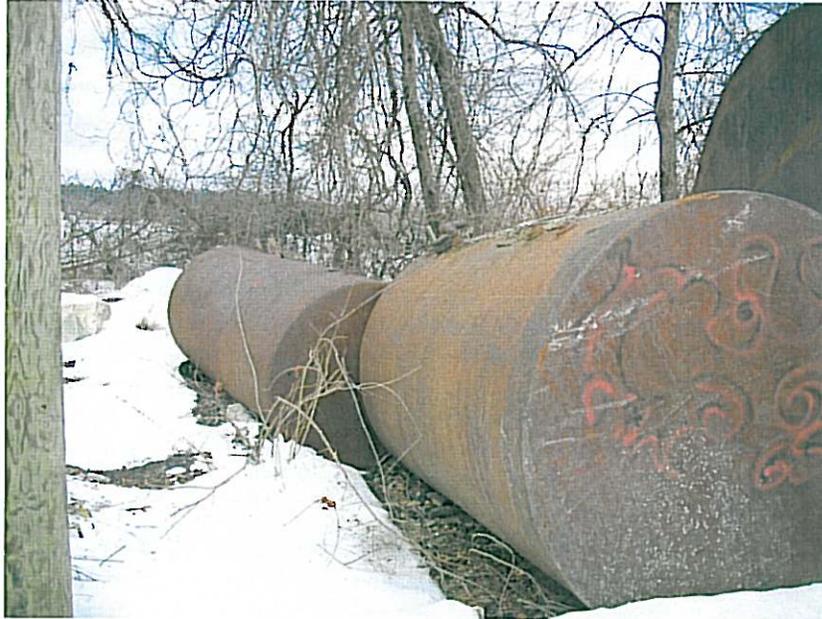
3. View looking to the west of the 1,500-gallon (foreground) and 1,000-gallon (background) ASTs prior to removal activities on January 12, 2010.

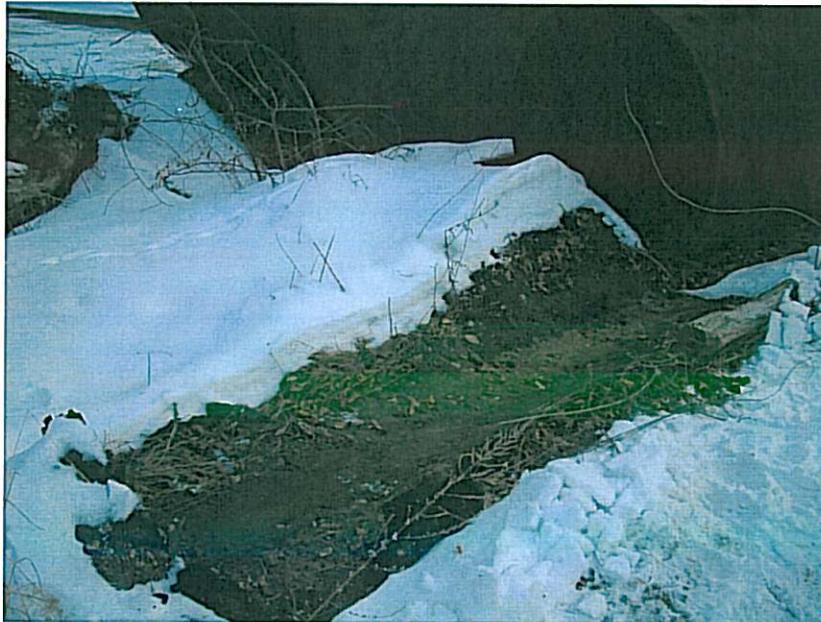
The City of Laconia contracted C.A.B. Service, Inc. (CAB) to clean and remove the tanks. CAB noted that approximately 1,500-gallons of partially hardened No. 6 oil remained in the 9,400-gallon AST though no product was observed in the gasoline or diesel tanks. CAB transported the tanks to their facility in Dover, New Hampshire, to properly clean and dispose of them. CAB noted that several small holes were observed in the bottom of the 9,400-gallon No. 6 fuel oil AST. No holes were observed in the gasoline or diesel tanks. GeoInsight reported that no petroleum staining or odors were observed beneath any of the ASTs.

4. View looking to the east of the ground beneath the 1,000-gallon AST following removal on January 12, 2010.

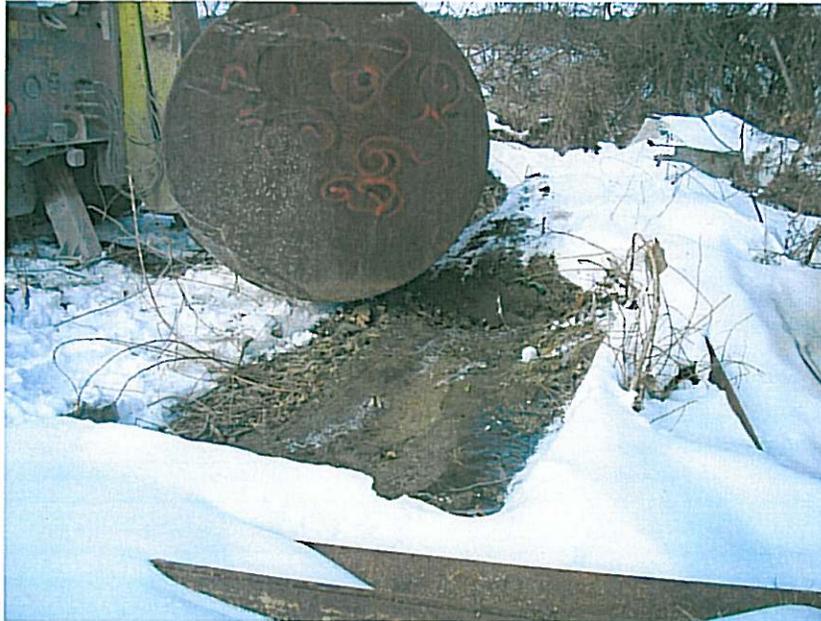
5. View looking to the west of the 1,500-gallon AST during removal activities on January 12, 2010.

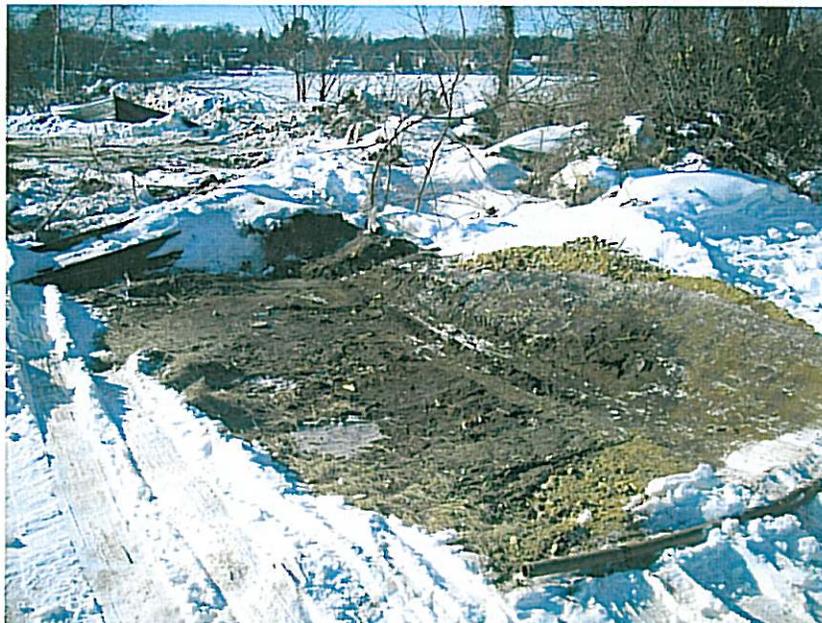
6. View looking to the west of the ground beneath the 9,400-gallon AST following removal on January 12, 2010.
