HYDROLOGIC & HYDRAULIC ANALYSIS OF LOWER JEWETT BROOK

Laconia, New Hampshire

**City of Laconia, NH
and
U.S. Army Corps of Engineers**

August 2011

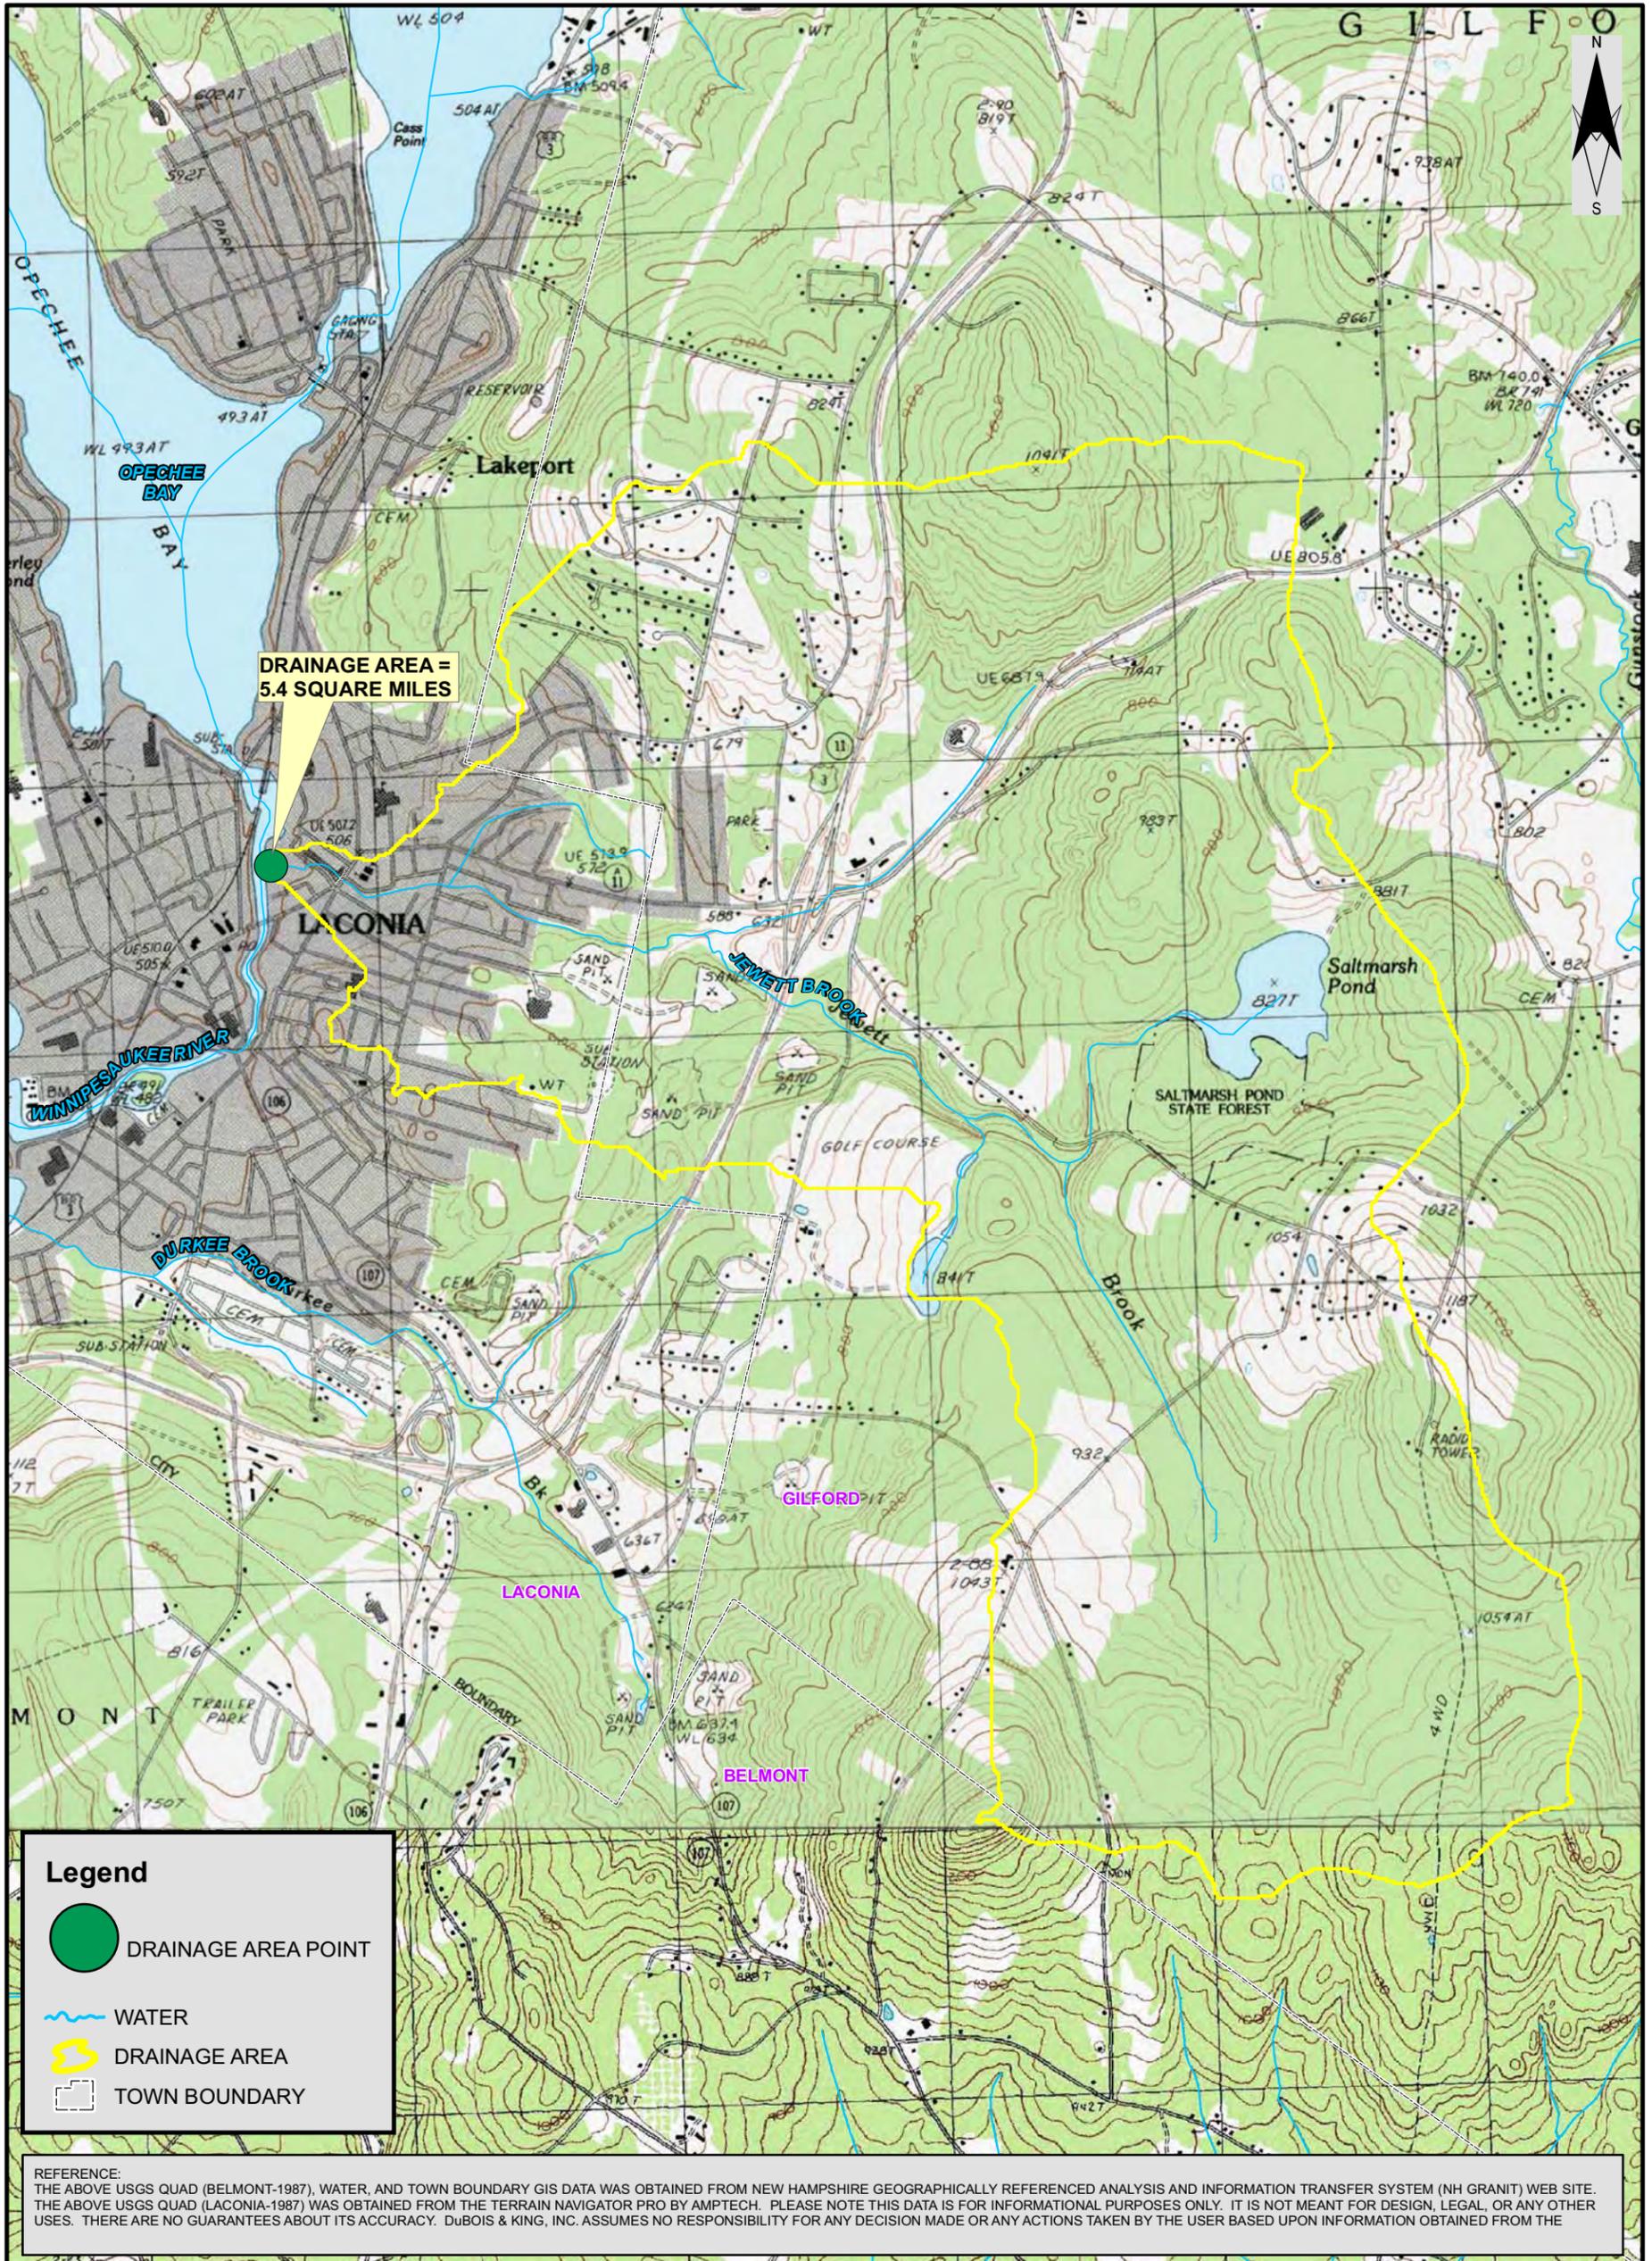
WATERSHED TOPOGRAPHIC MAP

JEWETT BROOK
 WATERSHED ASSESSMENT
 LACONIA, NH
 BELKNAP COUNTY

The watershed is a steeply sloped basin that consists of wooded areas, open lands and commercial and residential development. The total contributing drainage area is about 5.4 square miles at the mouth. A map showing the watershed is included in Attachment A. The main channel slope within the watershed is 144 feet per mile, or 2.7%, based on the USGS topographic map. The channel slope within the study reach is approximately 37 ft per mile or 0.7%.

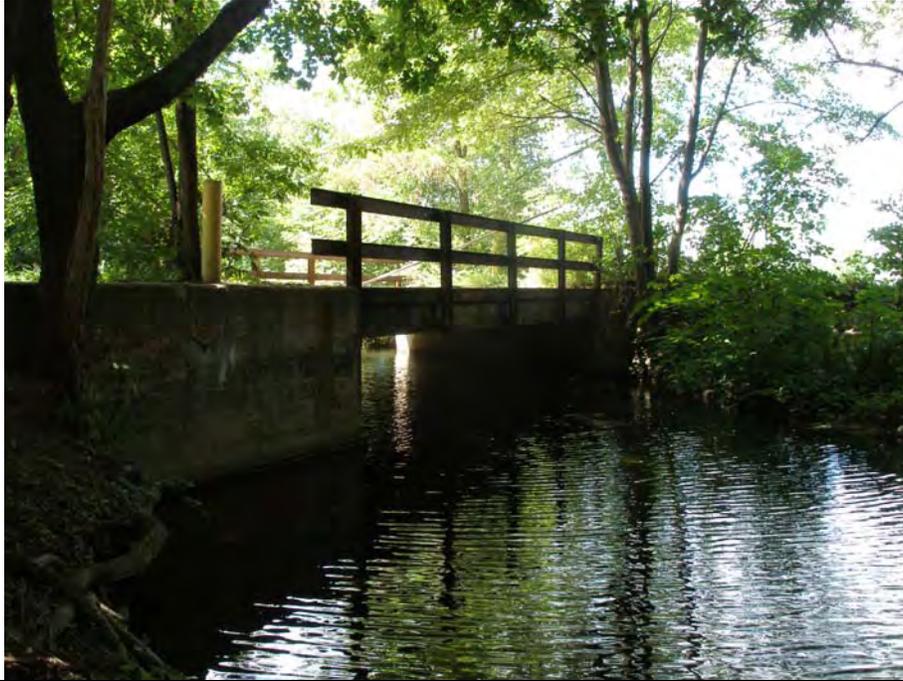
Jewett Brook – Access/pedestrian (RS 427) road bridge downstream of Davis Place Road, view looking west.

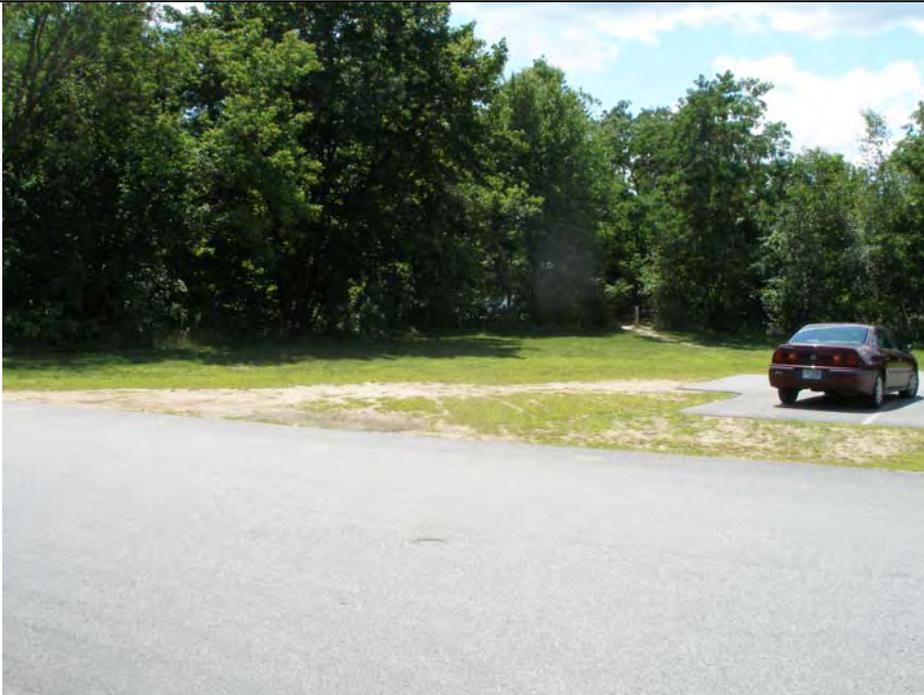
Jewett Brook – Davis Place road view looking toward Access/pedestrian bridge downstream of Davis Place bridge. View of right overbank (looking downstream).

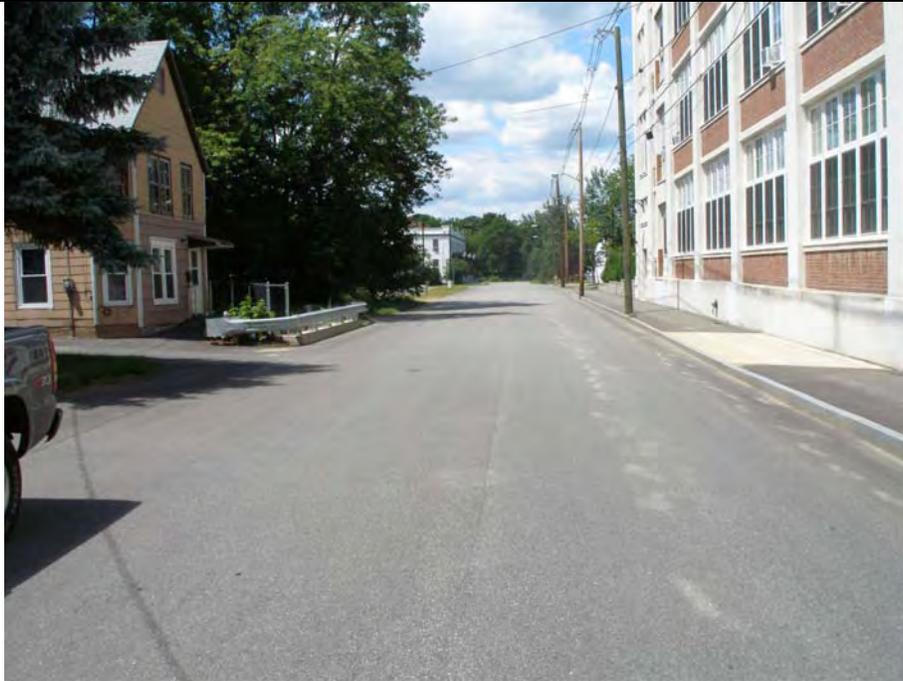
Jewett Brook – Davis Place road view looking westerly. Outlet of the Davis Place road bridge at the guardrail in the photograph. Davis Place road bridge connects to the Normandin Square building bridge structure at the new concrete on the sidewalk at the building in the photograph.

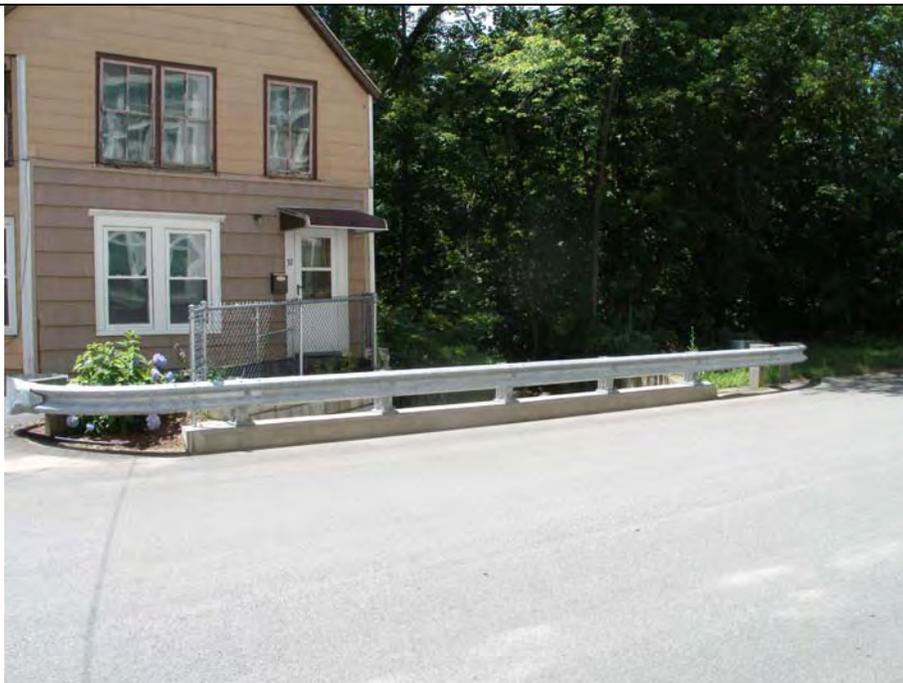
Jewett Brook – Davis Place road view looking west. Outlet of the Davis Place road bridge at the guardrail in the photograph. Home at 32 Davis Place.

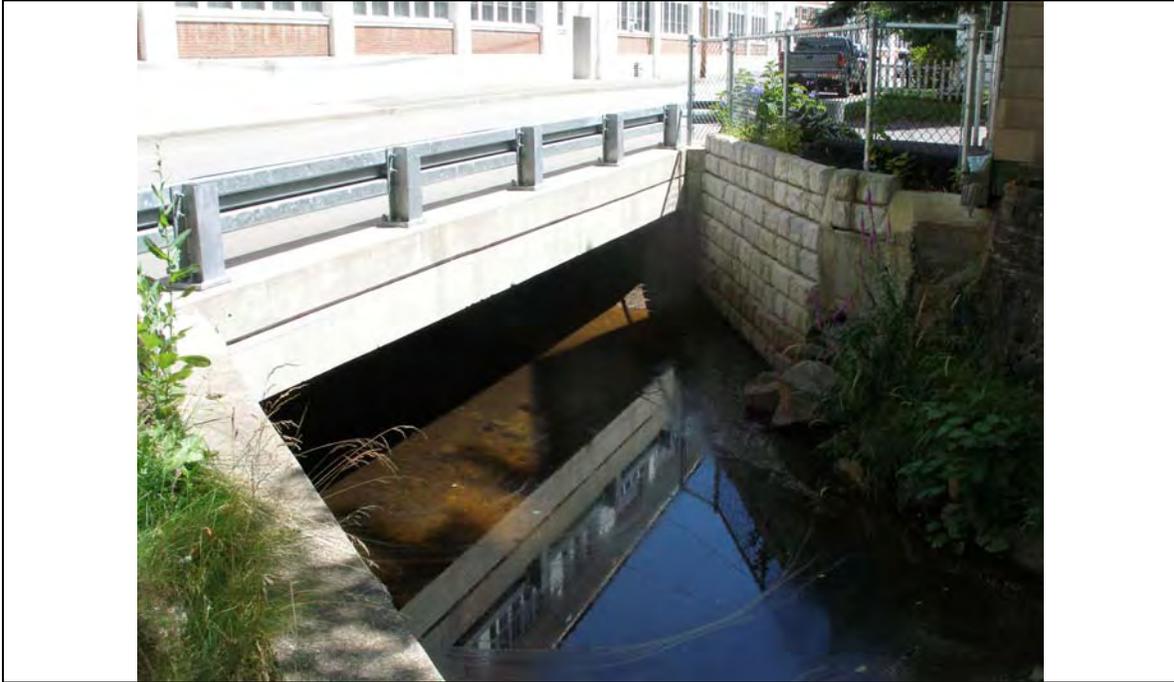
Jewett Brook – Davis Place road view looking at outlet (RS 587).

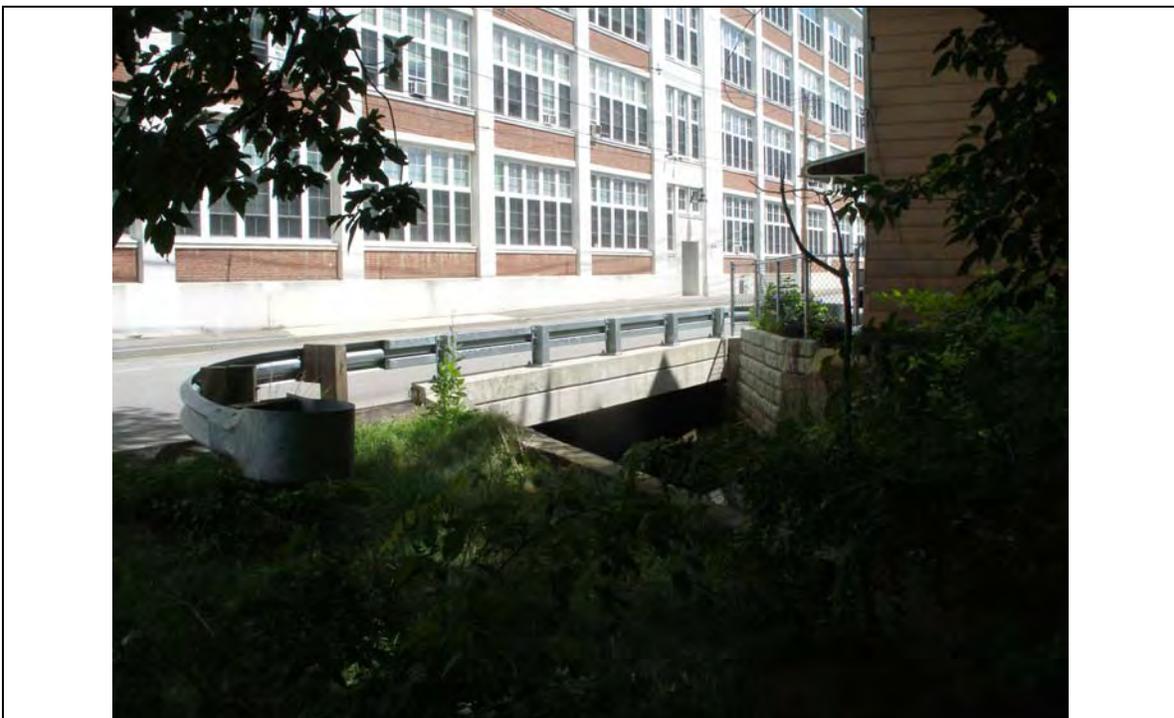
Jewett Brook – View looking upstream at the outlet of Davis Place bridge (RS 587).

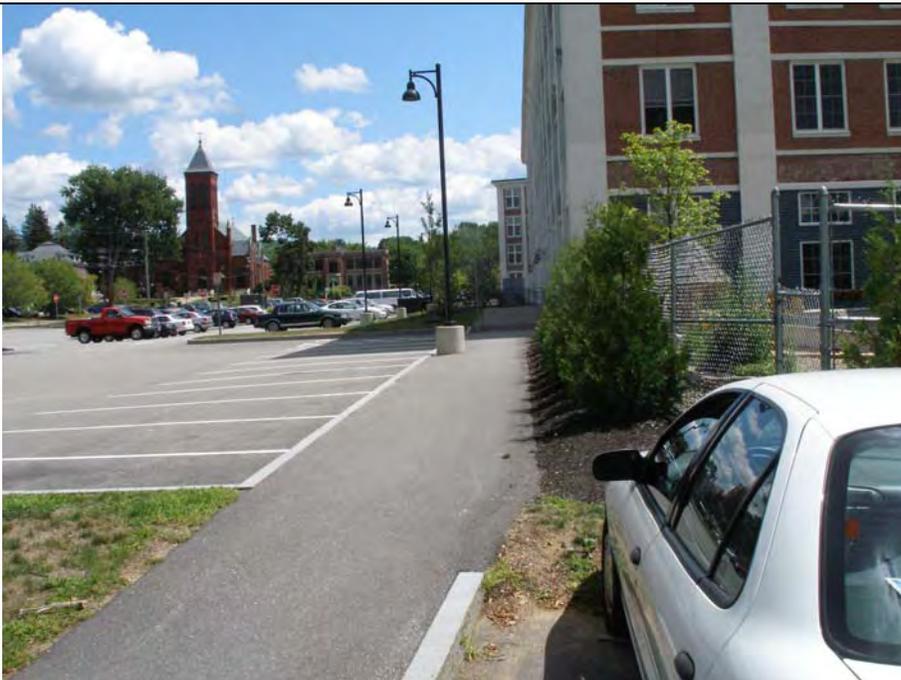
Jewett Brook – View looking along the north side of the Normandin Square building at 22 Stafford Street toward Union Ave.

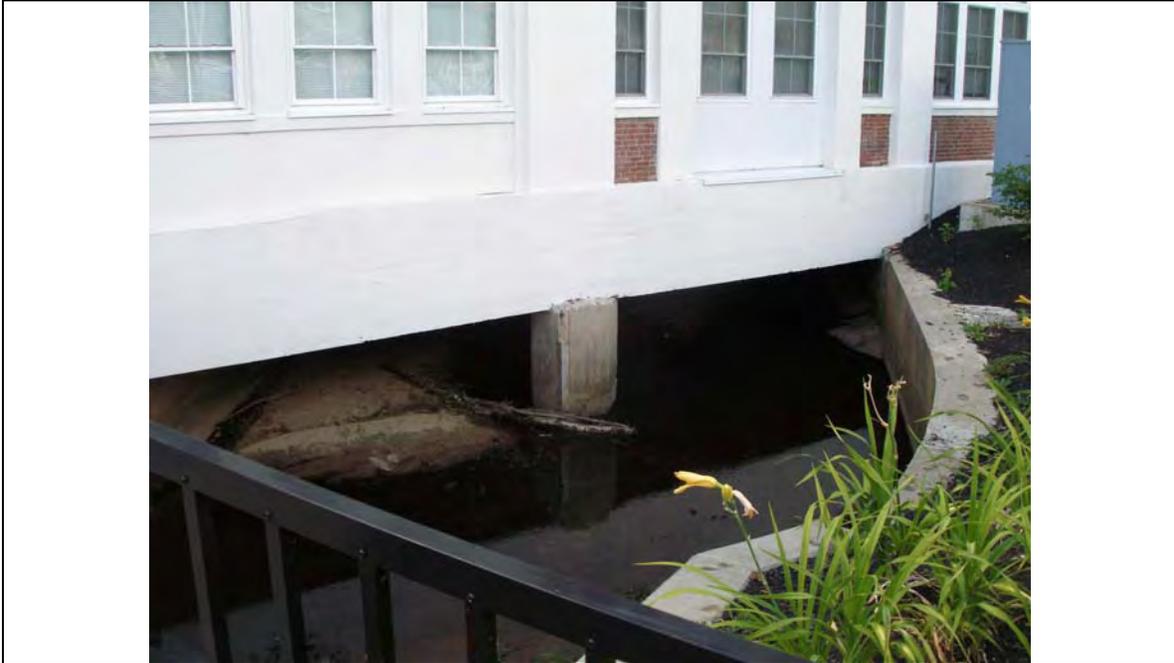
Jewett Brook – View looking at the entrance to the bridge that conveys Jewett Brook under the Normandin Square Building at 22 Stafford Street (RS 732).

- Between the Union Street Bridge and the Normandeau Square Building, the capacity before overtopping is approximately 700 cfs. The channel opening under the building, not the two pedestrian bridges, is the hydraulic control in this reach.

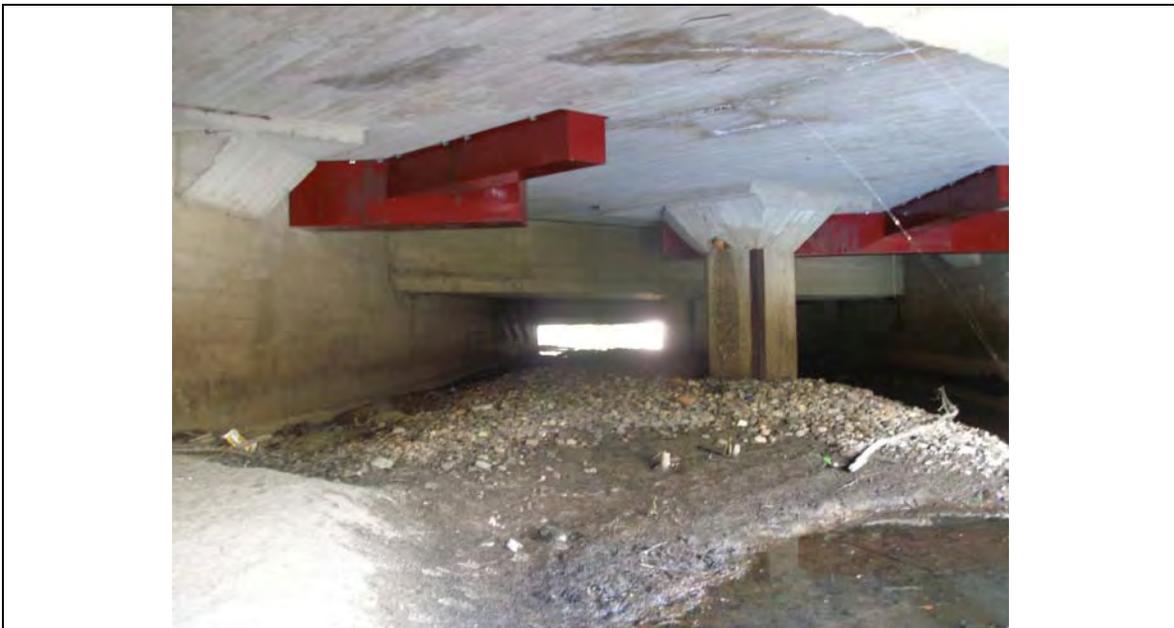
Jewett Brook – View looking through the entrance to the bridge that conveys Jewett Brook under the Normandin Square Building at 22 Stafford Street (RS 732).

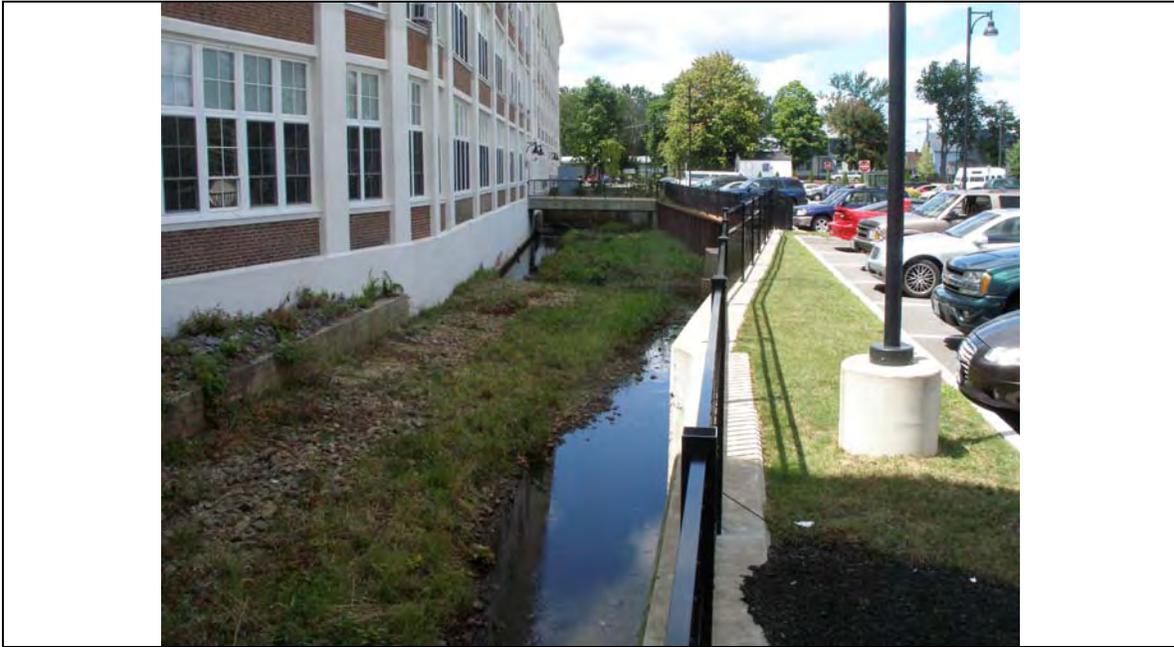
Jewett Brook – View looking downstream at Jewett Brook along the Normandin Square building at pedestrian bridge No.1 (RS 779)

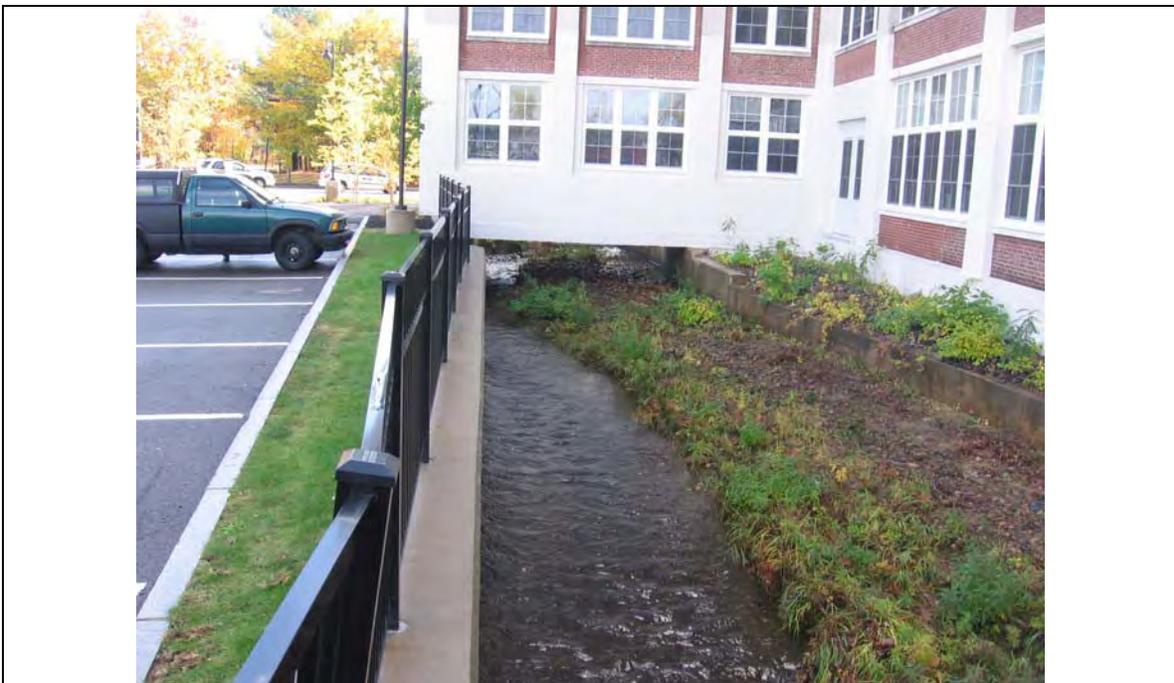
Jewett Brook – View looking upstream along the north side of the Normandin Square building toward Union Ave at pedestrian bridge No.2 (RS 998).

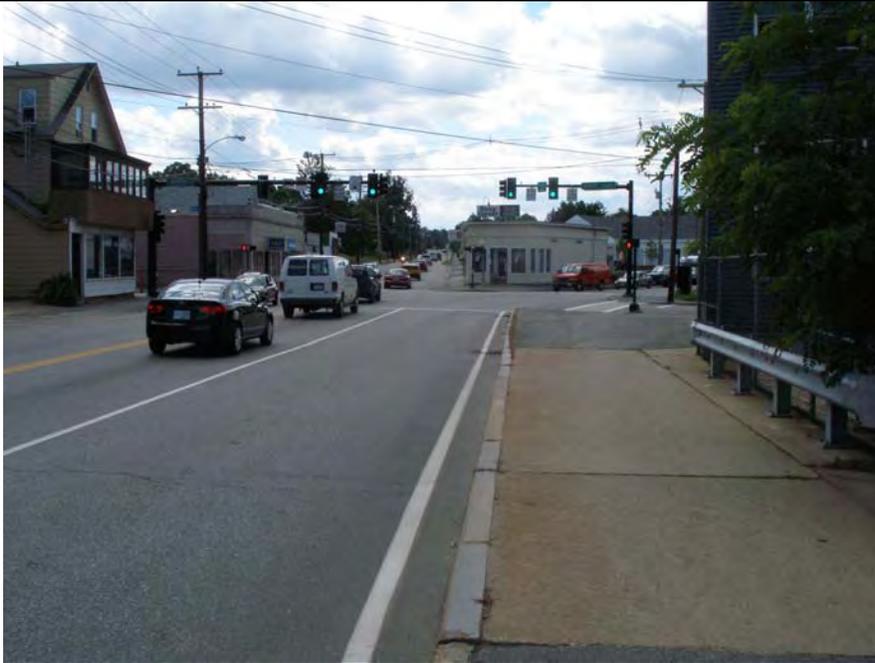
Jewett Brook - Union Ave view looking toward intersection of Union Ave, Davis Place, Winter Street and Church Street. The outlet of the Union Ave bridge is at the guardrail in the photograph.

Under existing conditions, flows above approximately the 10-year level exceed the capacity of the Union Avenue Bridge and spill toward and down Davis Place. The downstream channel between Union Avenue and the Normandeau Building has additional capacity, but it goes unused because water can't get under Union Avenue.

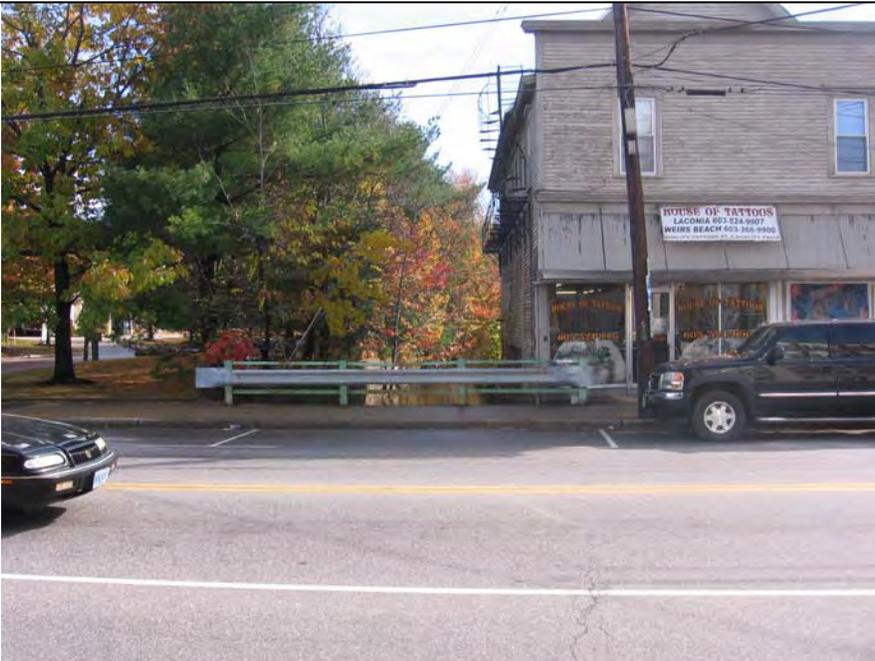
Jewett Brook – Jewett Brook flows under the Union Ave bridge; entrance to the bridge at guardrail in photograph.

- The Union Avenue Bridge at the upstream end of the modeled reach is the limiting hydraulic control point. This is not surprising given that the waterway opening of the bridge is approximately 50% of the downstream crossings and has the lowest available head (Table 2). The capacity of the Union Avenue Bridge prior to overtopping the road is approximately 450 cfs, which is only marginally (15%) higher than the 10-year flow.

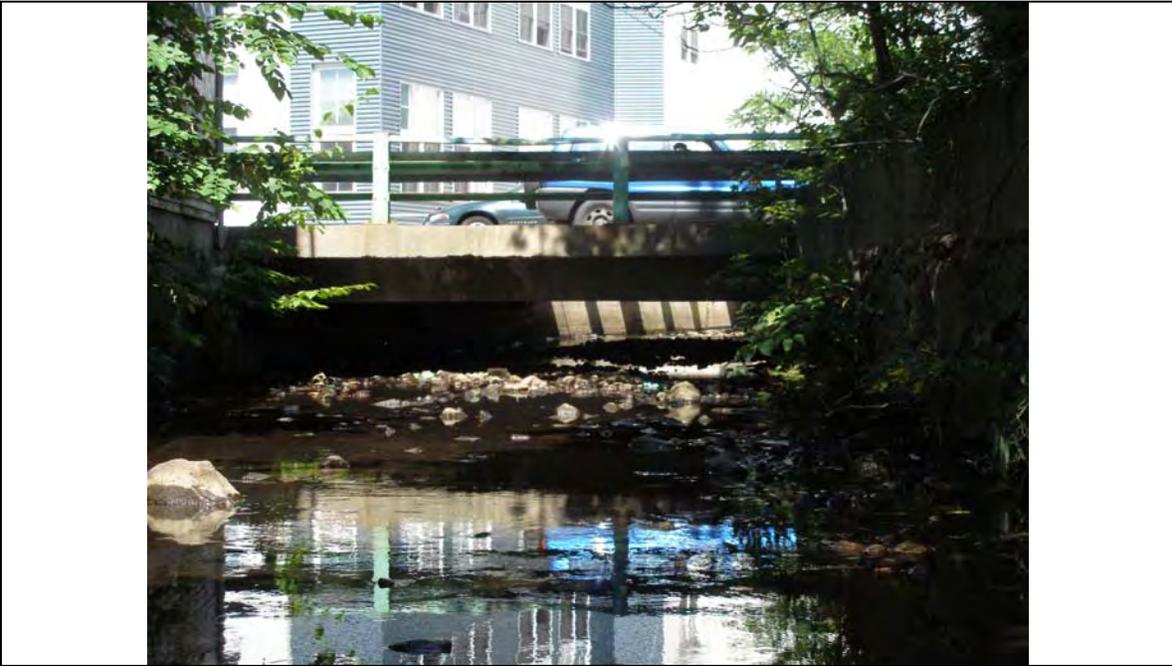
Jewett Brook – Entrance to the Union Ave bridge (RS 1108)

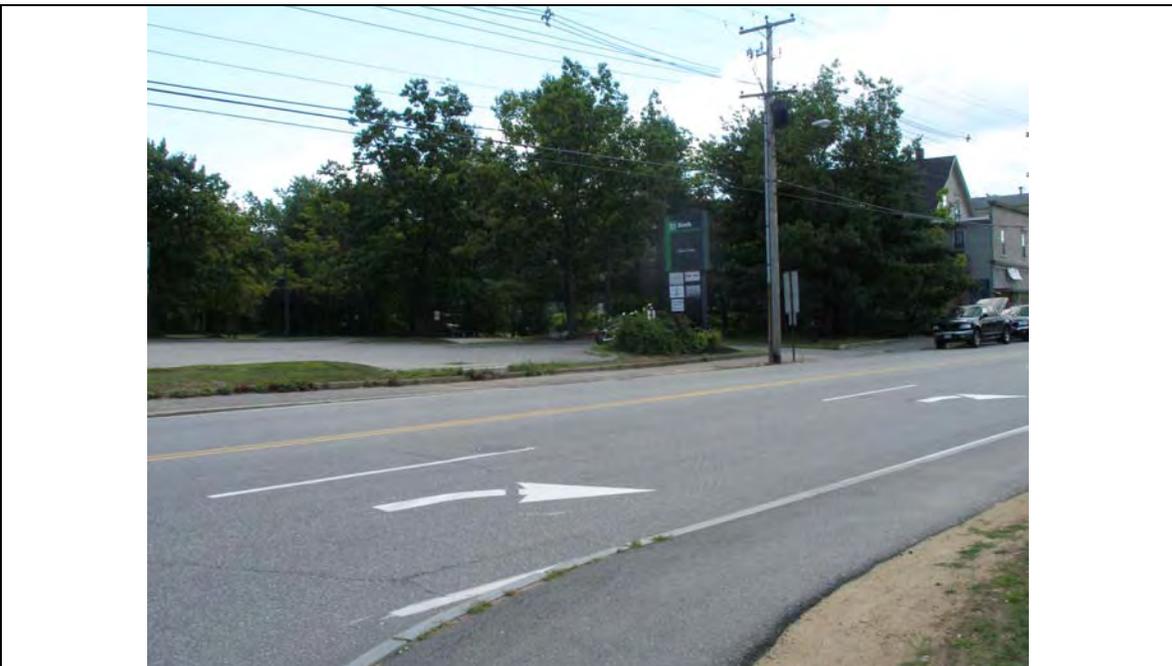
Jewett Brook - Photo from the intersection of Strafford and Union Ave toward bank parking lot (right overbank of Jewett Brook). RS 1108

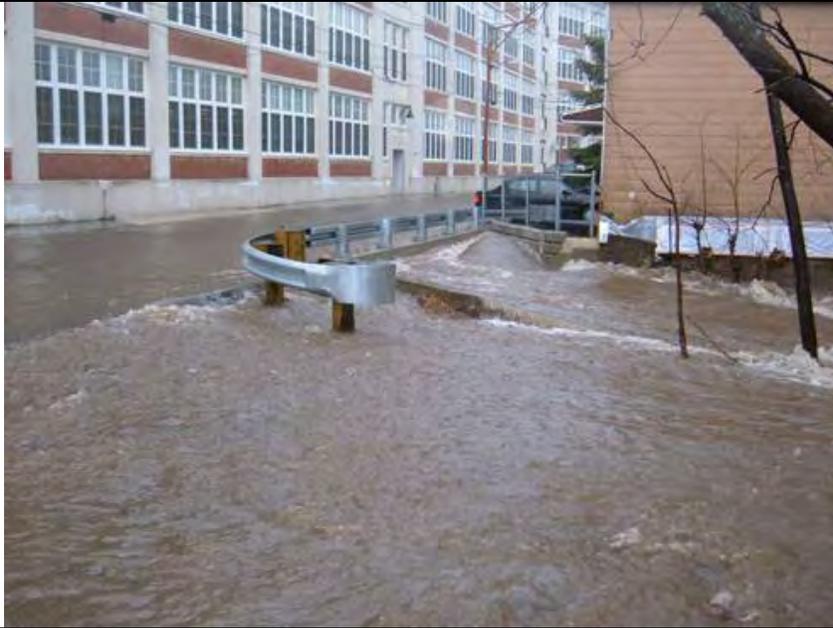
Jewett Brook – Outlet of Davis Place bridge

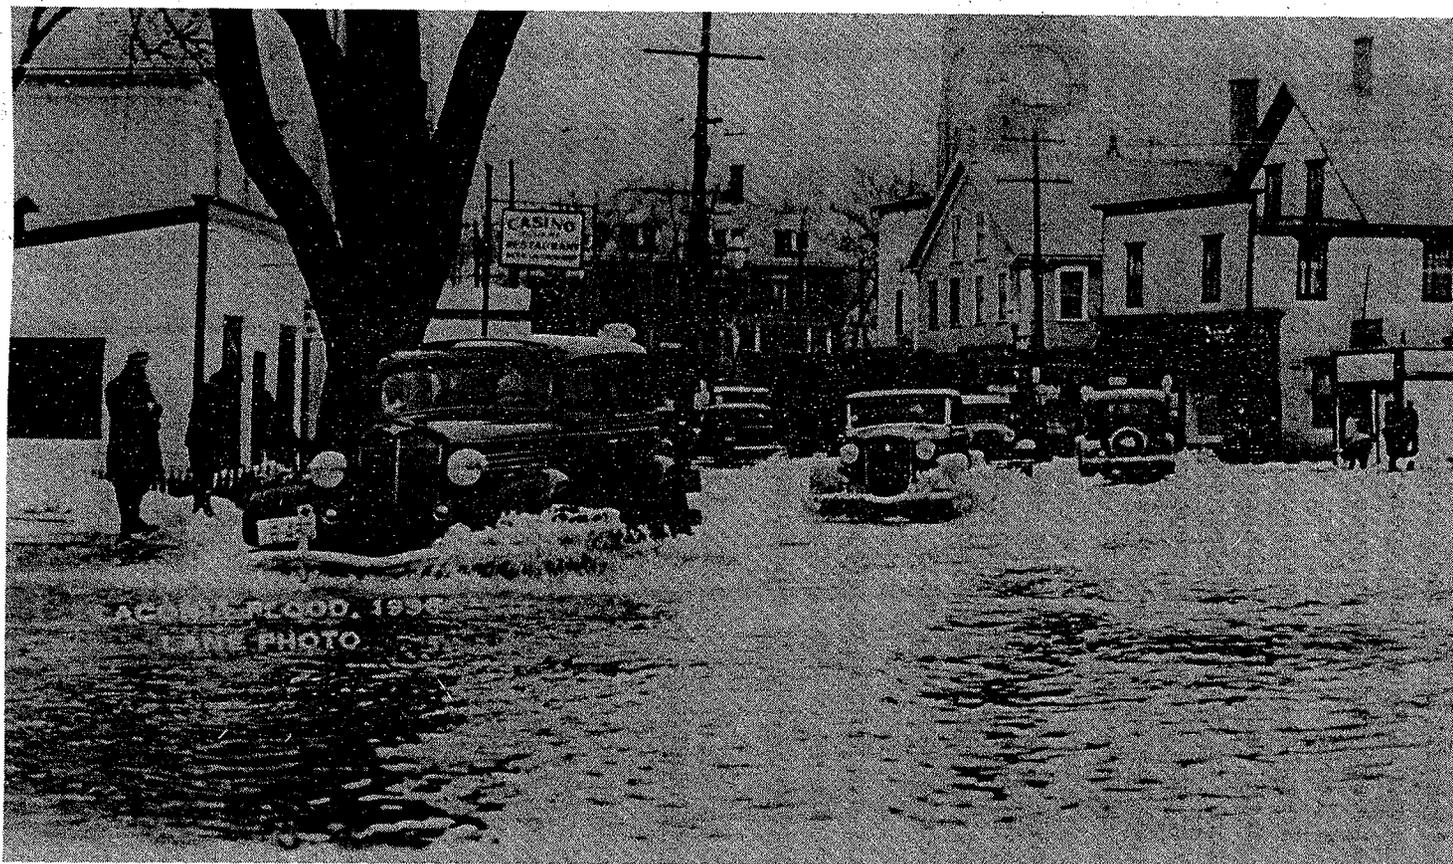
Figure 2 - Jewett Brook flooding in the area of Casino Square, as seen from Court Street looking toward the intersection of Church Street, Davis Place, Union Avenue, and Winter Street, 1936.

Photographic evidence of flooding at this location dates back to at least 1936 (see Attachment A). Anecdotal reports indicate that the frequency of flooding has increased in recent years. Flooding was reported at the site four times in 2007, for instance (see April 16, 2007 photos Attachment A). However, there has been no effort to date to discern whether there has in fact been an increase in flood frequency or whether that increase is due simply to precipitation patterns or to physical changes at the site.

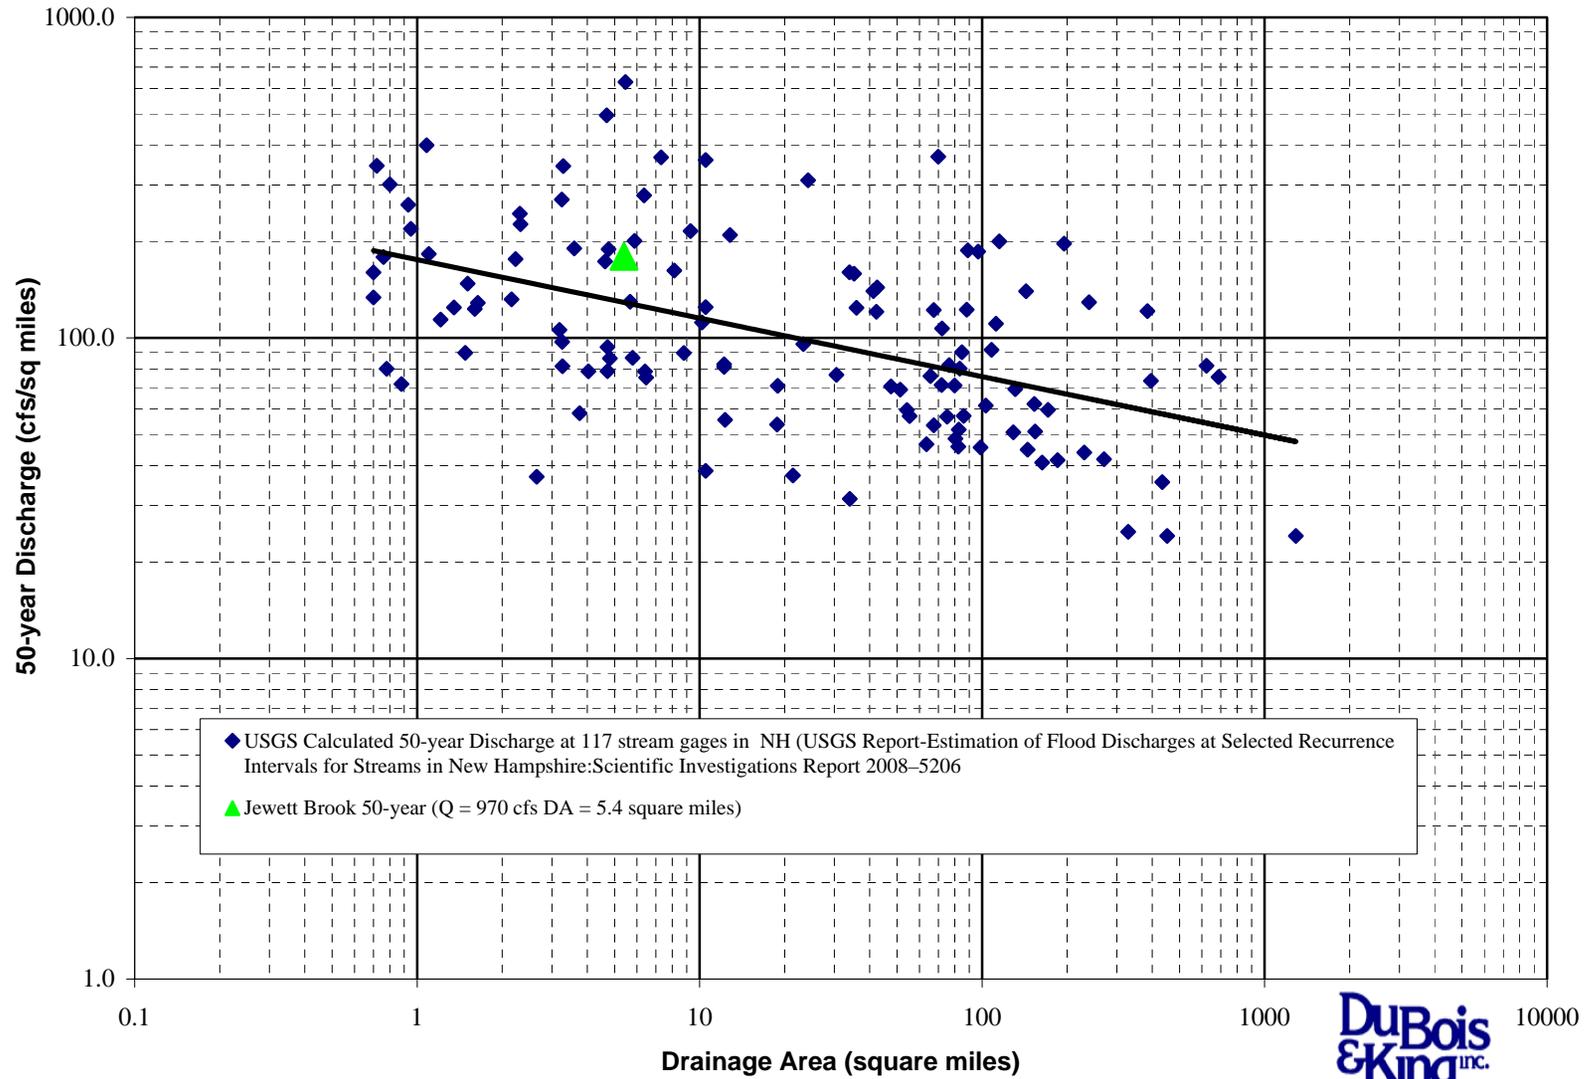
**Jewett Brook - Regional Analysis
Laconia, NH - Belknap County
50-Year Computed Peak Discharges For New Hampshire**

The computed values were checked for reasonableness against a plot of USGS-computed 50-year and 100-year flow at gaged sites located in New Hampshire and the surrounding States (Attachment B). The estimated discharges were deemed reasonable based on this comparison, and thus used for this analysis without modification.

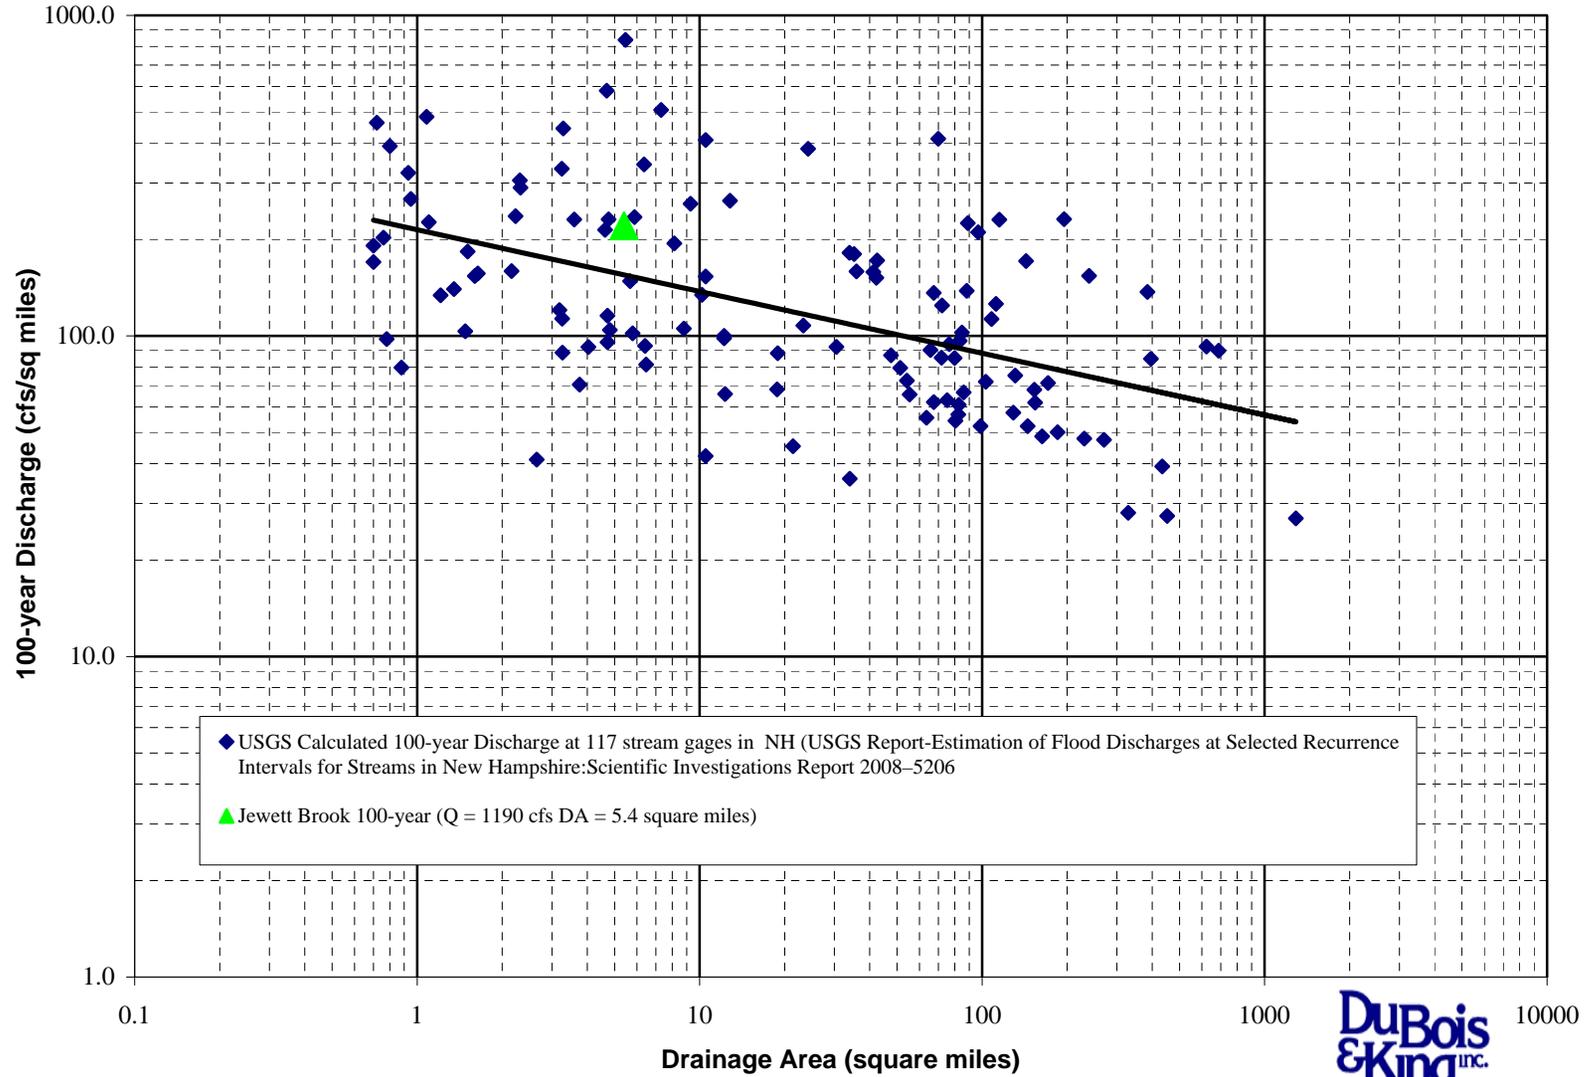
**Jewett Brook - Regional Analysis
Laconia, NH - Belknap County
100-Year Computed Peak Discharges For New Hampshire**

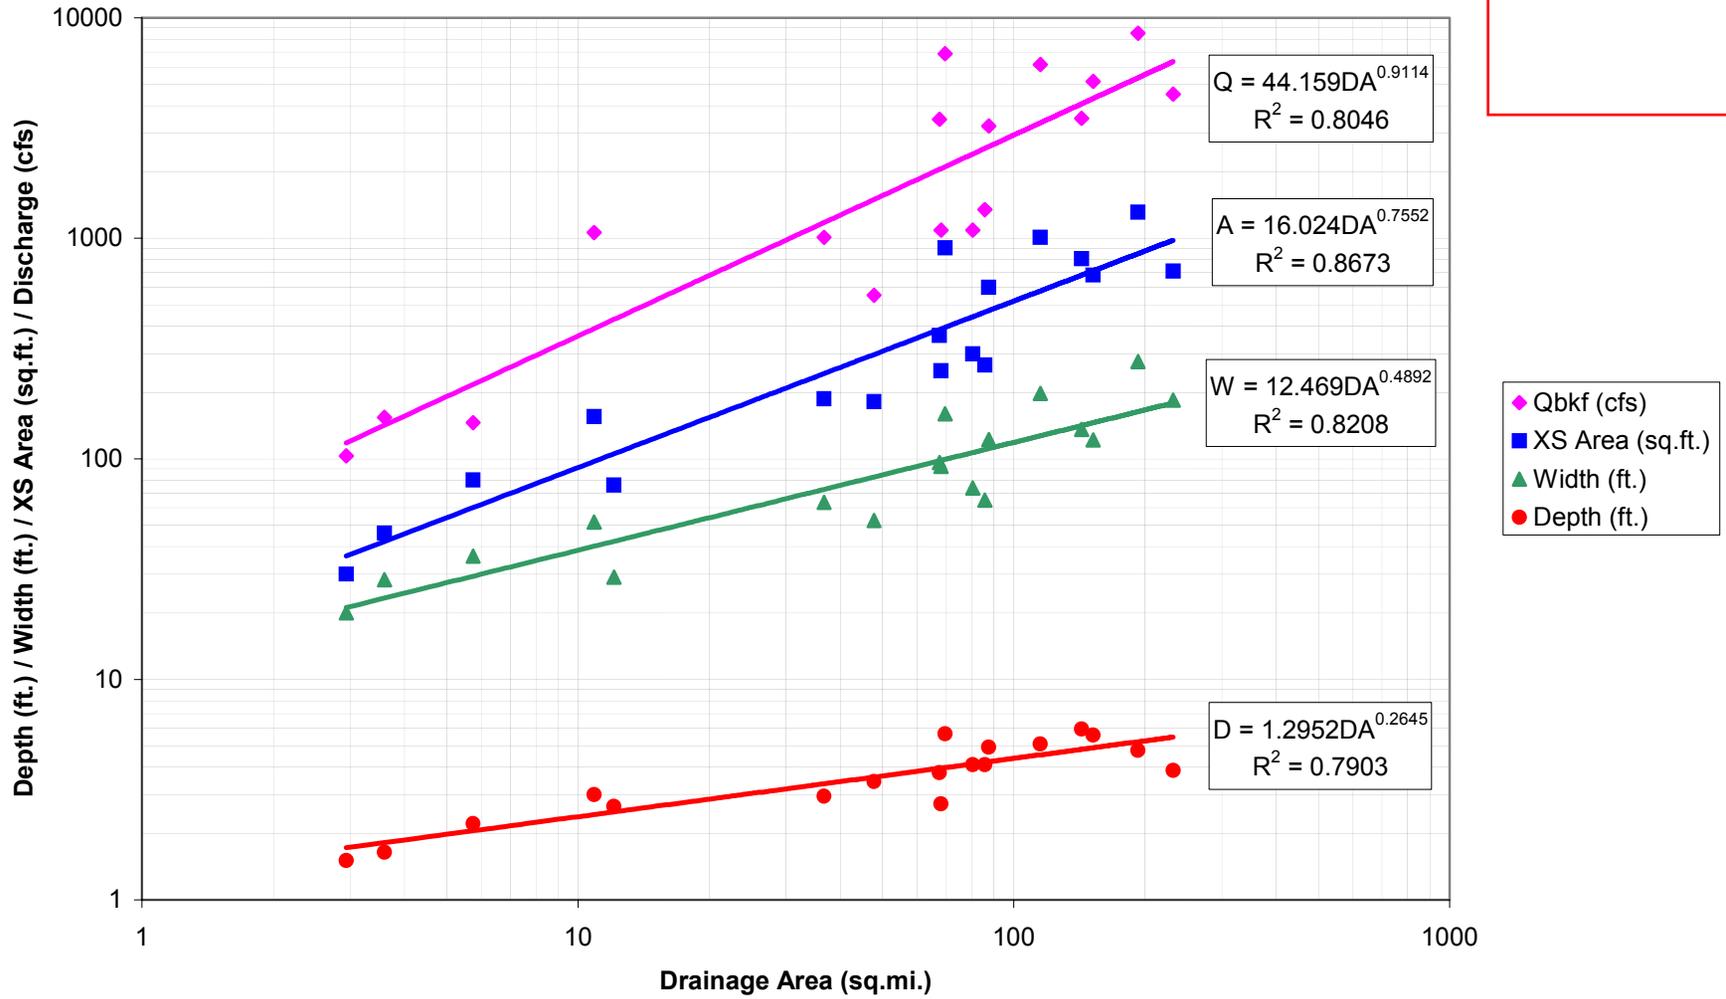
New Hampshire 2005 Regional Hydraulic Geometry Curves (provisional)

Figure 2.4: Provisional regional hydraulic geometry curves for the State of New Hampshire (Source: The New Hampshire Stream Team, 2005).
