HYDROLOGIC & HYDRAULIC ANALYSIS OF LOWER JEWETT BROOK

Laconia, New Hampshire

**City of Laconia, NH
and
U.S. Army Corps of Engineers**

August 2011

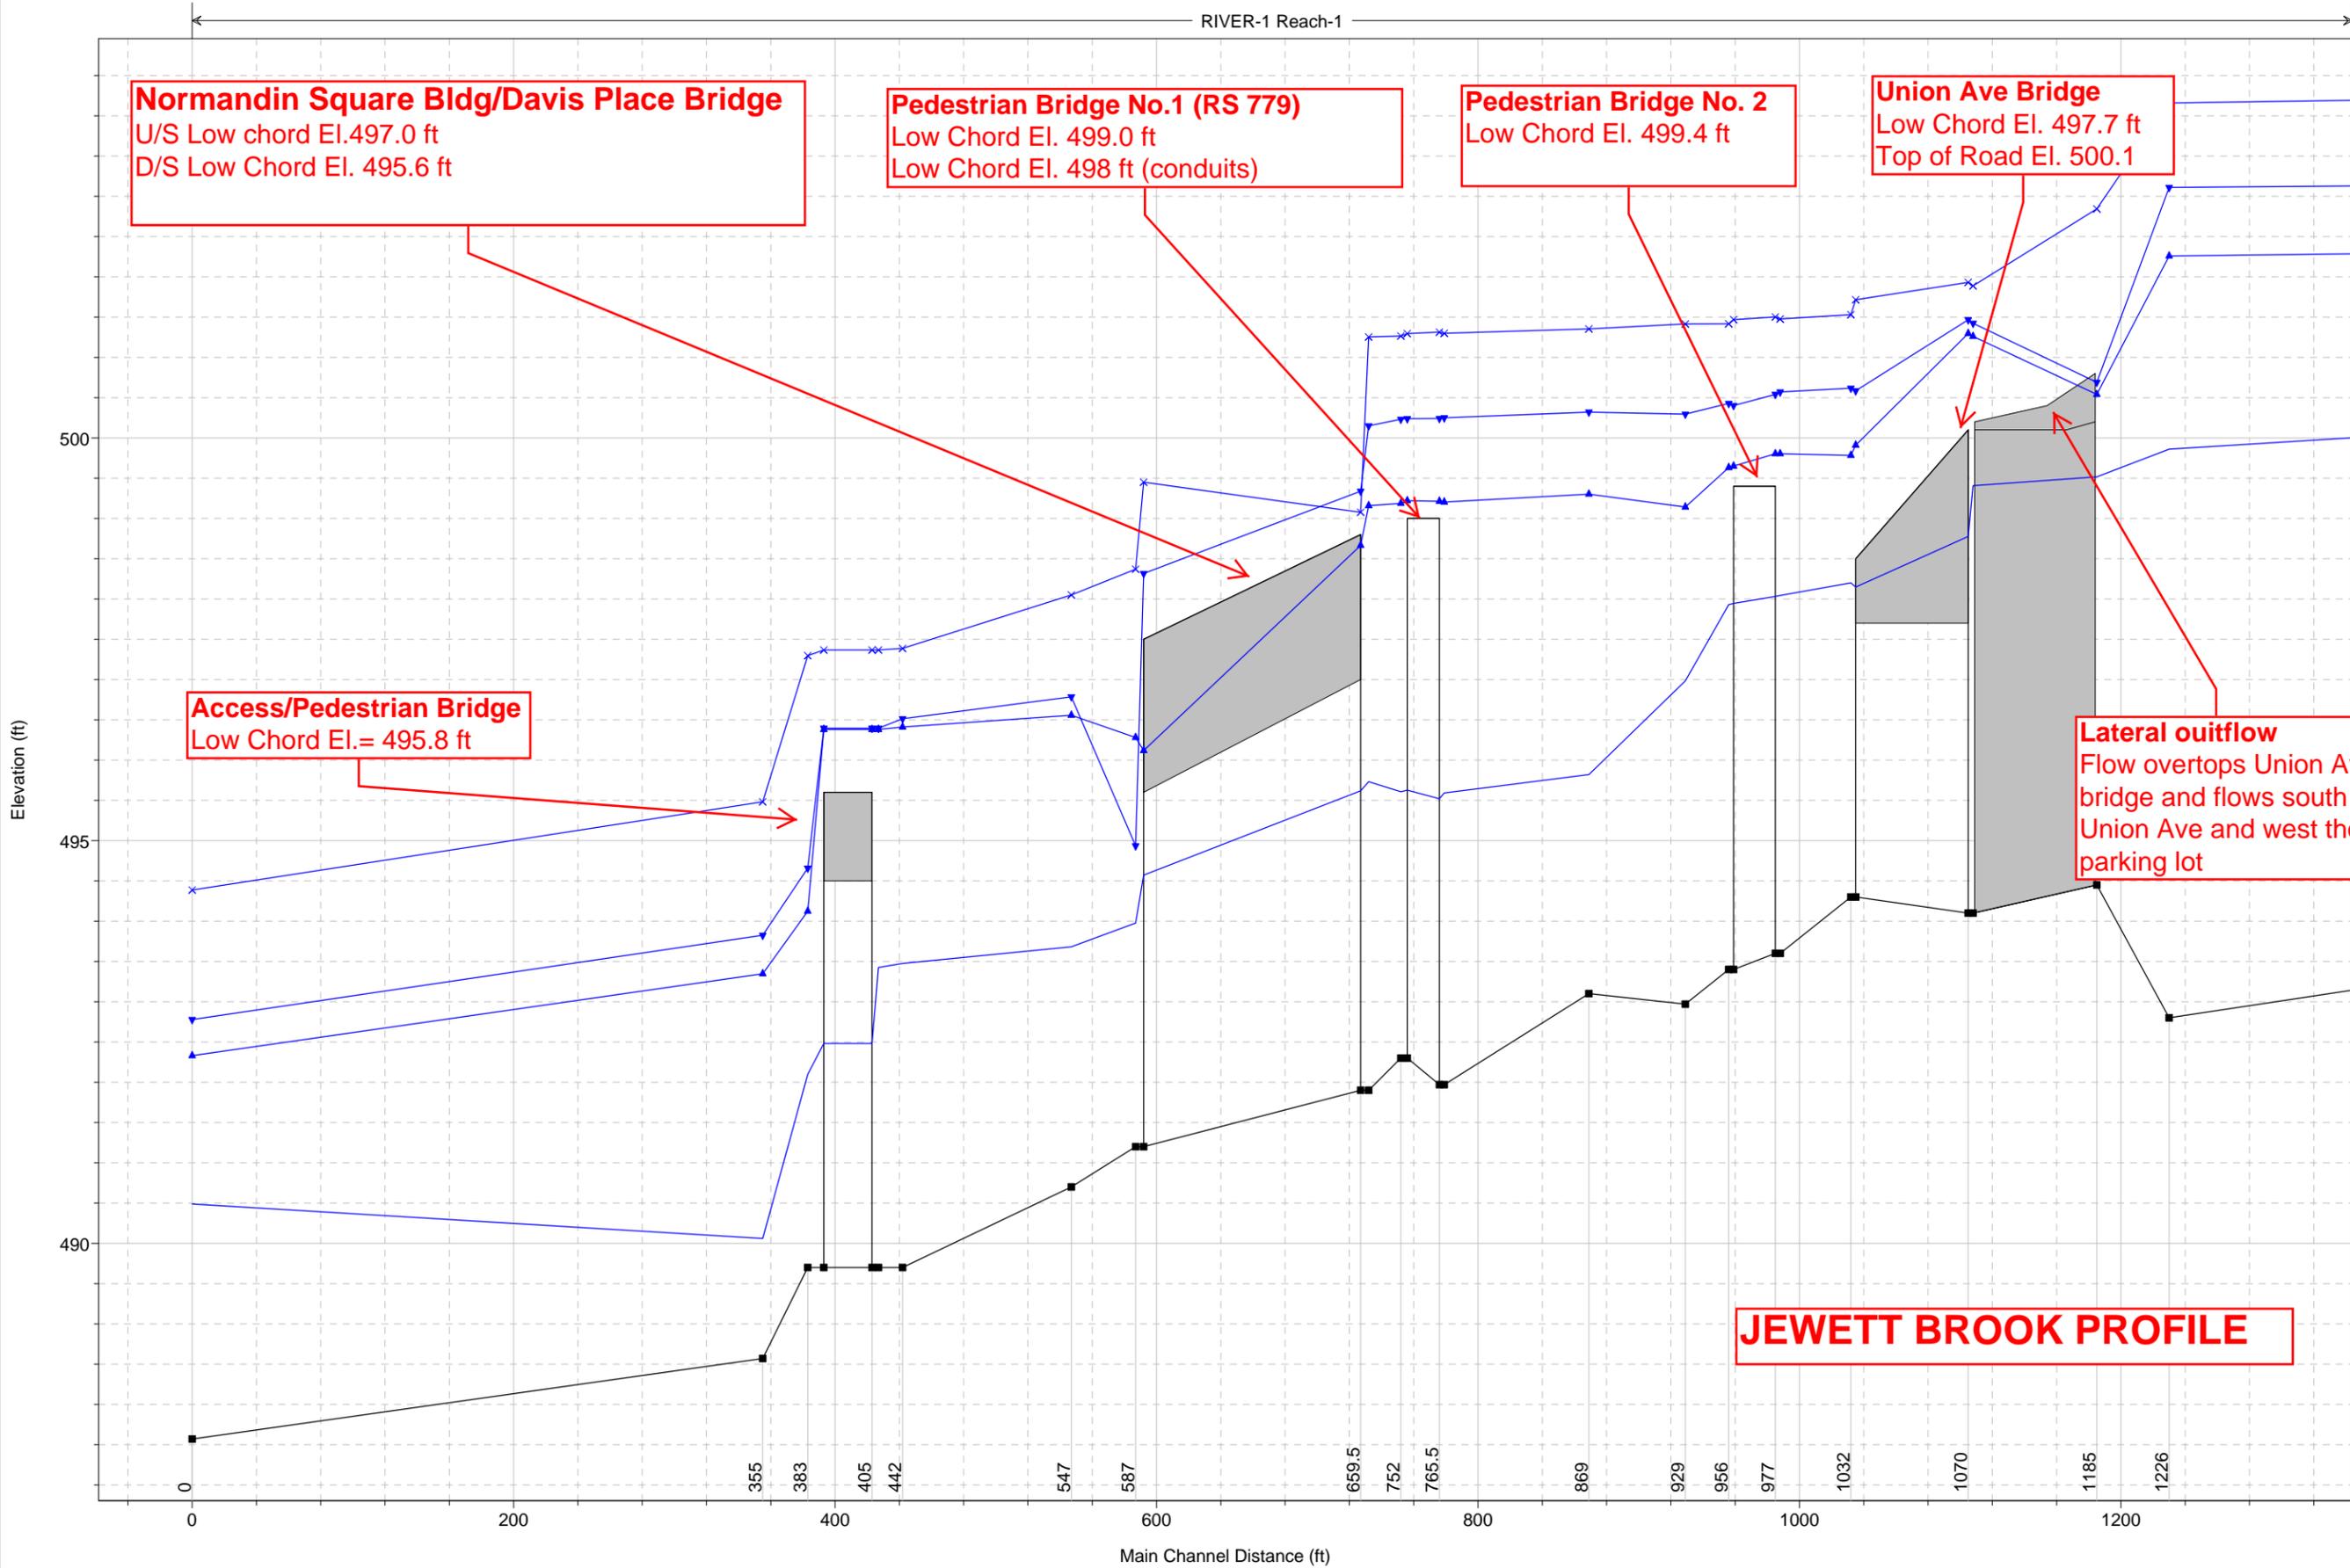
JEWETT BROOK PROFILE

Legend	
WS 500-yr(2500 cfs)	✕
WS 100-yr(1190 cfs)	▼
WS 50-yr (970 cfs)	▲
WS 10-yr (394 cfs)	◆
Ground	■

Normandin Square Bldg/Davis Place Bridge
 U/S Low chord El.497.0 ft
 D/S Low Chord El. 495.6 ft

Pedestrian Bridge No.1 (RS 779)
 Low Chord El. 499.0 ft
 Low Chord El. 498 ft (conduits)

Pedestrian Bridge No. 2
 Low Chord El. 499.4 ft

Union Ave Bridge
 Low Chord El. 497.7 ft
 Top of Road El. 500.1

Access/Pedestrian Bridge
 Low Chord El.= 495.8 ft

Lateral outflow
 Flow overtops Union Ave bridge and flows south on Union Ave and west though the parking lot

The following bullets summarize the significant results of the existing conditions hydraulic analysis. Table 3 summarizes the results at each of the five crossings for the 10, 50, and 100-year flows. Flood profiles and copy of the HEC-RAS summary output for existing and proposed conditions are included in Attachment C.

- The Union Avenue Bridge at the upstream end of the modeled reach is the limiting hydraulic control point. This is not surprising given that the waterway opening of the bridge is approximately 50% of the downstream crossings and has the lowest available head (Table 2). The capacity of the Union Avenue Bridge prior to overtopping the road is approximately 450 cfs, which is only marginally (15%) higher than the 10-year flow.

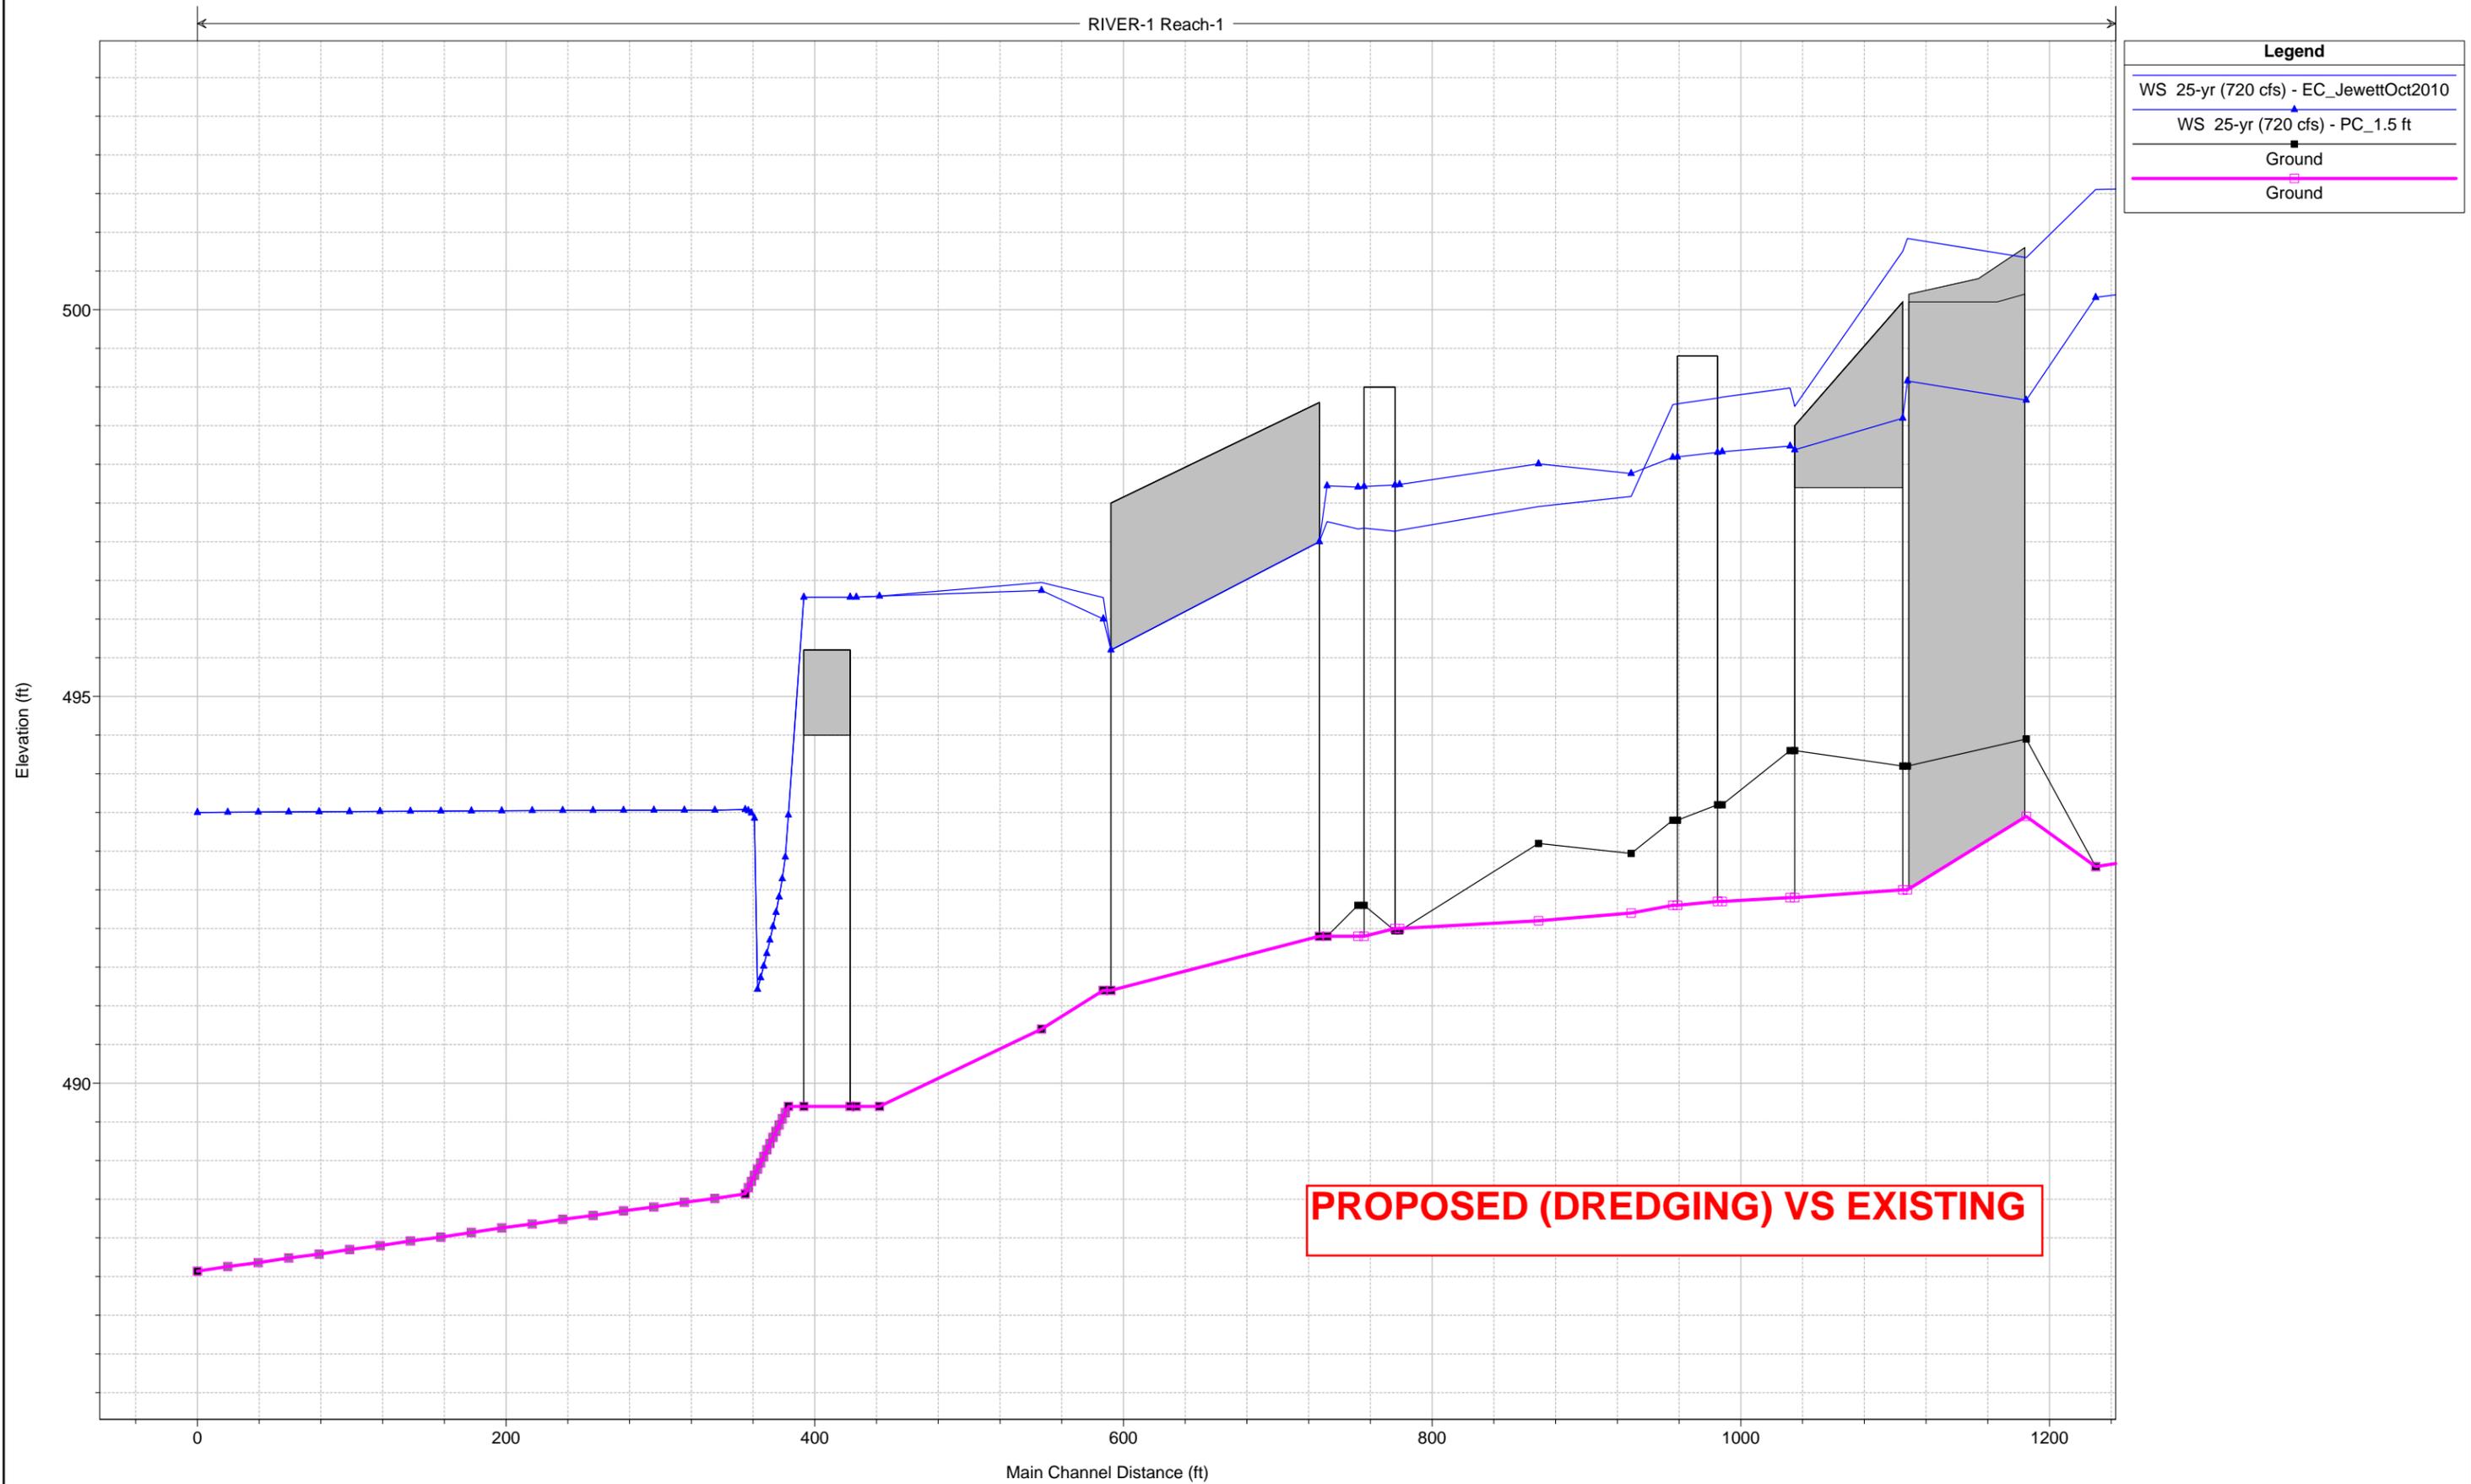
PROPOSED (DREDGING) VS EXISTING

Legend	
WS 25-yr (720 cfs) - EC_JewettOct2010	▲
WS 25-yr (720 cfs) - PC_1.5 ft	■
Ground	■
Ground	□

Dredging sediment out of the channel from the Union Avenue Bridge down to the Normandau Building increases the capacity of the channel and would reduce the frequency of flooding. Flood profiles included in Attachment C. With dredged conditions, the capacity at the Union Street Bridge increases 60% from 450 cfs to 720 cfs. Whereas flows only marginally above the 10-year event pass under existing conditions, flows just above the 25 year event can pass under dredged conditions. Even with improved hydraulic capacity due to dredging, the Union Avenue bridge remains the limiting hydraulic point in the system, which suggests that a dredging operation limited to the bridge and a relatively short distance downstream might be as effective at reducing road overtopping as an operation that dredged all the way to the Normandau Building.

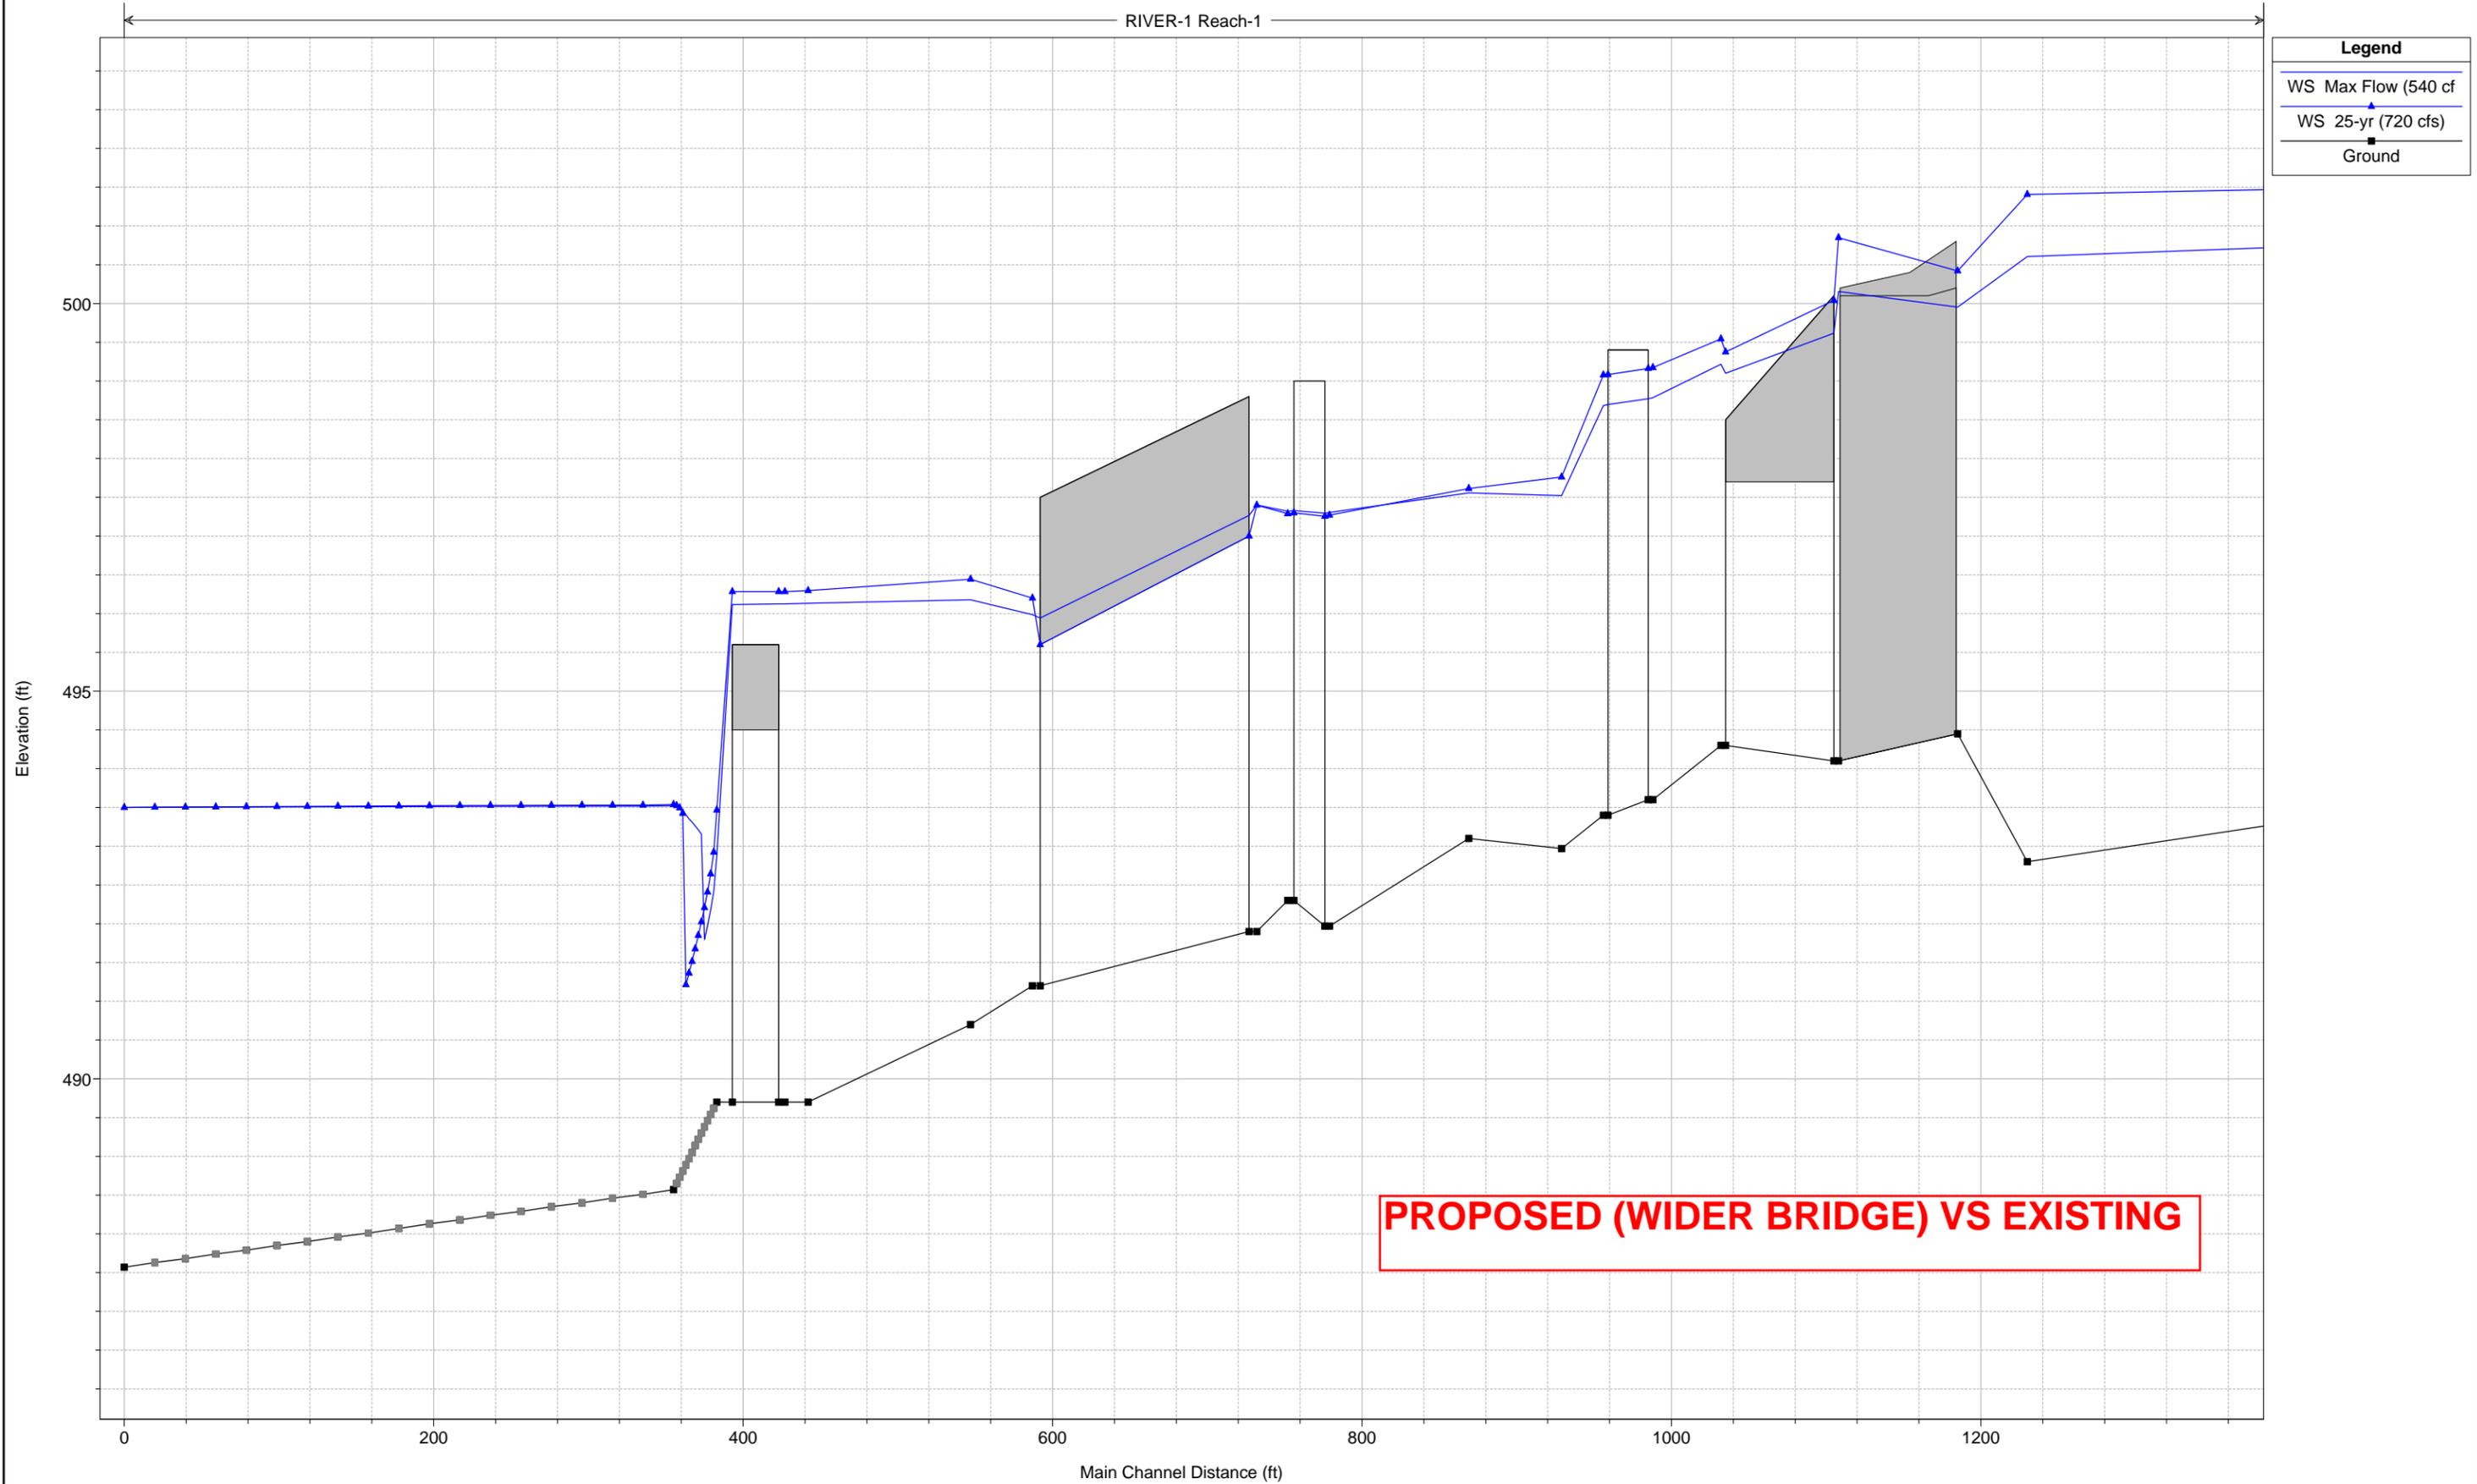
PROPOSED (WIDER BRIDGE) VS EXISTING

Legend	
WS Max Flow (540 cf	▲
WS 25-yr (720 cfs)	▲
Ground	■

Widening the Union Avenue Bridge by 10 feet (or installing a parallel box culvert with similar dimensions) increase the capacity of the channel and reduce the frequency of overtopping. The improvement is marginal, however: flow capacity increases 20% from 450 cfs to 540 cfs. While this is an improvement, Union Avenue still would not be able to pass even the 25-year storm event, and it would remain the limiting hydraulic point in the system.

The hydraulic analysis presented here demonstrates that a 50% increase in the waterway opening (i.e., widening from approximately 18 feet to 28 feet) at the Union Avenue bridge results in only a 20% increase in flow capacity. The marginal increase is due in large part to the backwater on the downstream side of the bridge; the water simply has nowhere to go.
