Jewett Brook Watershed Plan

City of Laconia and Town of Gilford, New Hampshire

February 17, 2012

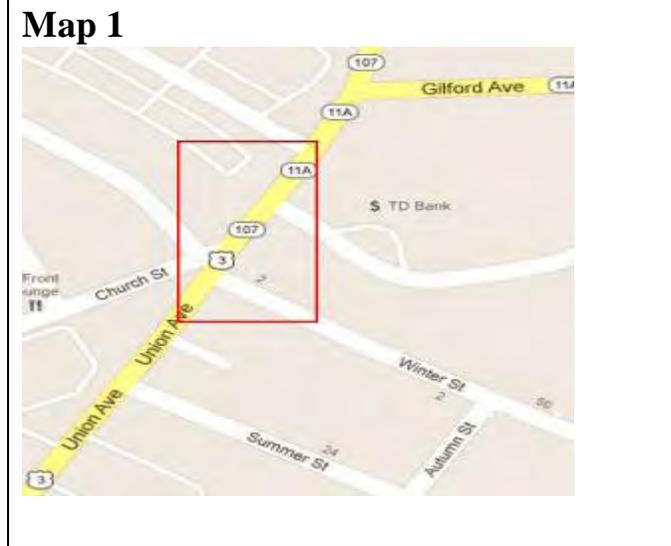
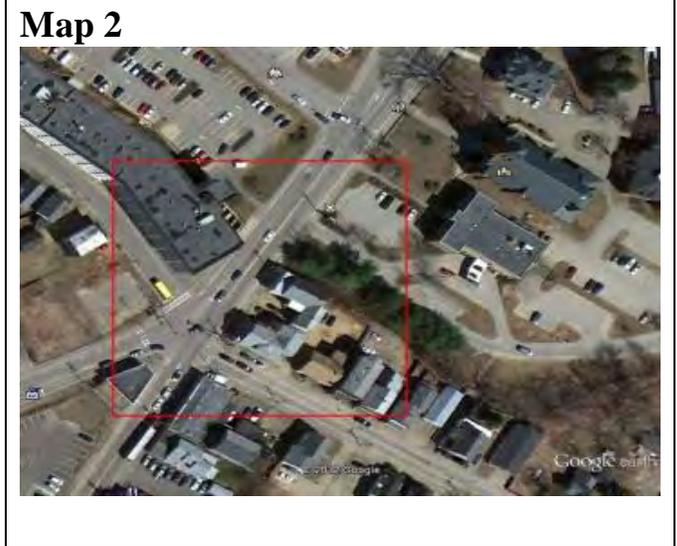
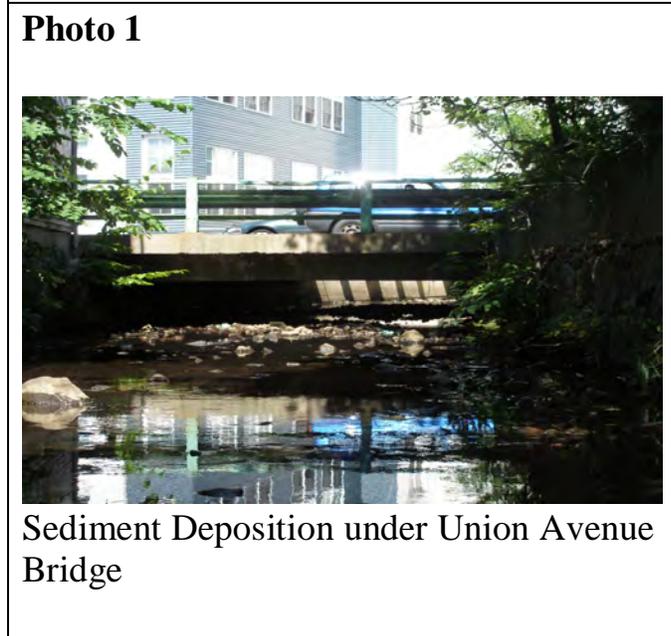
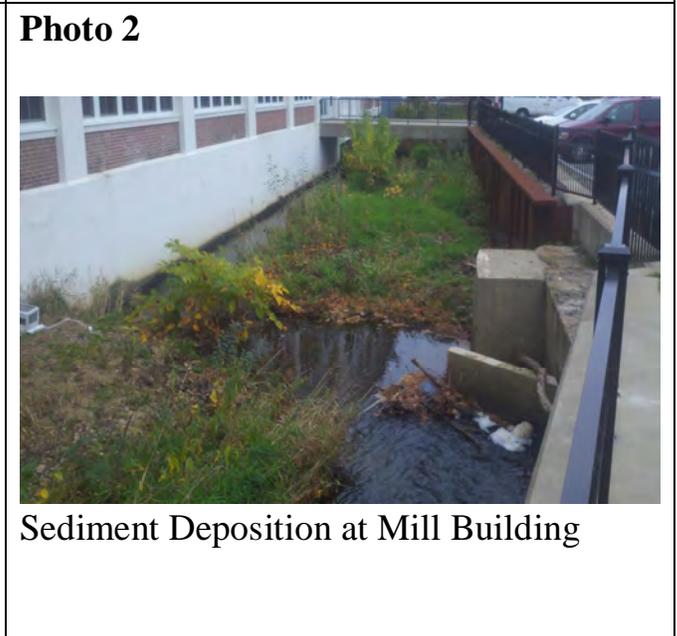
Site Issues and Relevance to the Watershed Plan Objectives:
Sediment deposition at Union Avenue bridge and downstream to the Normandin Mill Building reduces channel capacity and contributes to flood damages. Periodic removal by partial dredging would alleviate flood damage while maintaining aquatic organism passage.

Project Narrative Description (up/downstream limits, banks(s), etc):
 Partial dredging from the Union Avenue bridge downstream to the face of the Mill Building. Dredging would create a 10'-wide, 0.5'-deep pilot channel. Outside of the pilot channel, any sediment more than six inches above the pilot channel invert would be removed.

- 1. Project #1. Remove accumulated sediment to improve channel capacity at the Union Avenue Bridge and Normandeau Mill Building through on-going partial dredging.** (SGA Reach M01) Dredging is recommended from the Union Avenue Bridge downstream to the face of the building. The dredging would create a 10-foot wide, 0.5-foot deep pilot channel. Outside of the pilot channel, any sediment more than six inches above the pilot channel invert would be removed. Such a channel would increase the channel capacity at the Union Avenue bridge by 70% over current conditions, from 450 cubic feet per second (cfs) to 770 cfs. Such partial dredging would avoid over-widening of the channel as would occur with complete dredging. Over-widening is to be avoided, as it would slow the velocities of the water to the

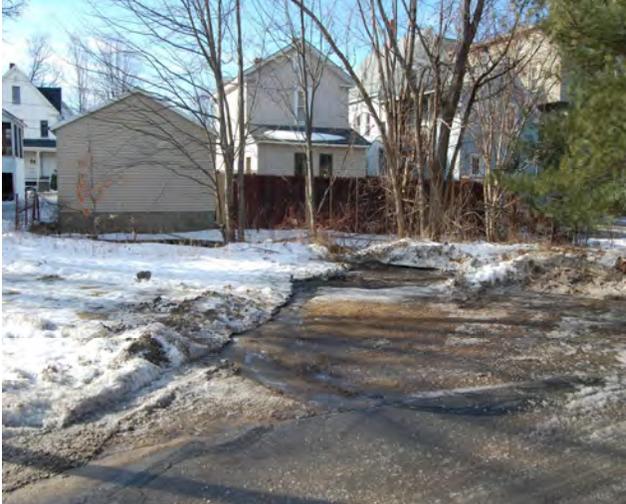
Photo 1

Area for potential stormwater pond or underground tank.	Photo 2

Project Narrative Description (up/downstream limits, banks(s), etc):
 Install stormwater detention system – either small open pond or larger underground chamber – to detain runoff prior to discharge to brook.

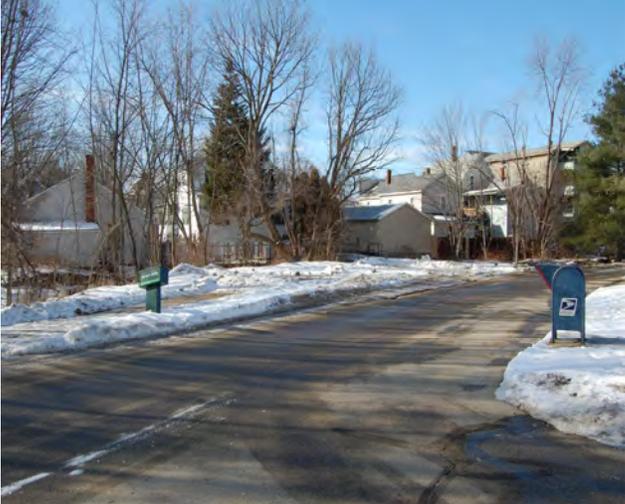
Source area for stormwater flows.
------------------------------------------------------------------------------------------------------------------------------------------------------------------	---------------------------------------------------------------------------------------------------------------------------------------------

Site Issues and Relevance to the Watershed Plan Objectives:
Stormwater runoff from adjacent roads, roofs and parking lots collects and flows uncontrolled into the brook immediately downstream of pedestrian bridge. Detaining this flow would reduce peak flow and flood potential at Union Avenue bridge.

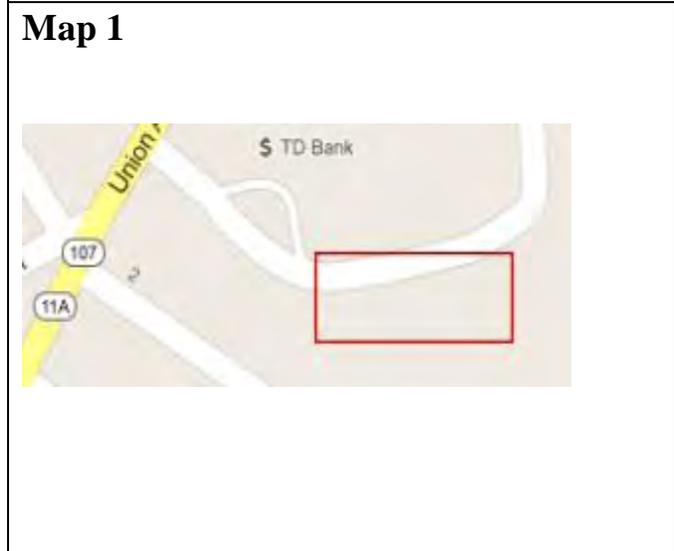
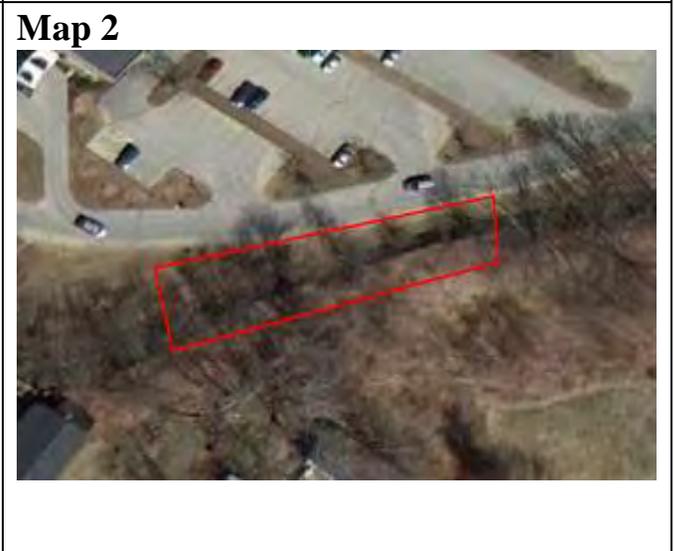
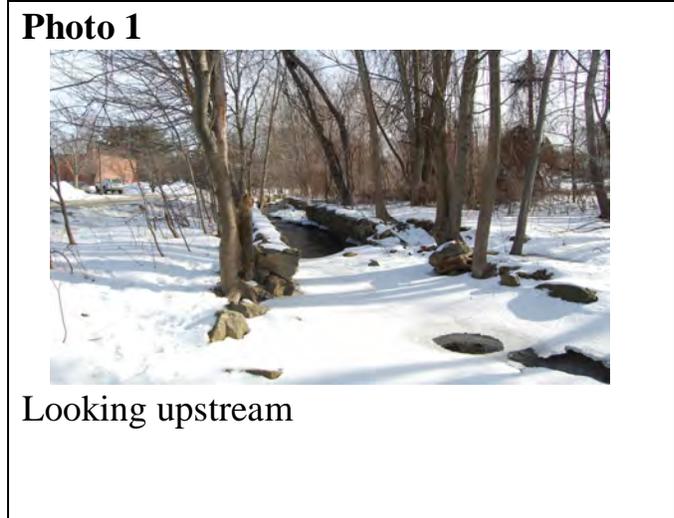
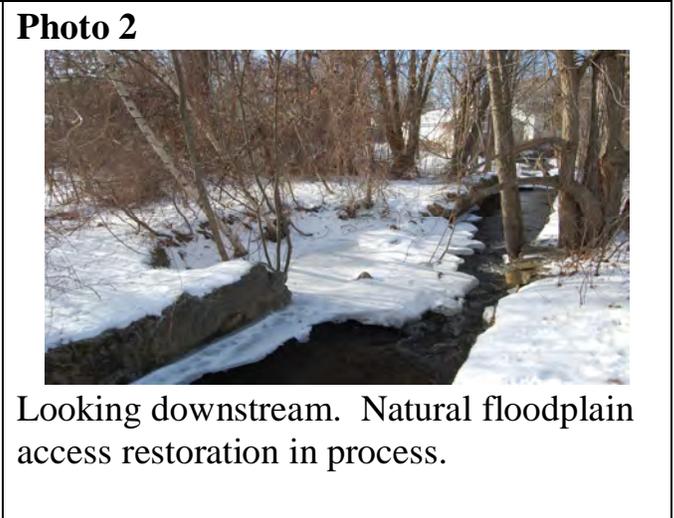
Site Issues and Relevance to the Watershed Plan Objectives:
 Stone wall forming the left bank prevents flows from accessing the left floodplain. Wall removal would allow for some reduction in peak flows downstream and would provide a location for natural sediment deposition without impact to infrastructure.

Project Narrative Description (up/downstream limits, banks(s), etc):
Remove 140' +/- of intact stone wall on left bank of brook. Remove fill behind wall. Regrade floodplain over a distance of approximately 175'. Minor channel realignment and shaping of new left bank necessary over approximately 80'. Some revegetation of floodplain recommended.

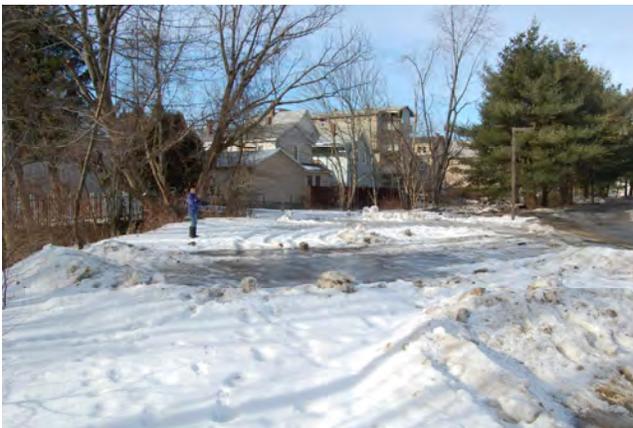
Photo 1

Looking downstream toward fill removal area.

Project Narrative Description (up/downstream limits, banks(s), etc):
Remove fill placed in the right overbank between the downstream limits of existing stonewall and the existing pedestrian bridge (approx.. 95'). Consider extending an additional 50' downstream using culverts to keep path to bridge elevated/dry. Add vegetation to new floodplain.

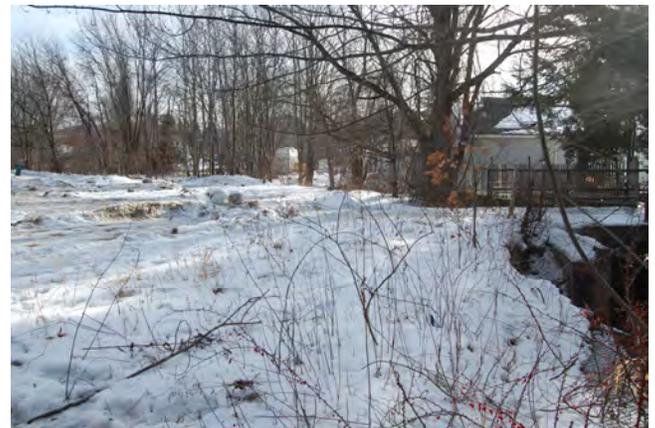
Photo 2

Looking upstream toward fill removal area.

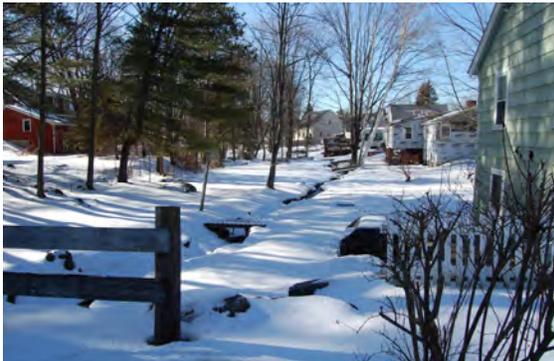
Photo 1

Looking downstream from Hutchinson Street.

5. **Project #5. Landowner outreach/education.** (SGA Reach M01.S1.01) The tributary to Jewett Brook from Hutchinson Street to the outlet above Highland Avenue is narrow and incised due to historic filling. Erosion and undercut banks create a source of sediment to Jewett Brook. Outreach/education efforts are recommended to educate residents about negative downstream consequences of poor management of the channel, and to introduce concept of channel management easements.

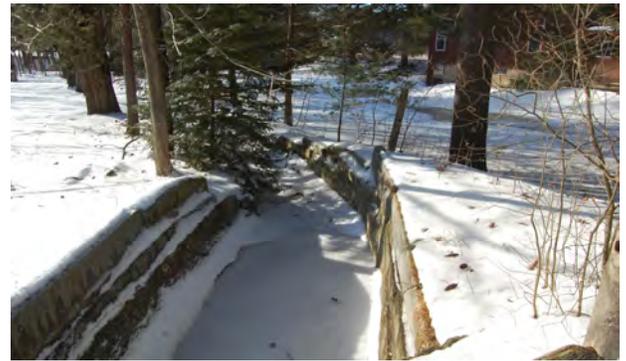
Photo 2

Looking downstream from Crescent Street.

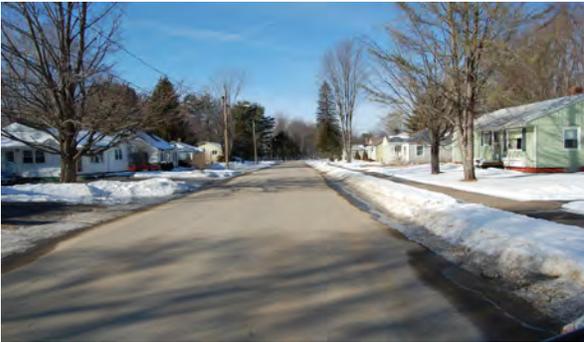
Photo 1

Stormwater control BMP study area.

Site Issues and Relevance to the Watershed Plan Objectives:
 Stormdrain system has no detention components (e.g., pond) and thus delivers runoff to Jewett Brook faster than undeveloped conditions. The increased volume and rate of runoff contribute to flooding and channel instability.

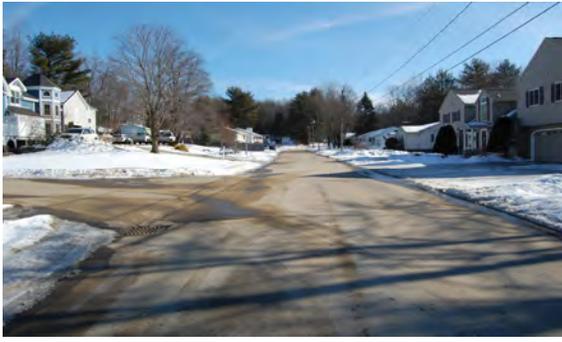
Photo 2

Stormwater control BMP study area.

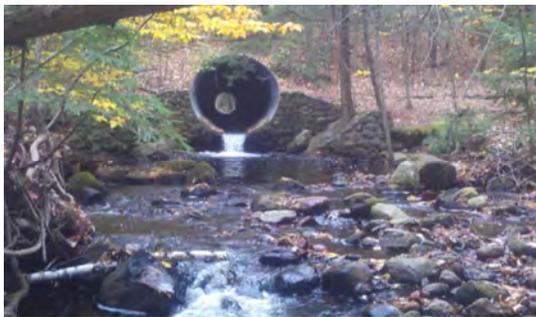
Photo 1

Culvert outlet.

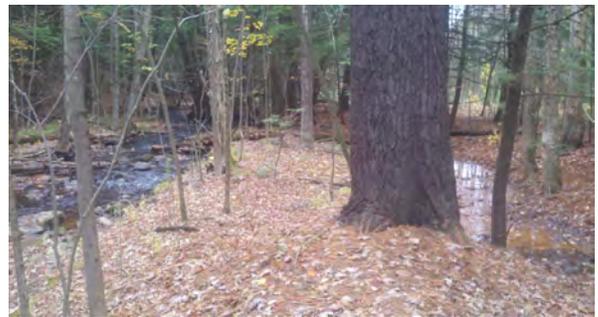
Photo 2

Downstream of culvert outlet.

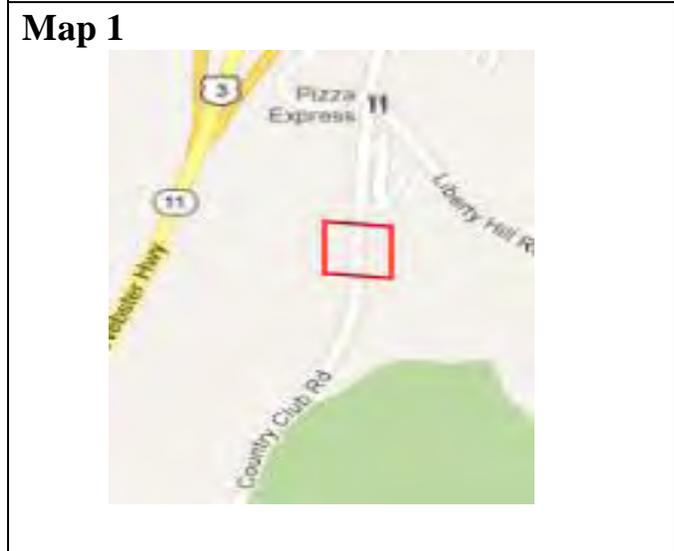
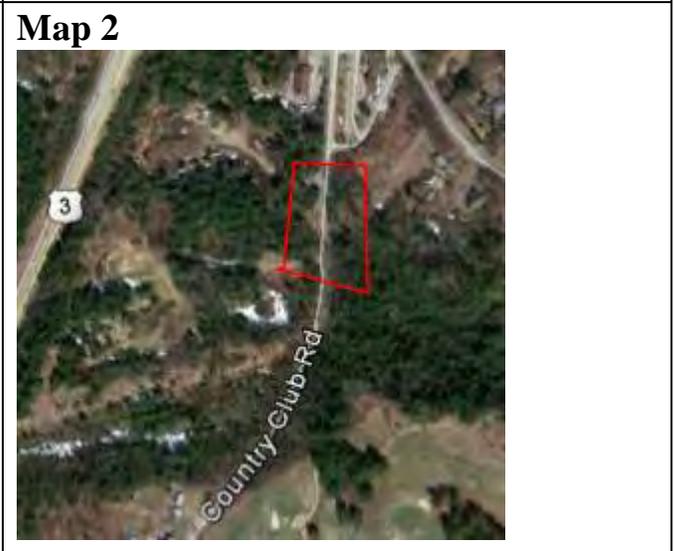
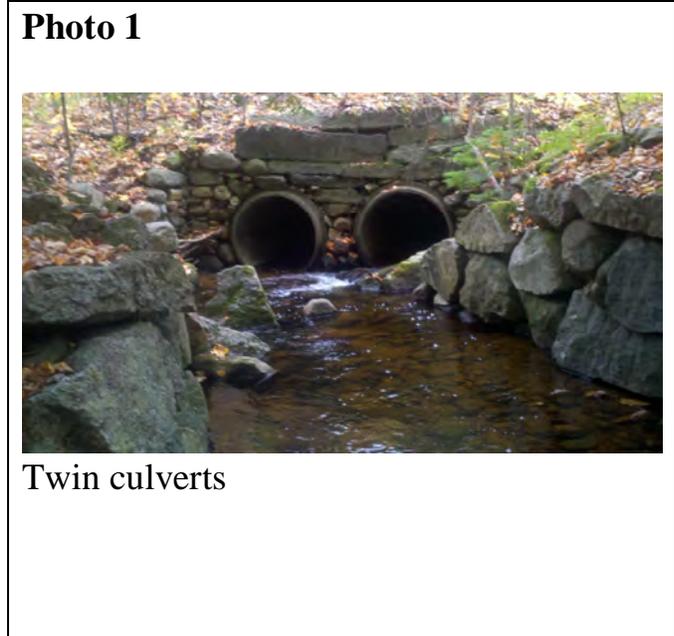
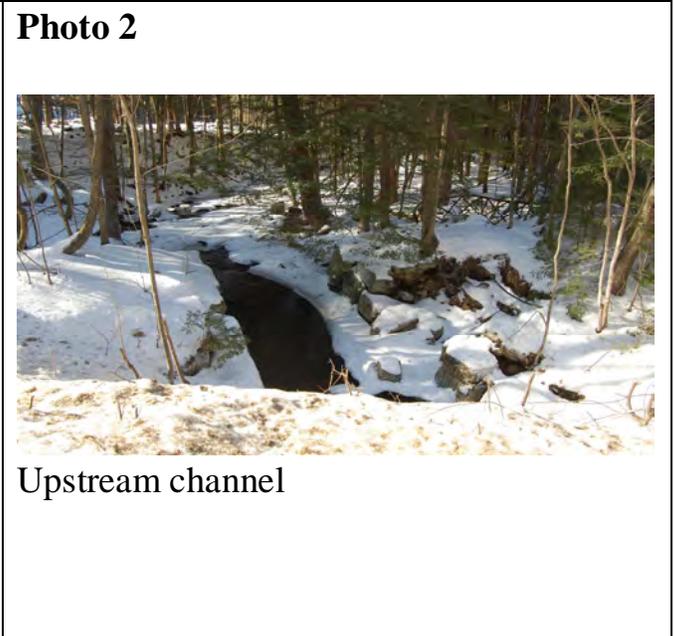
Site Issues and Relevance to the Watershed Plan Objectives:
 The culvert is significantly undersized, and the hard bank armoring is failing above and below the structure, thus contributing sediment to Jewett Brook. During major flood events, undersized culverts such as these can trigger significant channel instability that results in the erosion of bed and bank material.

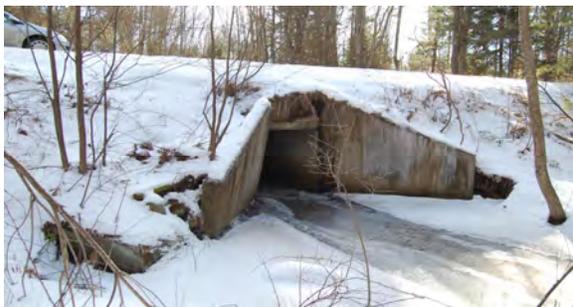
Photo 1

Culvert, looking upstream at the outlet.

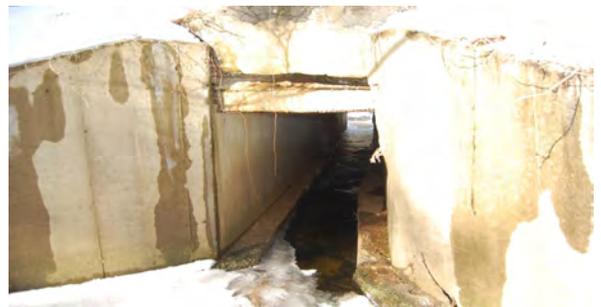
Photo 2

Culvert inlet.
