APPENDIX B

PROBLEM CULVERT IDENTIFICATION

Jewett Brook Stream Crossing Assessments
Data collection by Bear Creek Environmental, LLC
Assessment Conducted during August 2010

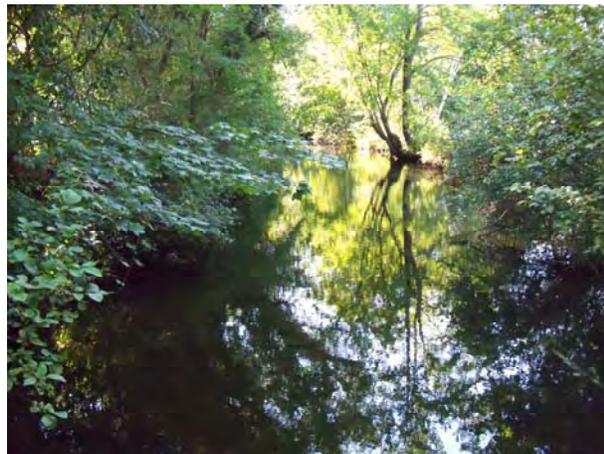
Channel below outlet

Erosion and Armoring – hard bank armoring not associated with bridge is failing above structure; bank erosion is low upstream and downstream of bridge.

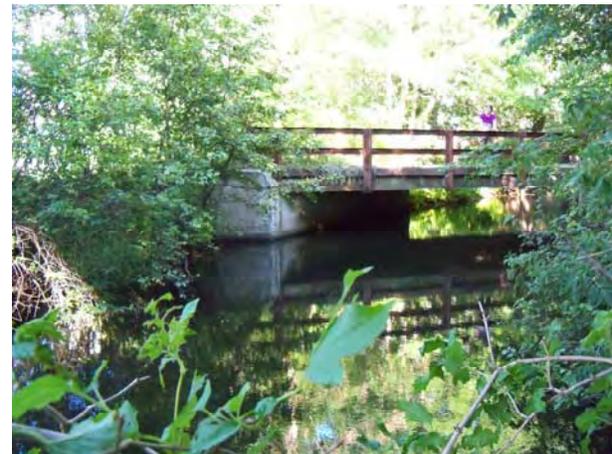
Outlet

Additional problems noted: Upstream alignment is poor; water hits the wing wall above the structure at the south side.

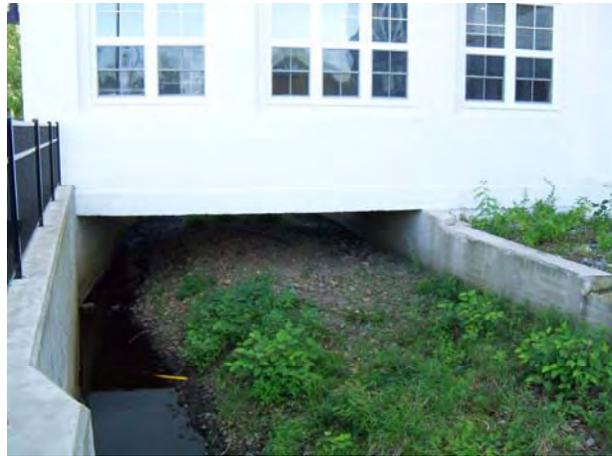
Side bar inside of and below Mill building

Erosion and Armoring – Armoring intact upstream and failing downstream; bank erosion low in channel below bridge.

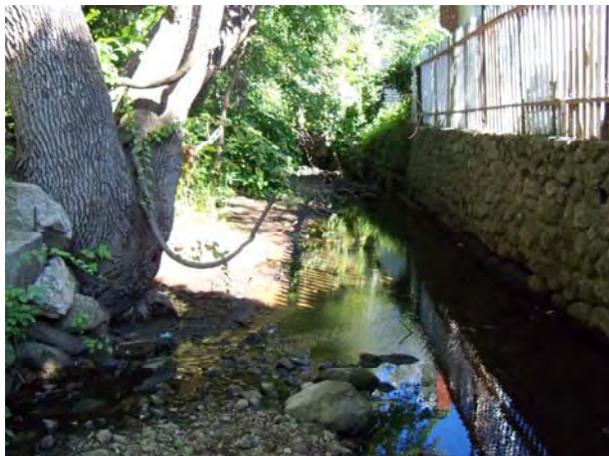
Channel above inlet

Erosion and Armoring – Hard bank armoring failing above and below structure; streambed scour undermining abutments at both upstream and downstream ends.

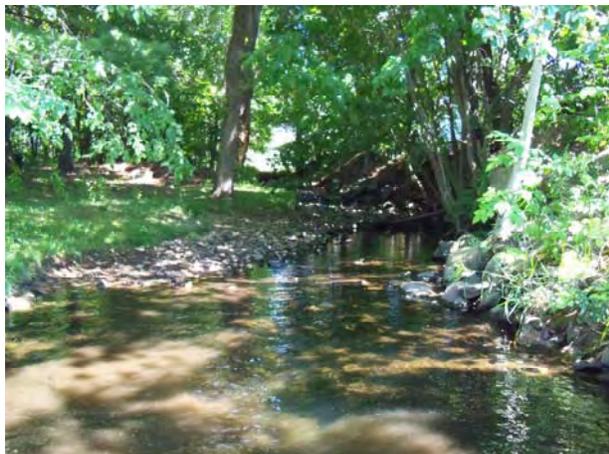
Channel above inlet

Erosion and Armoring – Hard bank armoring along banks above bridge is failing; high bank erosion above the structure; low bank erosion below structure with hard bank armoring intact.

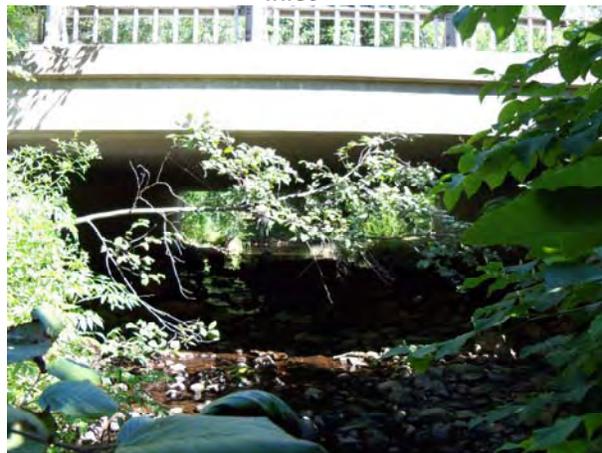
Outlet

Notes: Structure looks relatively new. No major problems noted other than significant deposition below the bridge. Japanese knotweed (invasive plant) is growing on bars.

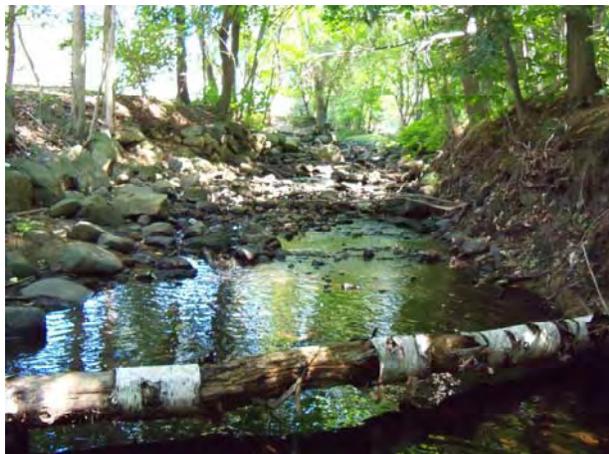
Channel above inlet

Erosion and Armoring – Hard bank armoring failing above and below structure; high bank erosion upstream and downstream; scour causing undermining around/under structure at upstream end.

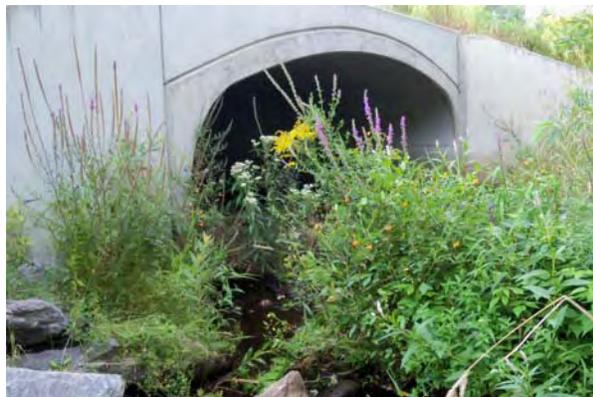
Inlet - sharp bend

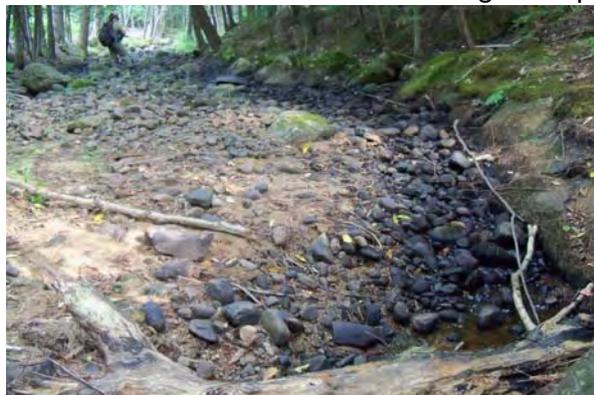
Channel above inlet

Notes: Culvert is in good to fair condition. The steep riffle and high side bar upstream of the structure indicate the culvert is undersized. Downstream bank heights are substantially higher than upstream bank heights. Iron precipitate in pipe.

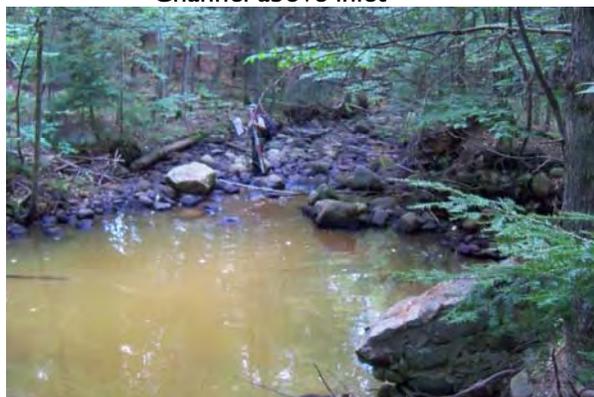
Channel below Outlet

Erosion and Armoring – Bank erosion is high below structure and hard bank armoring is failing

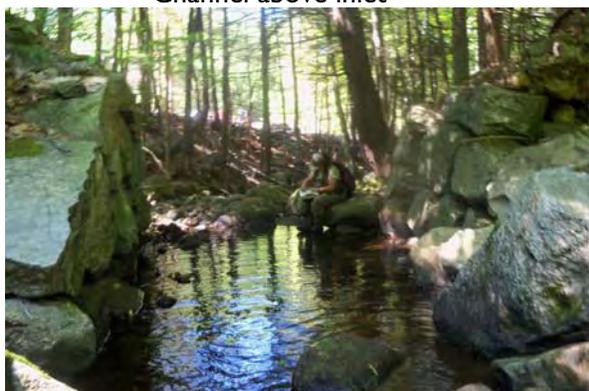
Channel below Outlet

Erosion and Armoring – Low erosion upstream and high erosion downstream; hard bank armoring is failing above and below structure.

Notes: Debris and sediment at upstream end of structure. Riprap on north bank is failing – severe bank erosion. Riprap is slightly blocking the south outlet.

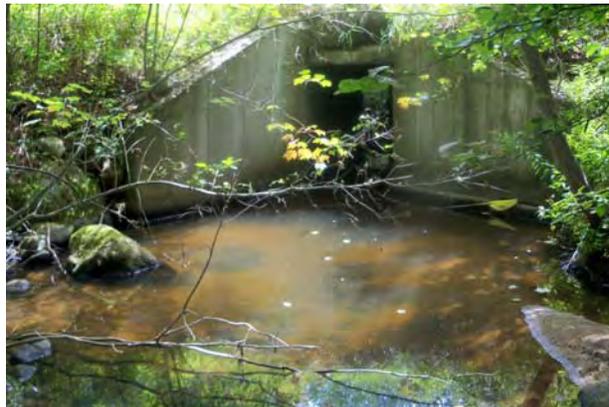
Outlet

Notes: Culvert appears to be old; concrete is deteriorating on bottom. Significant scouring of wingwalls at downstream end.

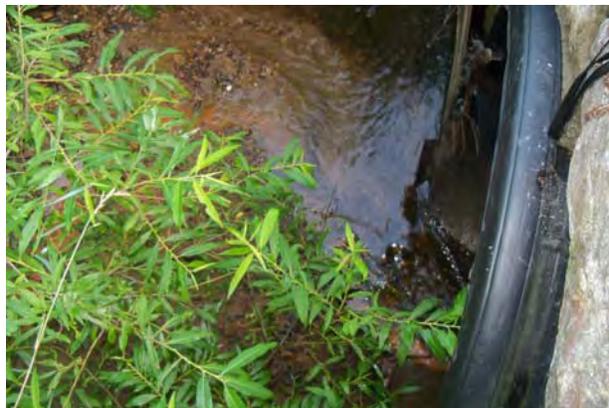
Inlet

Notes: Culvert is in good condition, but is very undersized. Significant aggradation at upstream end (with sediment obstructing the inlet) and scour below structure.

Priority for Replacement – High (structure in good condition – consider retrofit options)

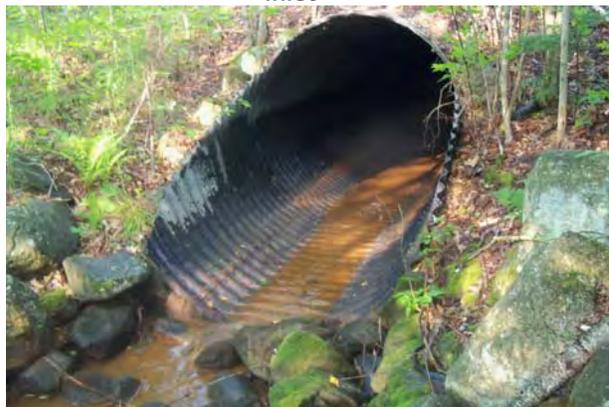
Outlet

Notes: Channel below structure has good floodplain access. Culvert is rusted out on bottom.

Priority for Replacement – High priority (structure in poor condition)

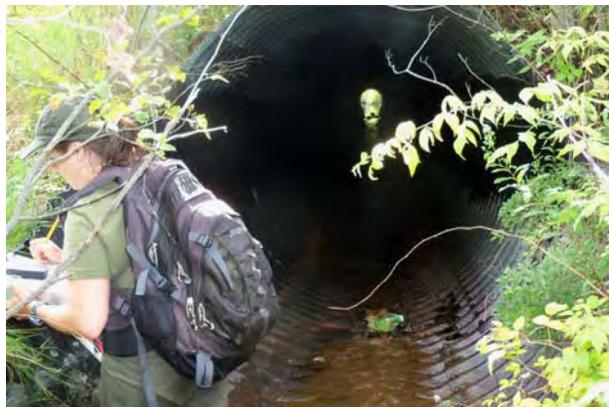
Inlet

Erosion and Armoring – No bank erosion noted upstream and low bank erosion downstream. Hard bank armoring is failing above and below structure.

Notes: Culvert is in poor condition – rusted out on bottom near inlet.

Priority for Replacement – High (structure is in poor condition)

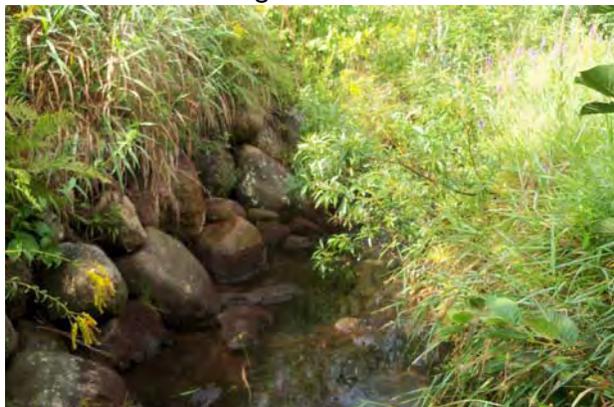
Channel above inlet

Erosion and Armoring – Bank erosion low upstream and none observed downstream. Hard bank armoring failing above structure and intact below.

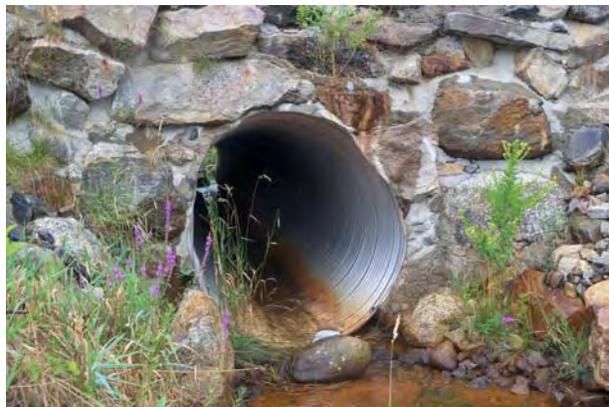
Inlet

Erosion and Armoring – No bank erosion noted above and below culvert. Hard bank armoring is failing at upstream and downstream ends. Streambed scour causing undermining around/under culvert at both ends.

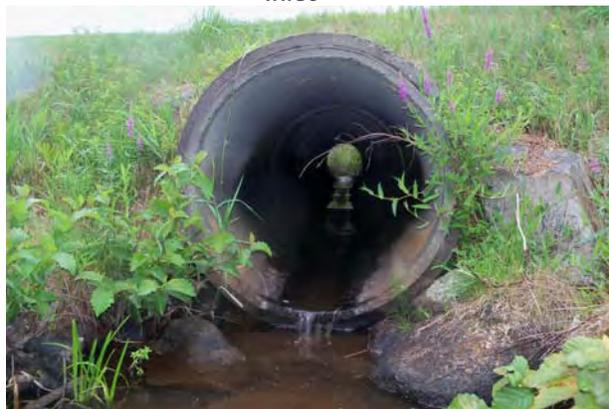
Outlet

Notes: No significant issues noted other than culvert is perched.

Priority for Replacement – High (if culvert cannot be replaced consider retrofit options)

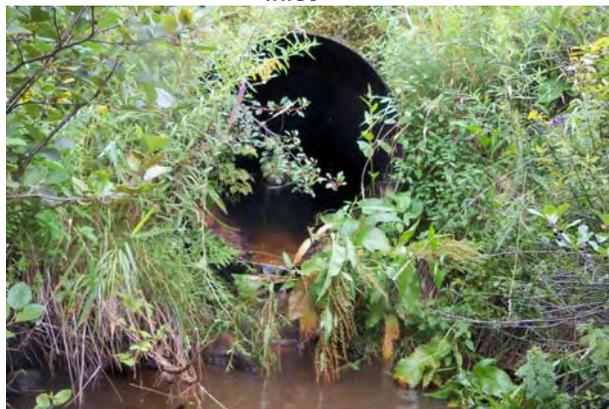
Outlet

Erosion and Armoring – No bank erosion noted upstream of structure and bank erosion below culvert is high. Hard bank armoring is failing above and below culvert. Streambed scour is causing undermining around/under culvert at downstream end.

Notes: Wetland approximately 100 feet upstream of culvert crossing. Culvert is in poor condition (rusted).

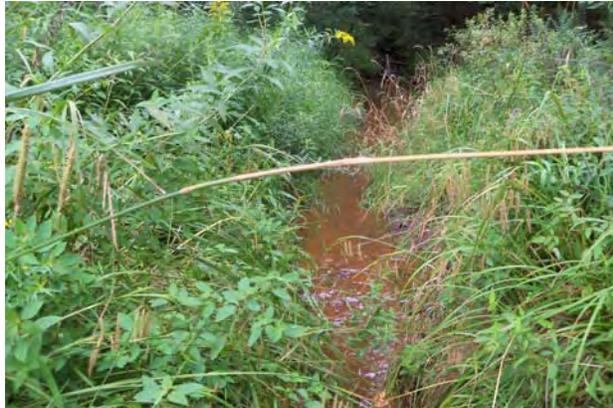
Channel above inlet

Erosion and Armoring – Low bank erosion upstream and no bank erosion noted downstream; no hard bank armoring.

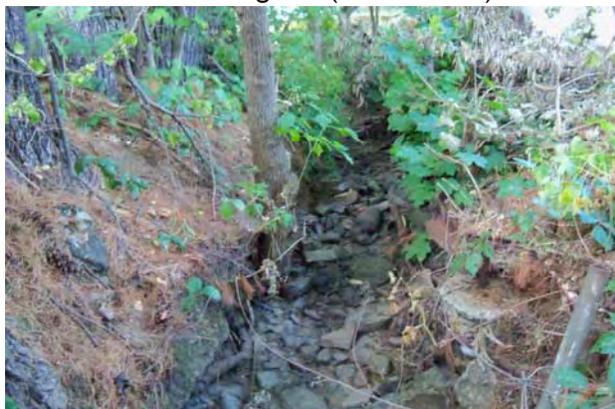
Channel above inlet

Erosion and Armoring –High bank erosion above and below culvert; upstream hard bank armoring failing; streambed scouring around culvert upstream and around wing walls downstream.

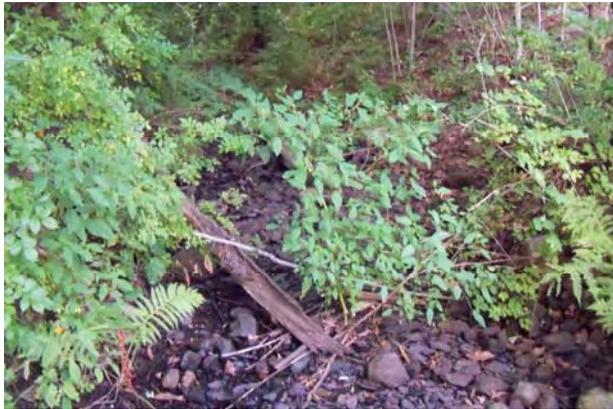
Channel above inlet

Erosion and Armoring –High bank erosion upstream and low erosion downstream; hard bank armoring is failing; streambed scour causing undermining around/under culvert at upstream end.

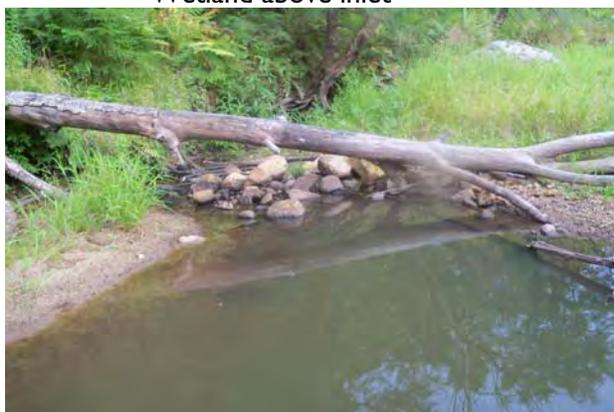
Chanel below Outlet

Erosion and Armoring –No bank erosion upstream and high erosion downstream; hard bank armoring is failing.
