Jewett Brook Watershed Stream Geomorphic Assessment Laconia and Gilford, New Hampshire May 30, 2011

Prepared by:
Bear Creek Environmental, LLC
297 East Bear Swamp Road
Middlesex, Vermont 05602

Prepared for:
New England District, U.S. Army Corps of Engineers
696 Virginia Road
Concord, MA 01742-2751

1.0 EXECUTIVE SUMMARY

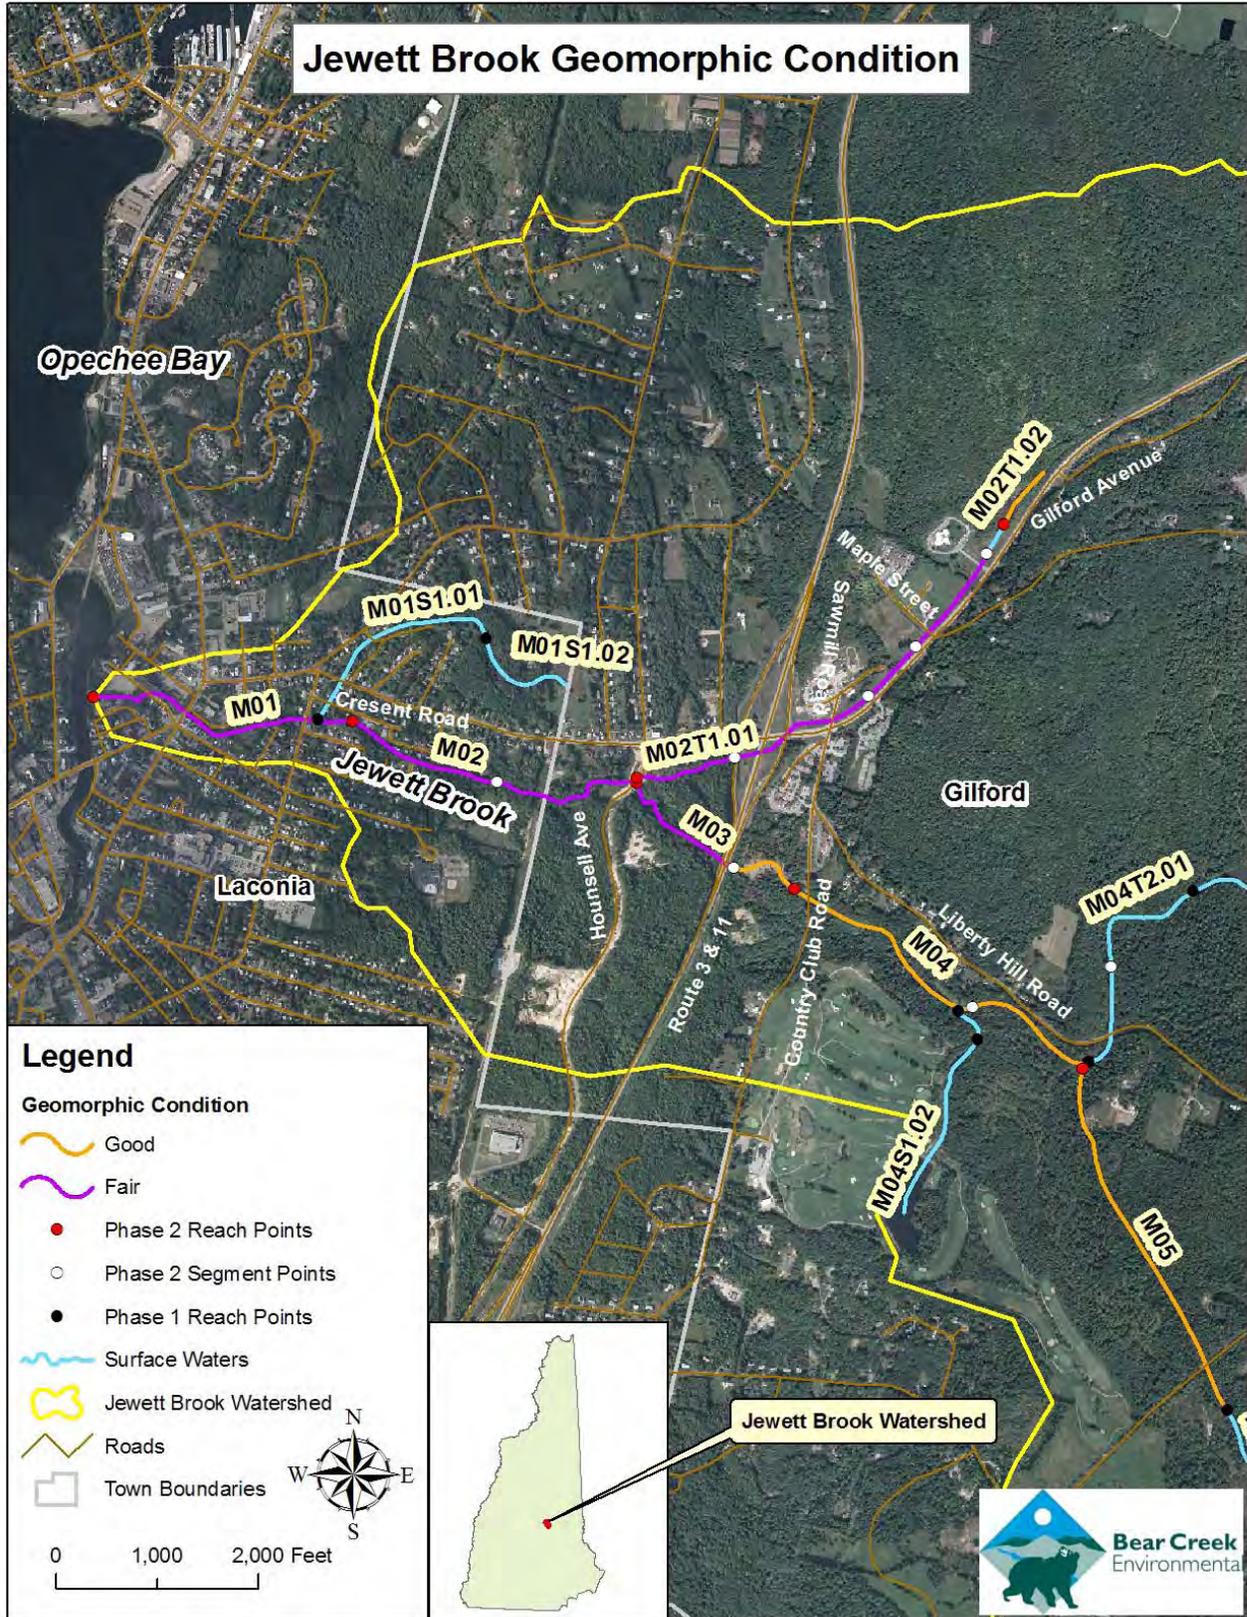
Figure 5.1. Phase 2 Geomorphic Condition of the Jewett Brook Watershed

The reach condition ratings of the Jewett Brook watershed indicate that most of the reaches/segments are actively or have historically undergone a process of minor or major geomorphic adjustment. Many of the reaches studied in the Jewett Brook watershed are undergoing a channel evolution process in response to large scale changes in its sediment, slope, and/or discharge associated with the human influences on the watershed. Table 3 below summarizes the channel evolution of each study reach and the primary adjustment processes that are occurring.
