Phase I – Environmental Site Assessment

Lakes Region Facility
1 Right Way Path
Laconia, New Hampshire

August 10, 2010

In Reference to:
Project No. 10001086

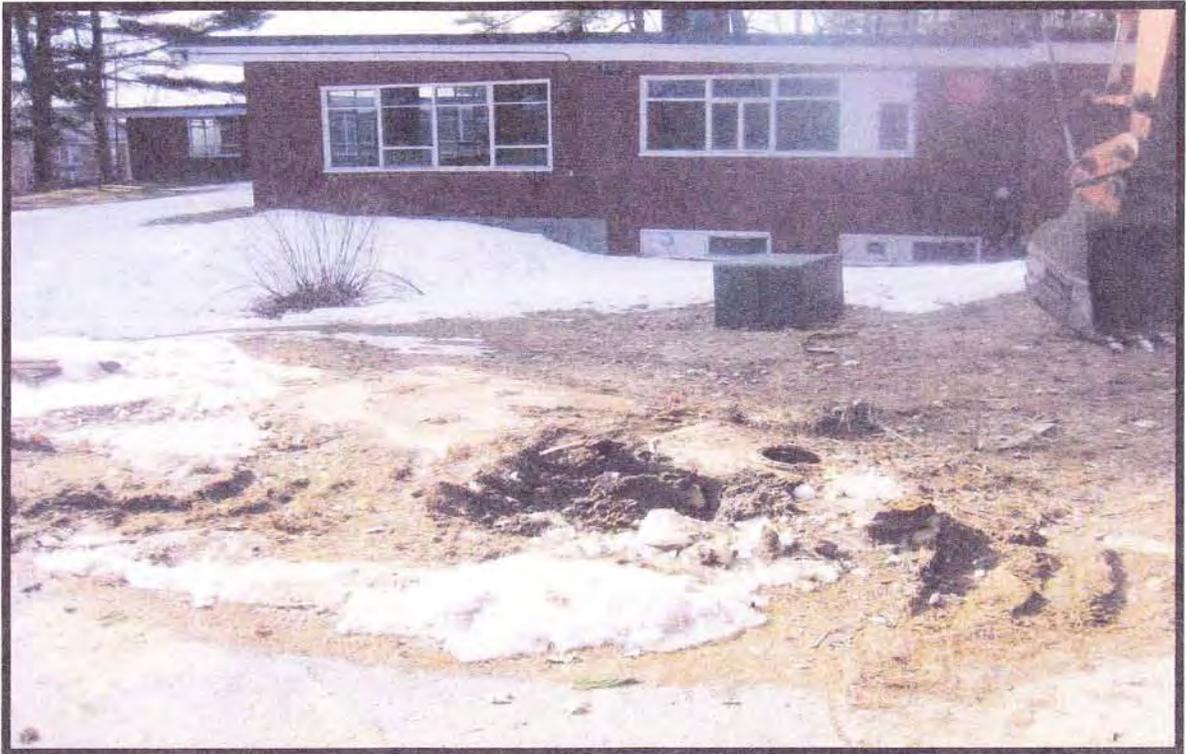
Description: View of the work area prior to excavation of the underground fuel storage tank.

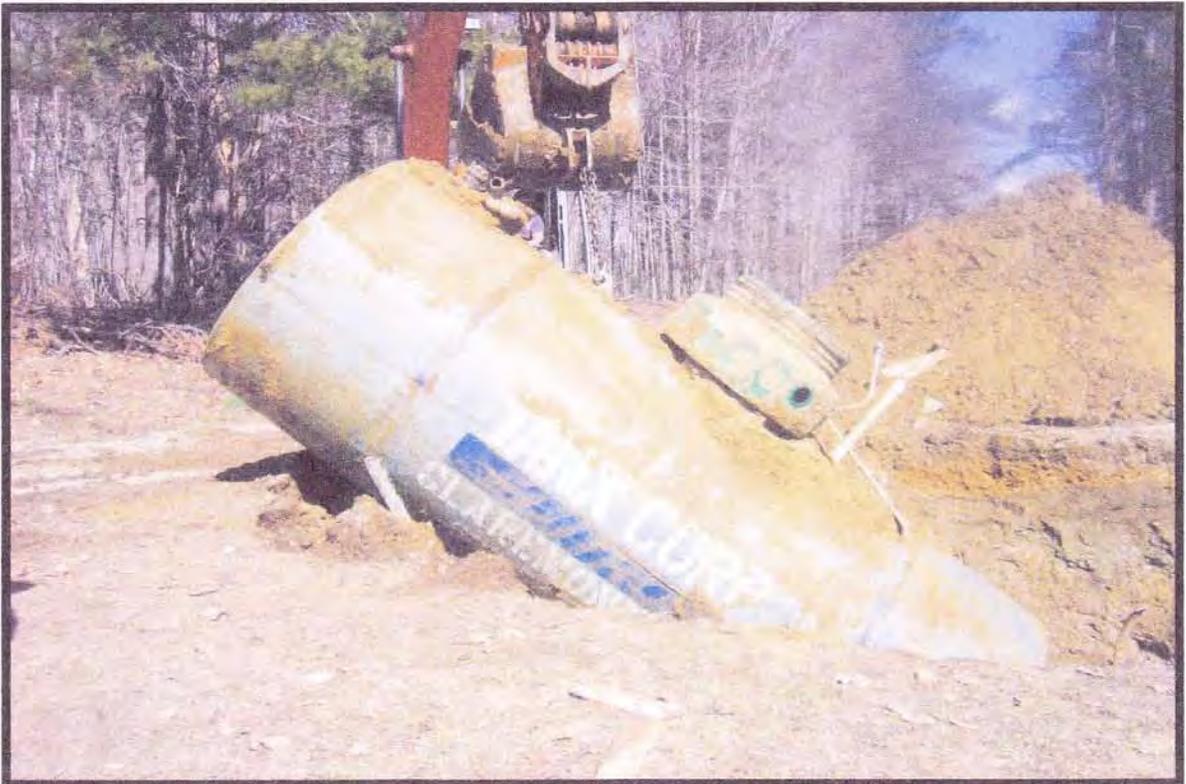
Description: Removal of the 3,000g. underground fuel oil storage tank from the ground.

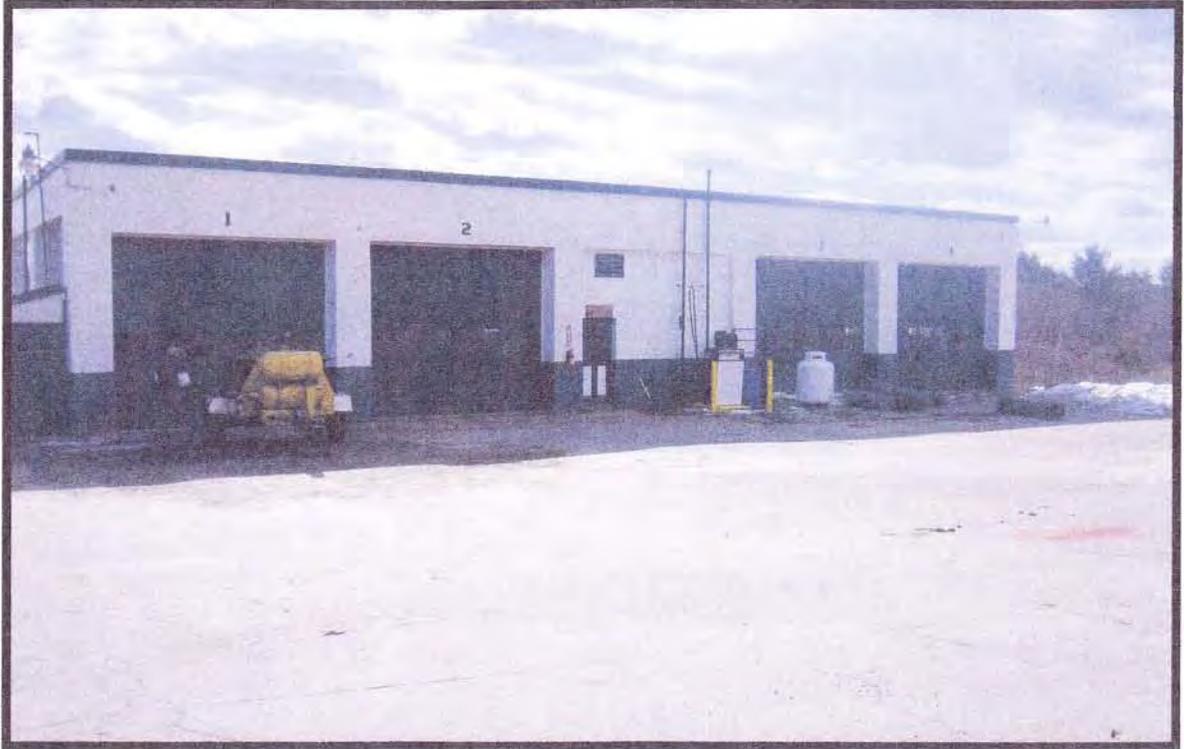
Description: View of the work area prior to excavation of the underground gasoline tank.

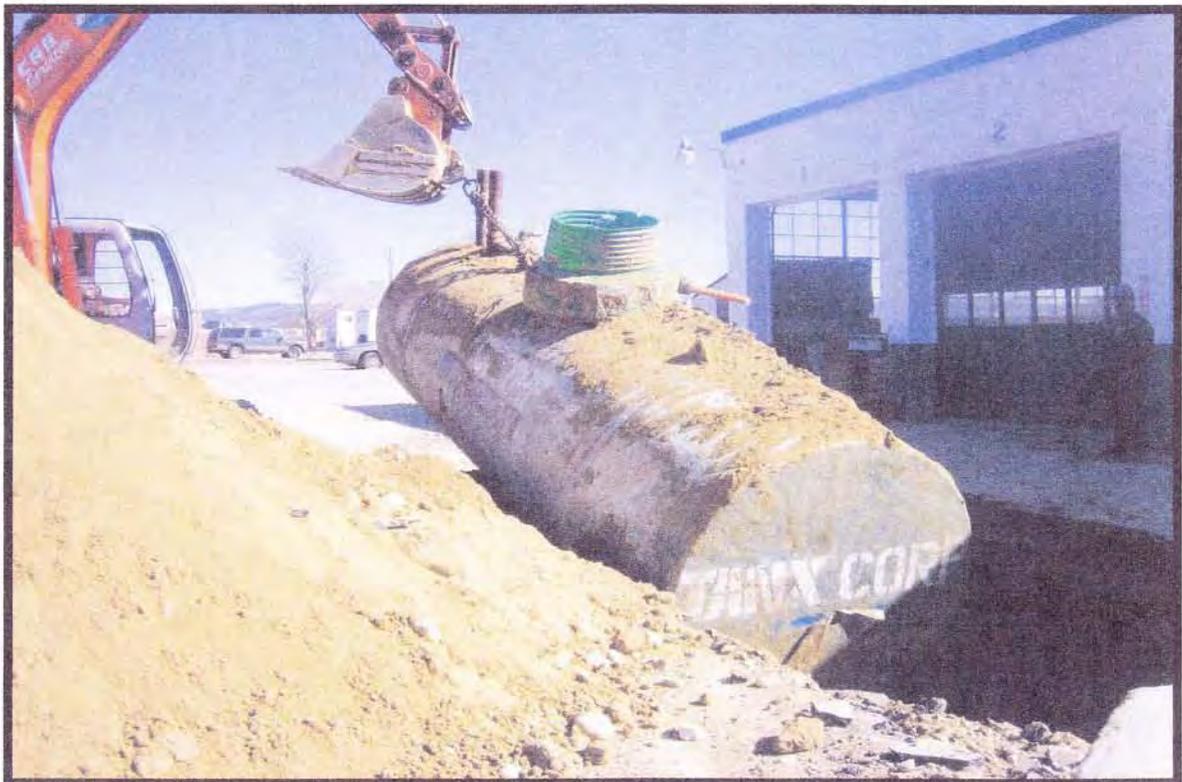
Description: Removal of the 4,000g. underground gasoline storage tank from the ground.

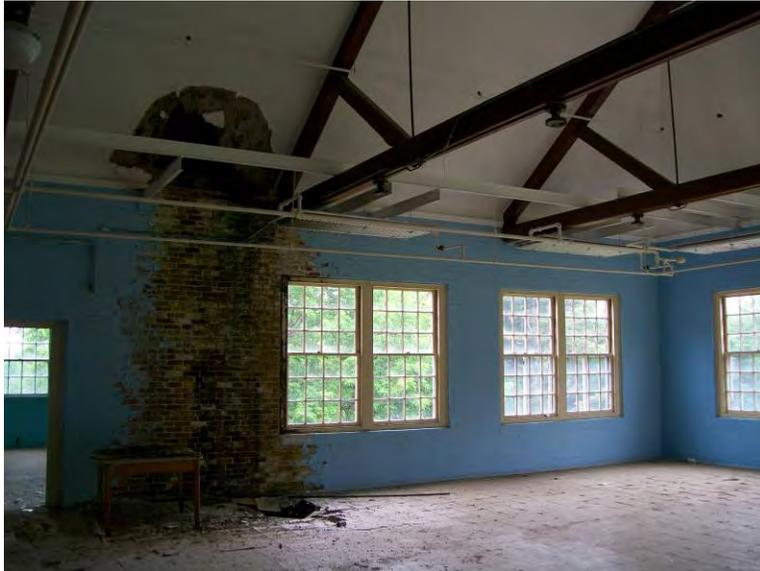
Picture 5.
Representative interior conditions of the third floor of
Building 2—Baker. Note water damage.

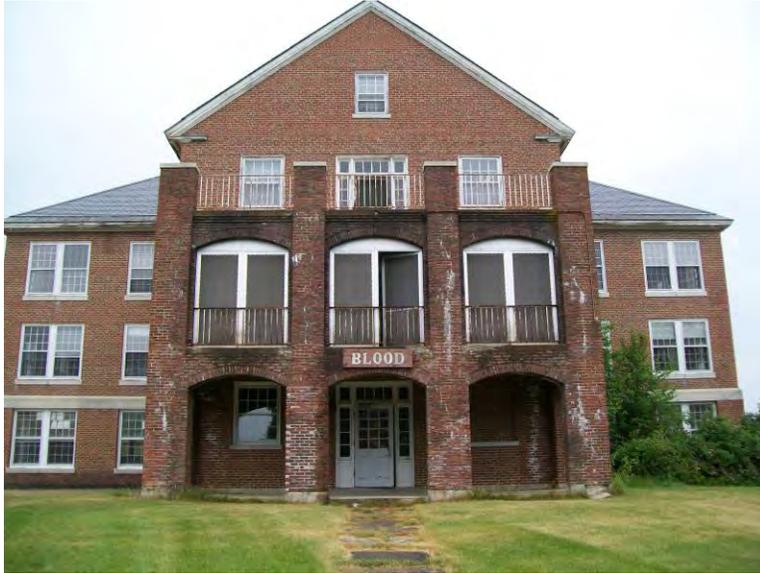
Picture 7.
Representative exterior conditions of Building 3—Blood.

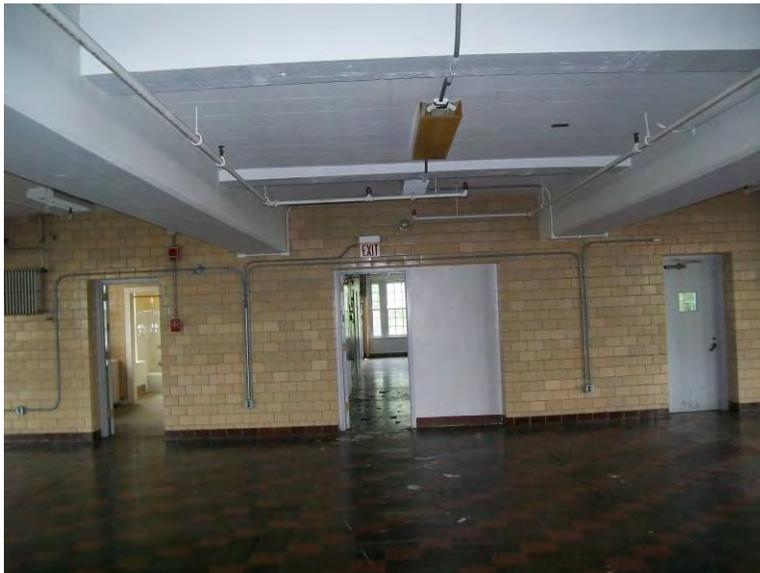
Picture 8.
Representative interior conditions of the central portion of
the first floor of Building 3—Blood.

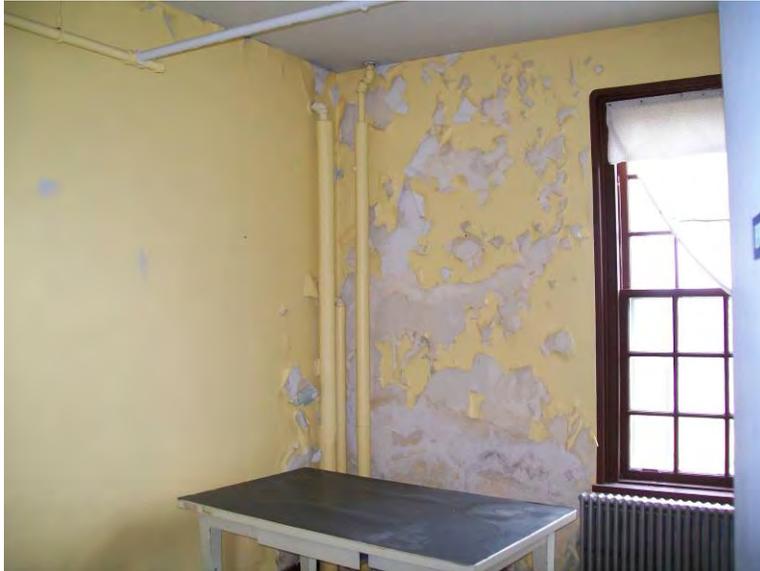
Picture 11.

Representative interior conditions of the fourth floor of Building 3—Blood. Note loose and flaking paint.

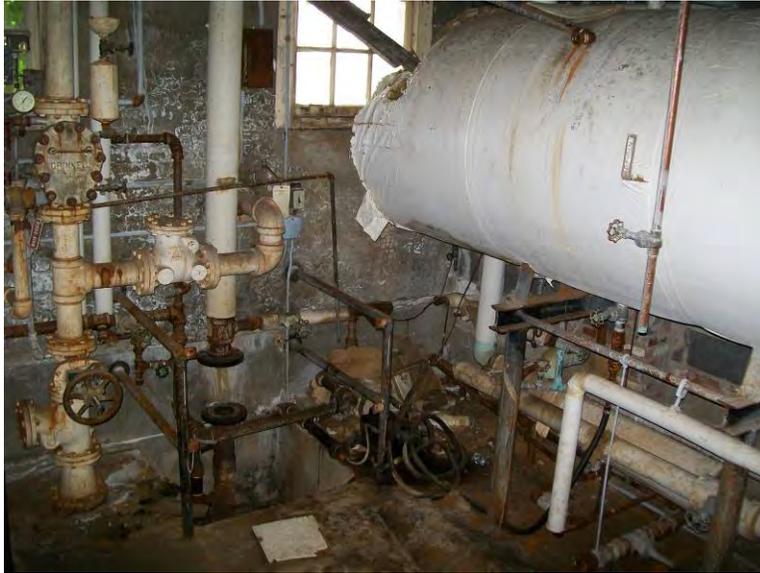
Picture 13.

Hot water tank and former steam system components within the first floor of Building 3—Blood.

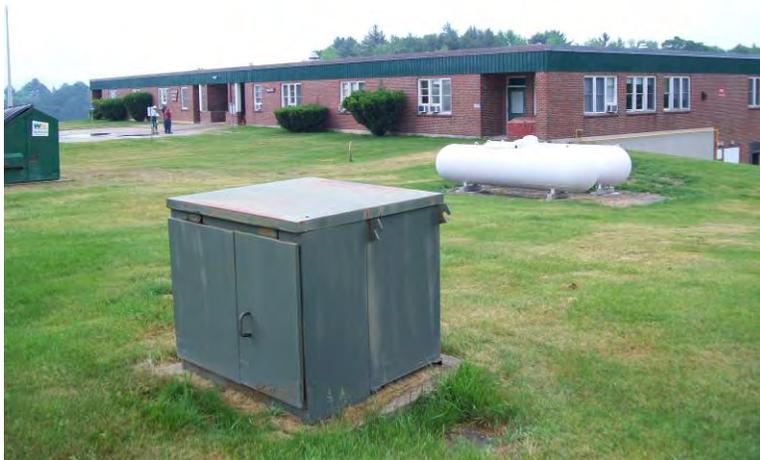
Picture 14. Representative exterior conditions of Building 4—Dube as viewed from the north. Note: pad-mounted electrical transformer and propane ASTs.

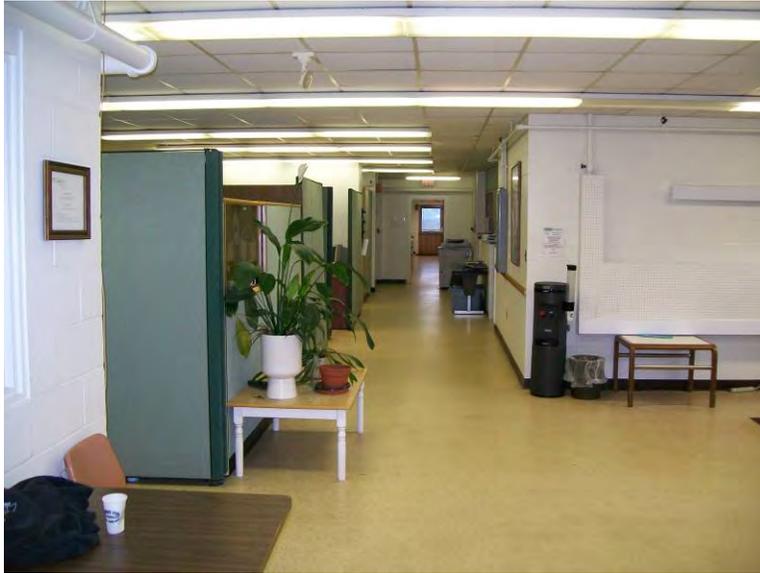
Picture 15.
Representative interior conditions of the first floor of
Building 4—Dube.

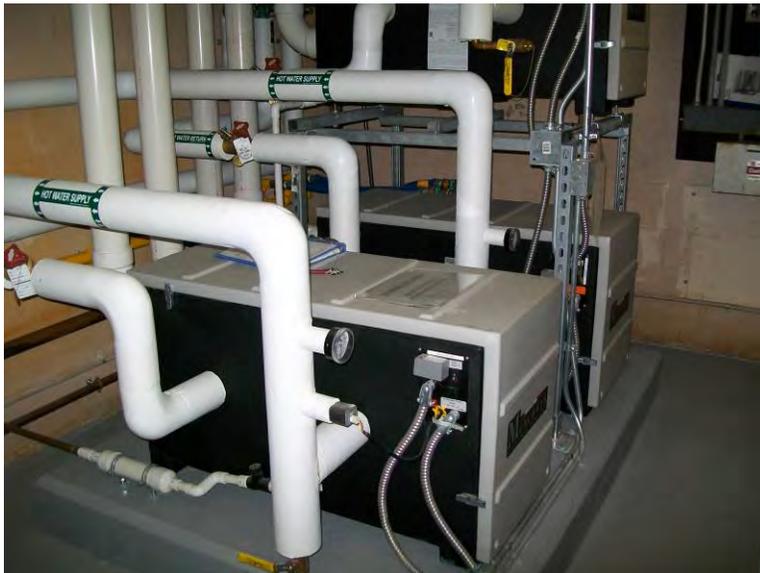
Picture 16.
Propane-fired hot water boilers located on the first floor of
Building 4—Dube.

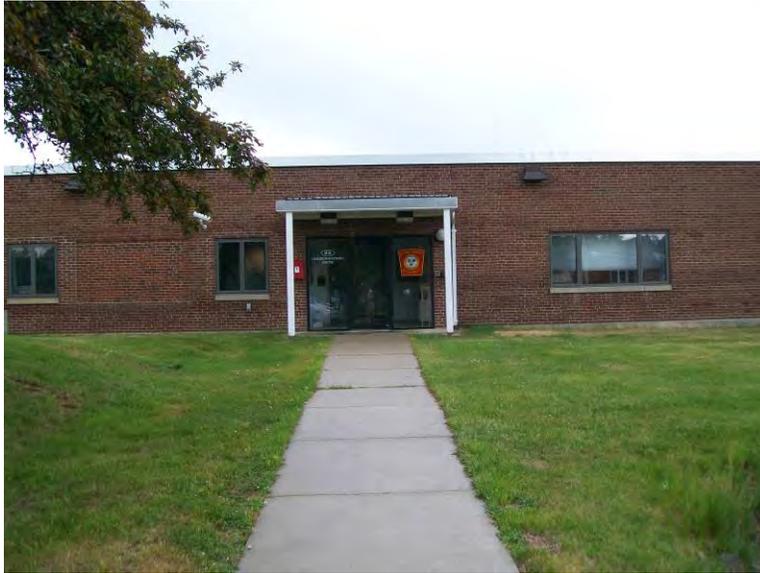
Picture 17.
Representative exterior conditions of
Building 5—Dwinell.

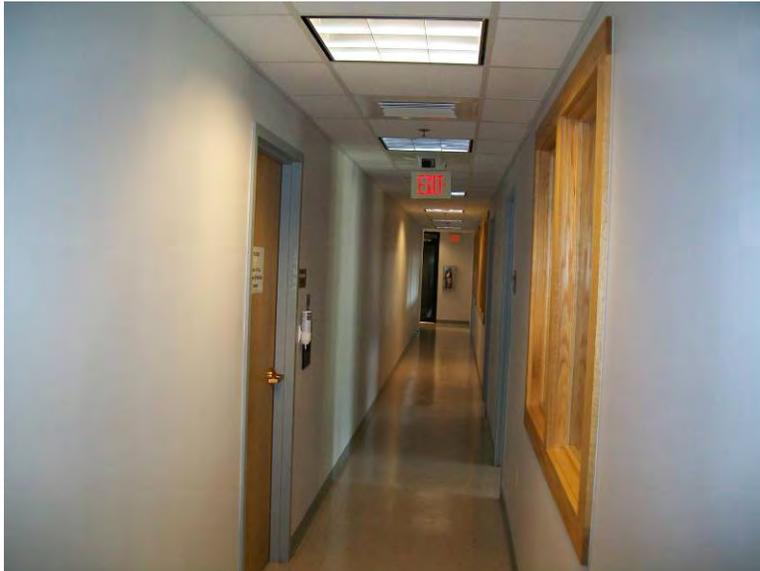
Picture 18. Representative interior conditions of the first
floor of the Lakes Region Mutual Fire Aid section of
Building 5—Dwinell.

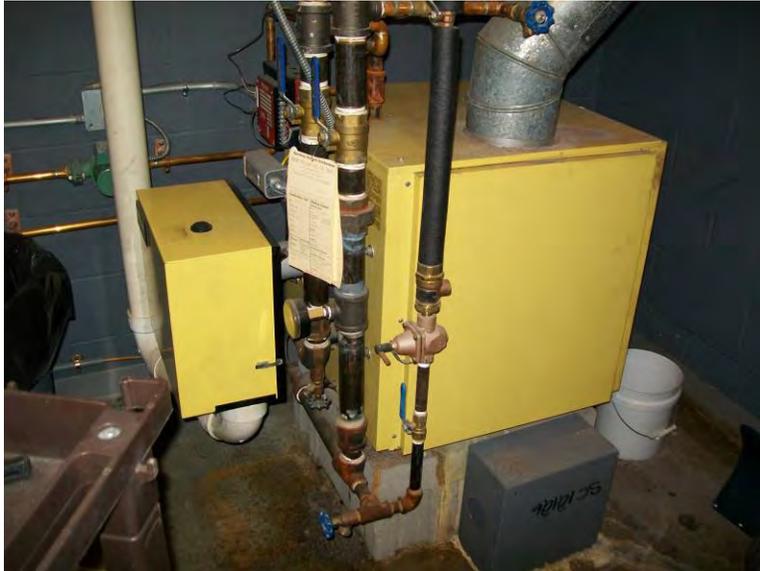
Picture 19. No. 2 fuel oil-fired boiler located on the first floor of the Lakes Region Mutual Fire Aid section of Building 5—Dwinell.

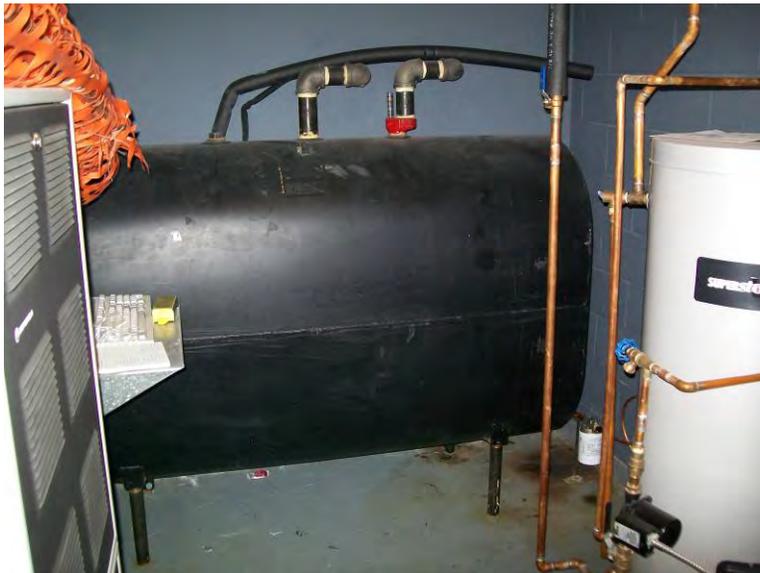
Picture 20. 330-gallon No. 2 fuel oil AST located on the first floor of the Lakes Region Mutual Fire Aid section of Building 5—Dwinell.

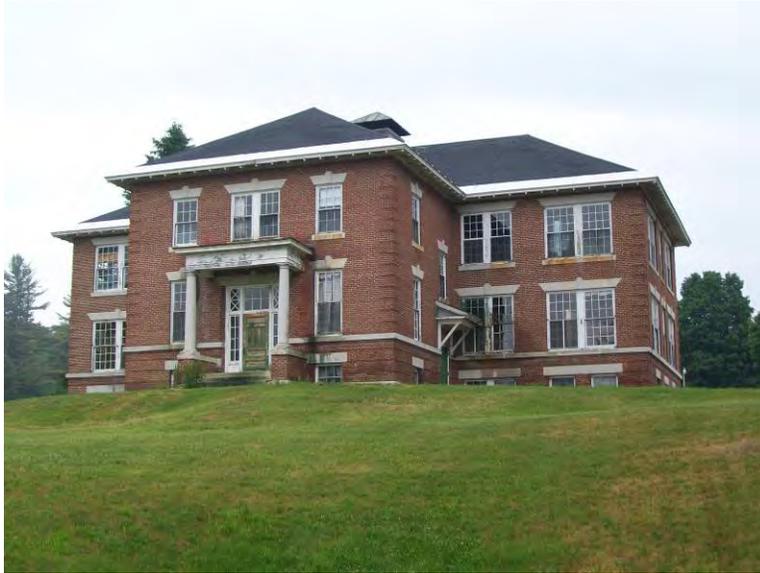
Picture 21.
Representative exterior conditions of Building 6—Felker.

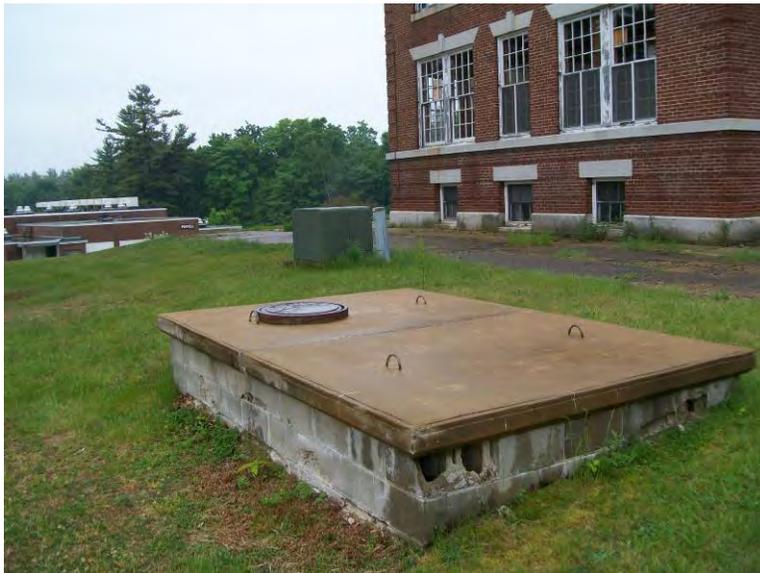
Picture 22.
Sewer system structure and pad-mounted electrical transformer located east of Building 6—Felker.

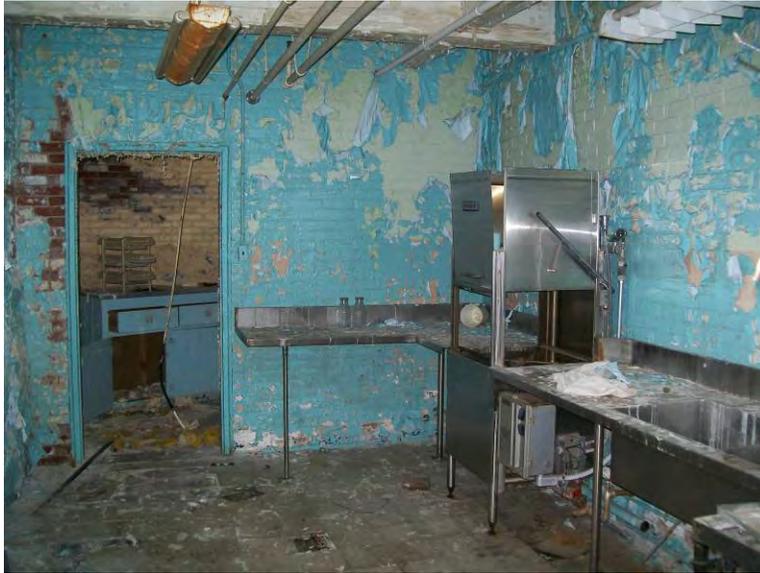
Picture 23.
Representative interior conditions of the basement of Building 6—Felker.

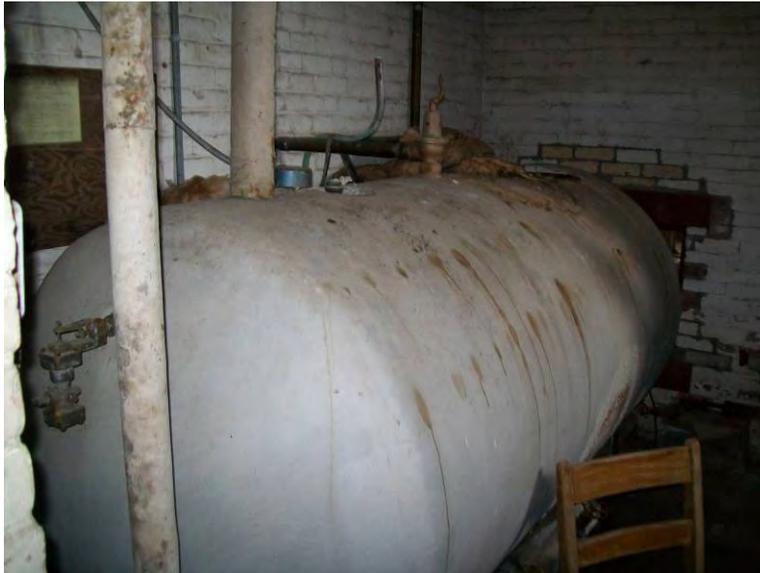
Picture 24.
Hot water tank and associated potential ACM observed within the basement of Building 6—Felker.

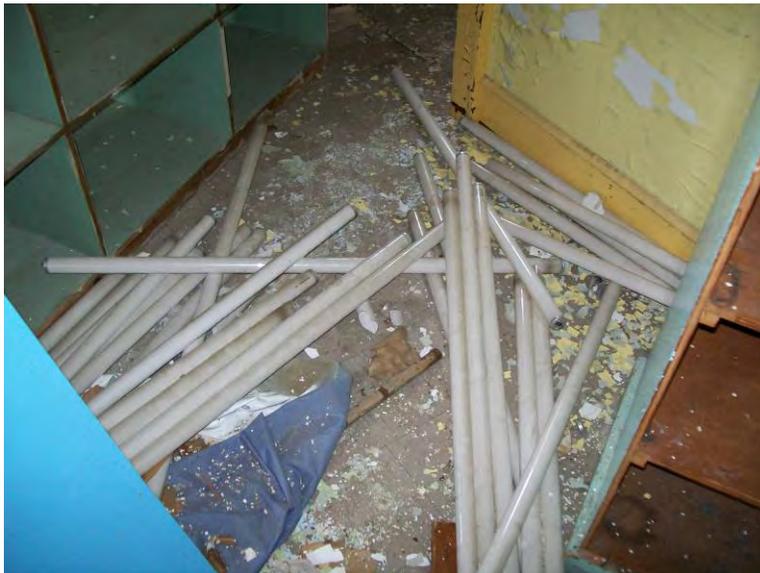
Picture 26.
Universal waste observed on the first floor of
Building 6—Felker.

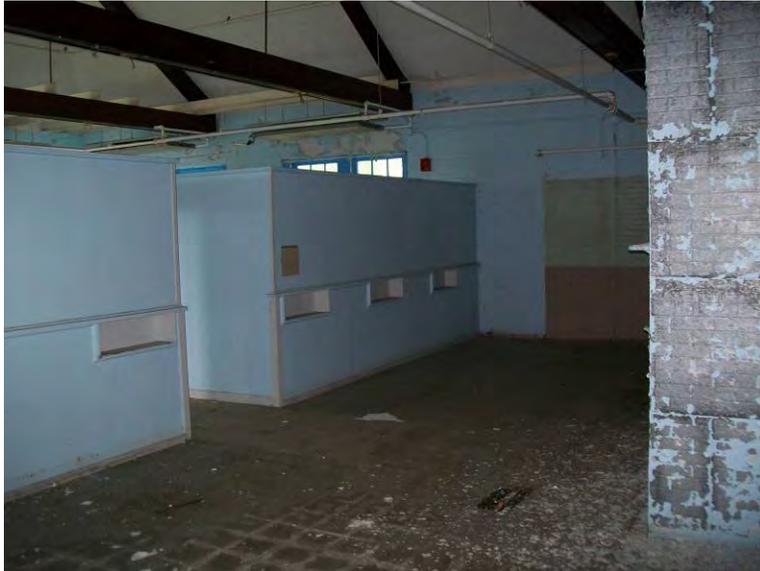
Picture 27.
Representative interior conditions of the second floor of Building 6—Felker.

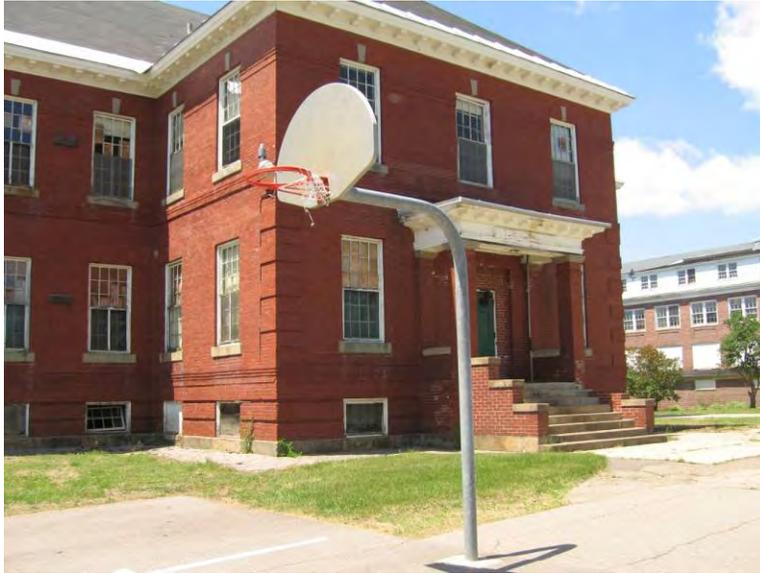
Picture 29.
Representative exterior conditions of Building 7—Floyd.

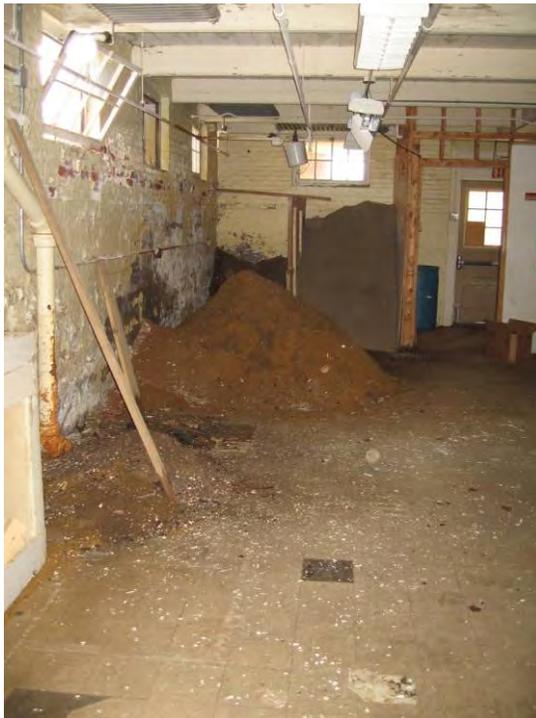
Picture 30.
Representative interior conditions of the basement of Building 7—Floyd.
Note: Piled material is reportedly sand which is applied to pedestrian walkways during freezing conditions.

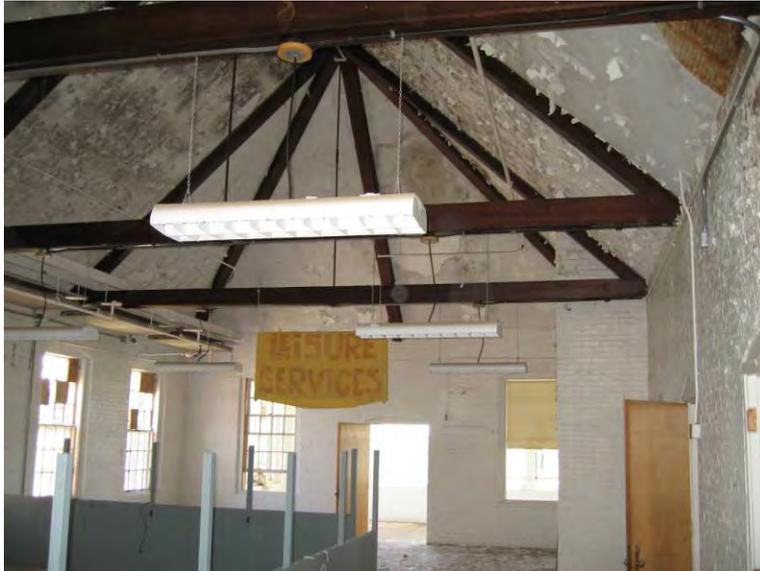
Picture 33. Representative interior conditions of the second floor of Building 7—Floyd. Note: Suspect ACM floor tiles, mold, and loose and flaking paint.

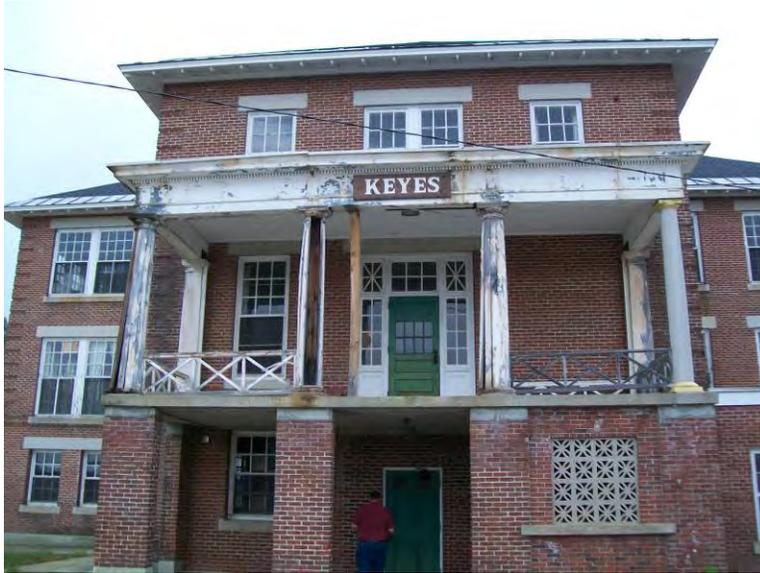
Picture 35.

Representative exterior conditions of Building 8—Keyes.

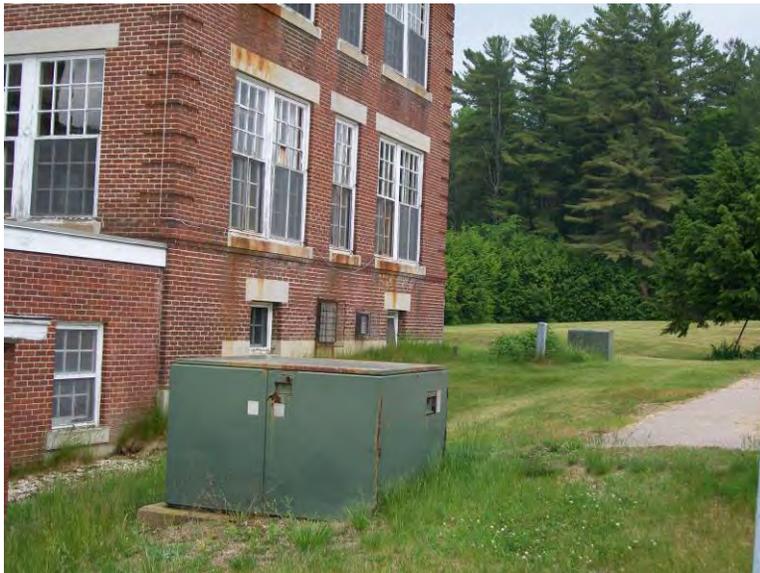
Picture 36.

Pad-mounted electrical transformer and associated switchgear located east of Building 8—Keyes.

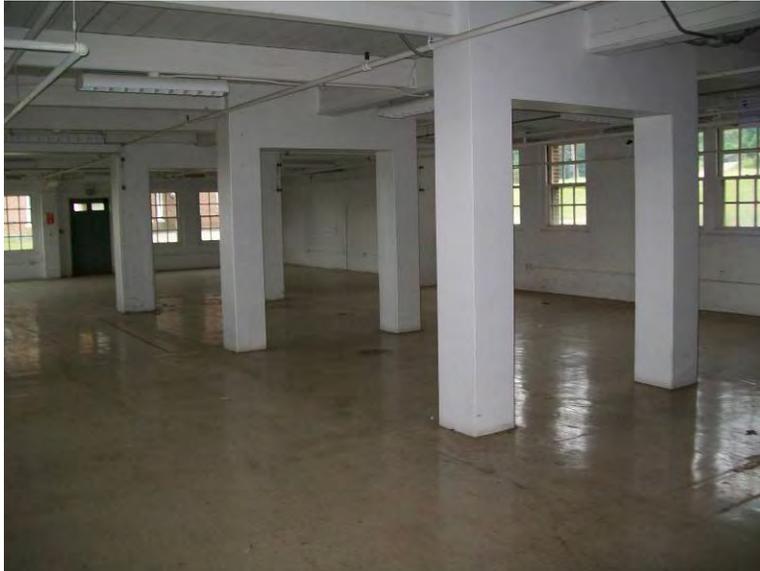
Picture 37.

Representative interior conditions of the first floor of Building 8—Keys. Note: Suspect ACM floor tiles.

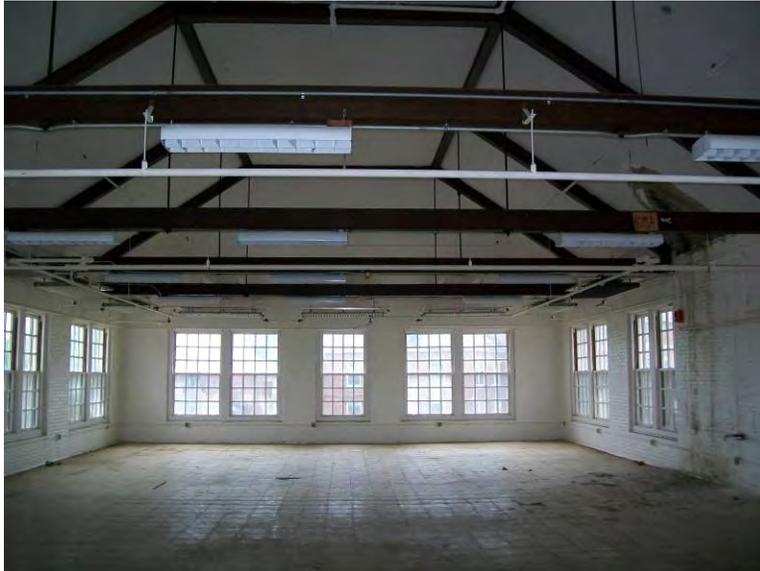
Picture 39. Representative interior conditions of the third floor of Building 8—Keys. Note: Suspect ACM floor tiles, water damage, and mold.

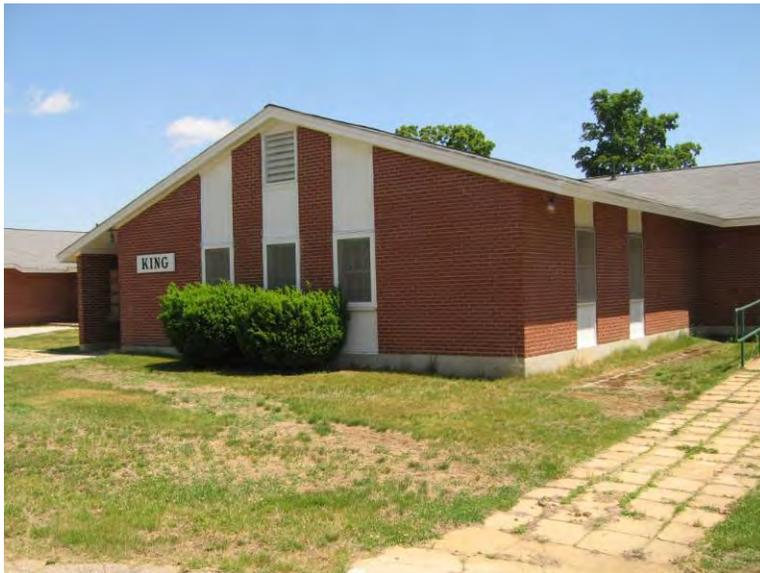
Picture 40.
Representative exterior conditions of Building 9—King.

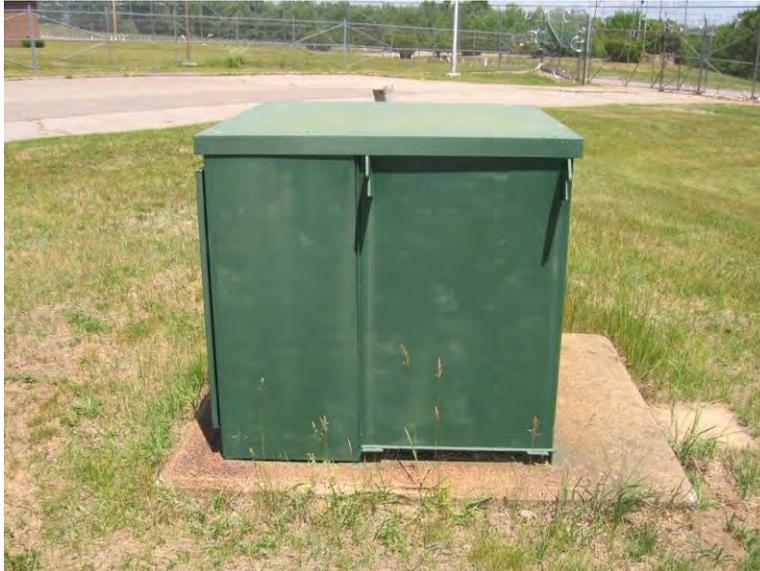
Picture 41.
Pad-mounted electrical transformer located south of
Building 9—King.

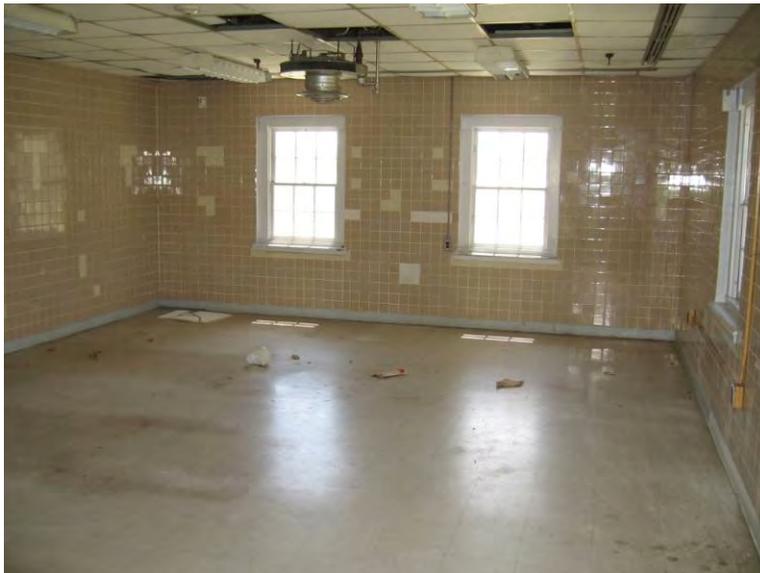
Picture 42.
Representative interior conditions of the first floor of
Building 9—King.

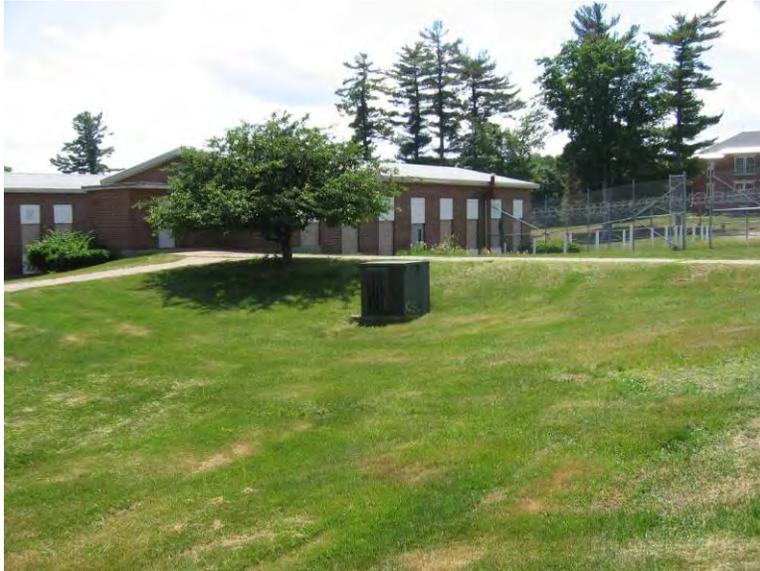
Picture 43. Representative exterior conditions of Building 10—Murphy including pad-mounted electrical transformer as viewed from the east..

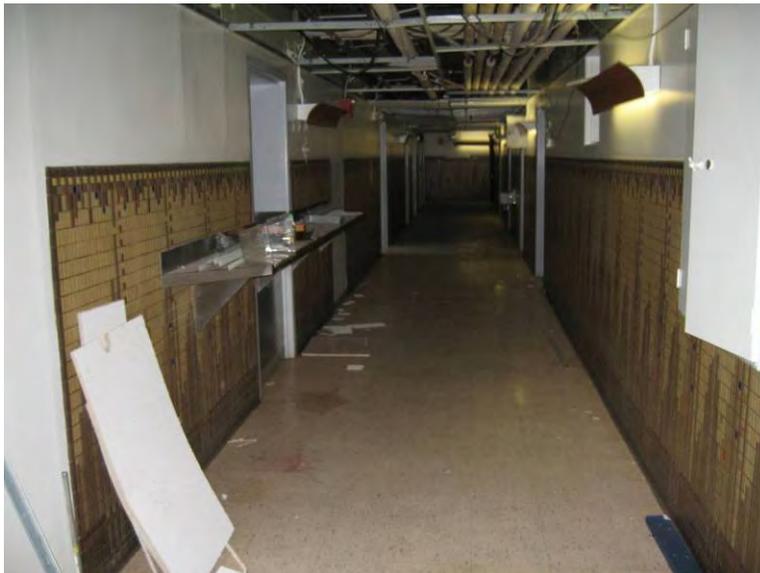
Picture 44.
Representative interior conditions of the basement of Building 10—Murphy.

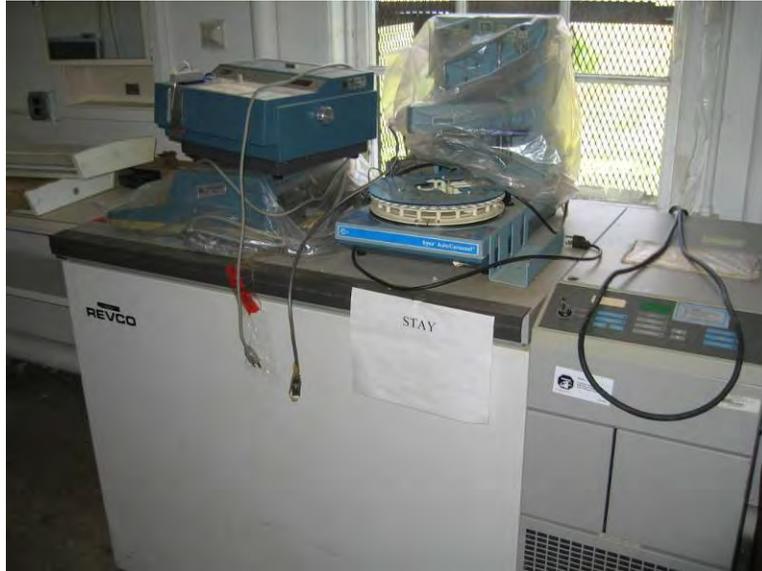
Picture 45.
Representative laboratory equipment located in the
basement of Building 10—Murphy.

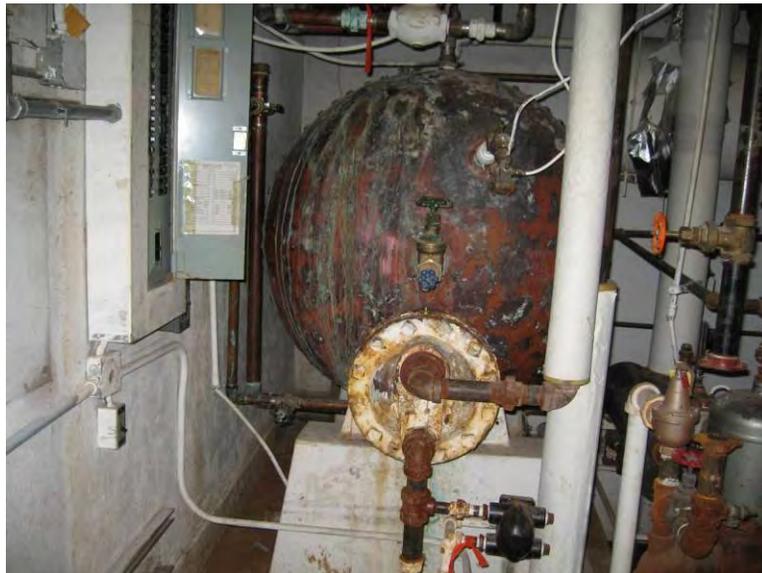
Picture 46. Copper hot water tank and former steam
System components located in the basement
of Building 10—Murphy.

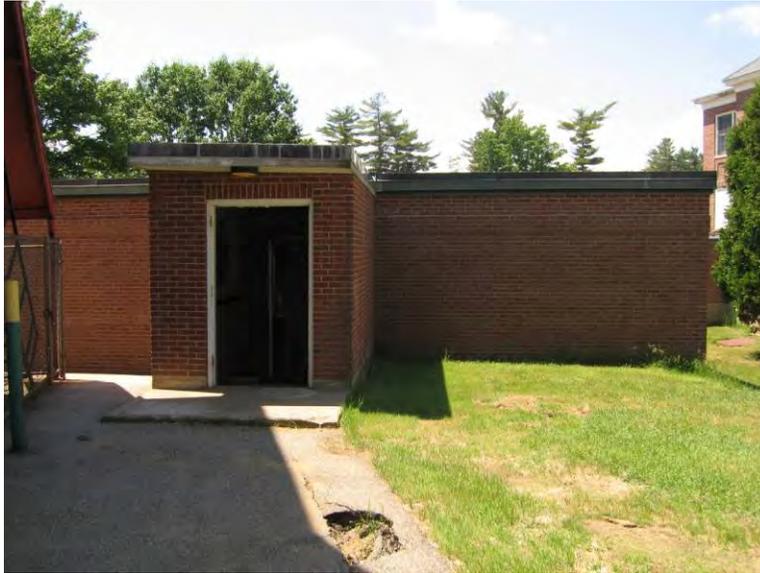
Picture 49.
Representative exterior conditions of
Building 11—Murphy Wing.

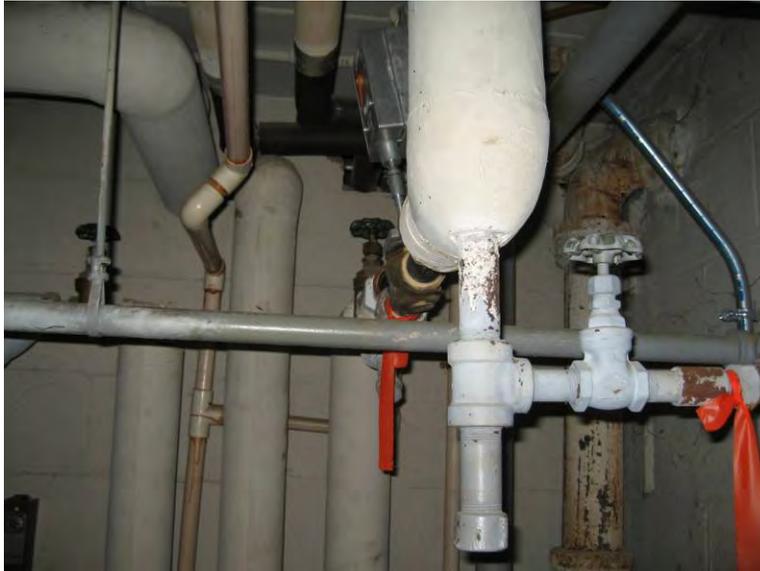
Picture 51.

Suspect ACM pipe insulation within the mechanical room in the basement of Building 11—Murphy Wing.

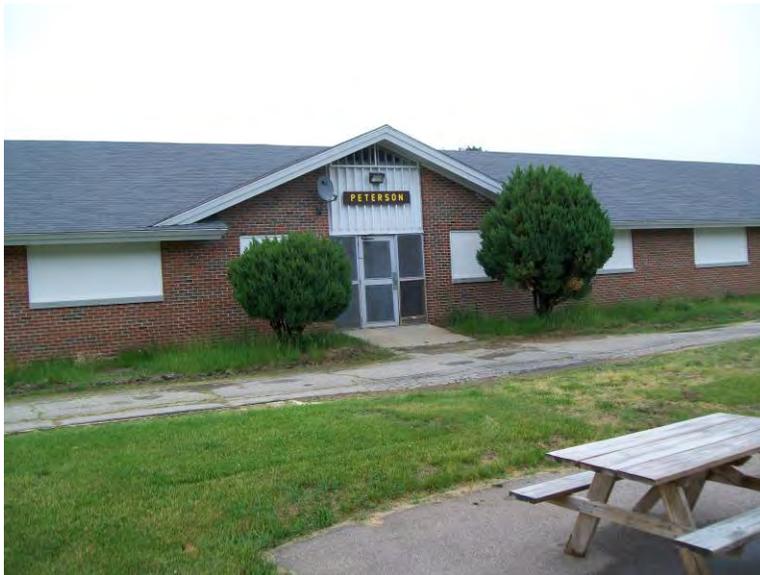
Picture 54.
Representative exterior conditions of Building 12—Peterson.

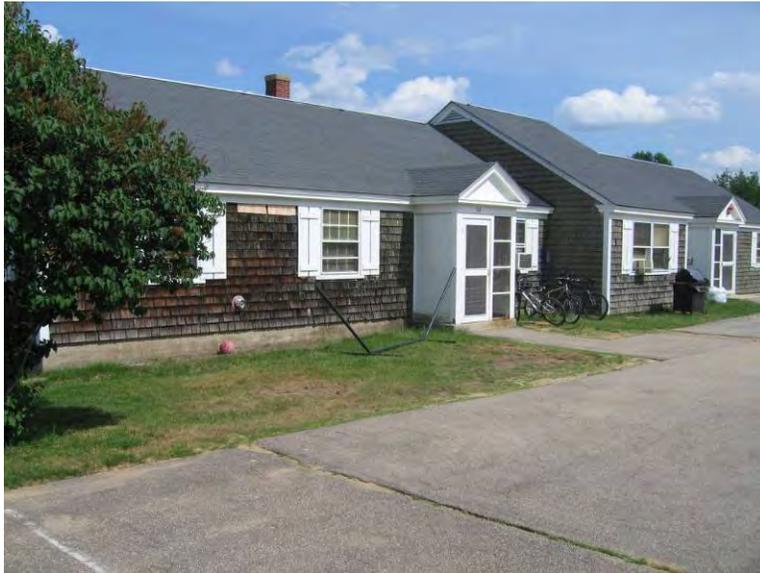
Picture 56.

Representative exterior conditions of Building 13—Physician's Cottage.

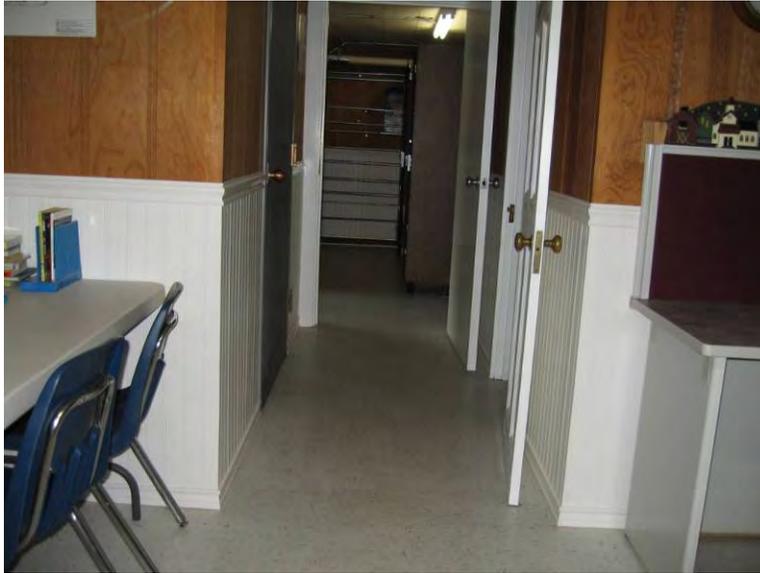
Picture 57.
Representative conditions of the basement of
Building 13—Physician’s Cottage.

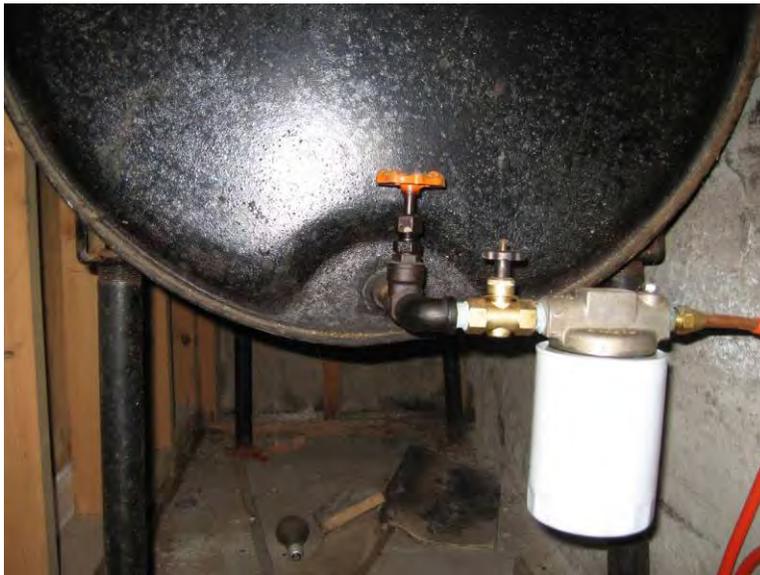
Picture 58.
275-gallon No. 2 fuel oil AST located in the basement of
Building 13—Physician’s Cottage.

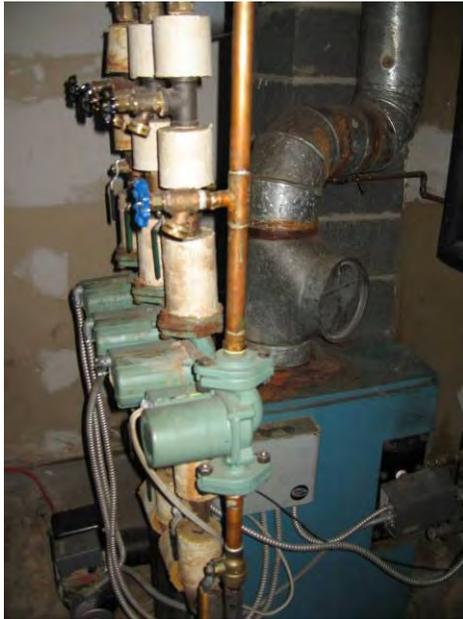
Picture 59.
No. 2 fuel oil-fired boiler
located in the basement of
Building 13—Physician’s
Cottage.

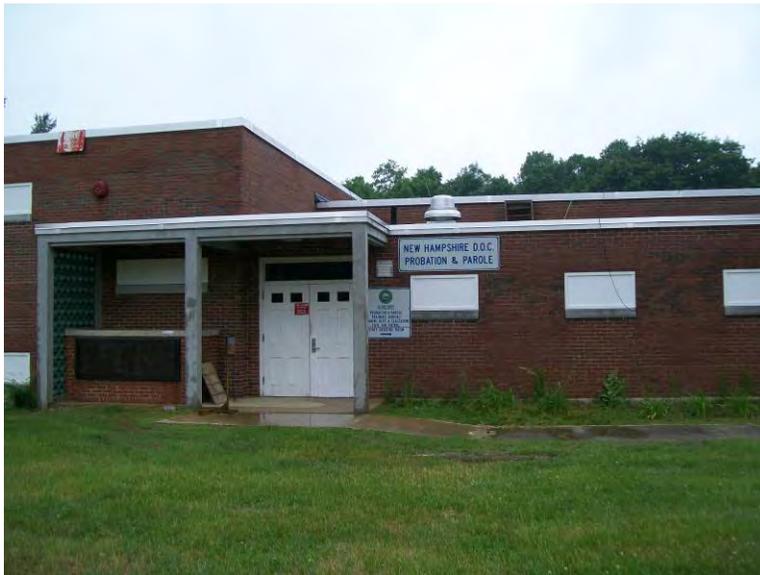
Picture 60.
Representative exterior conditions of
Building 14—Powell.

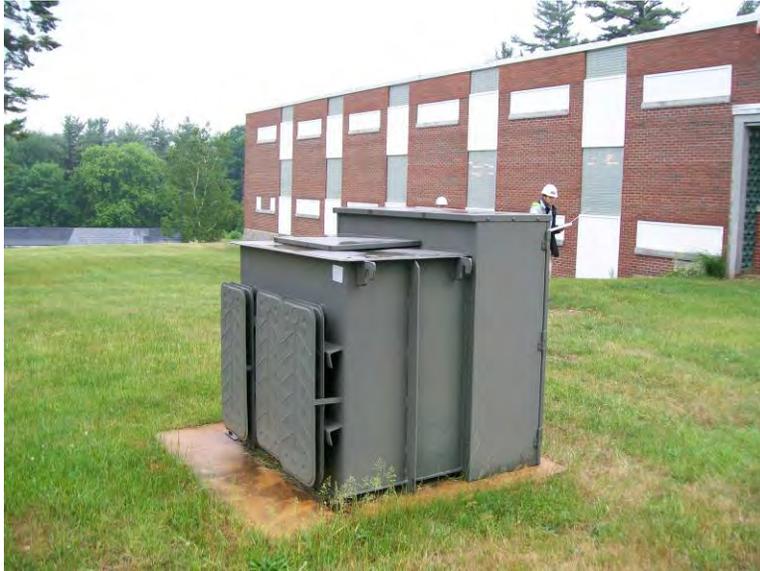
Picture 61. Pad-mounted electrical transformer located east of Building 14—Powell. Note: Wet conditions at the time of photograph.

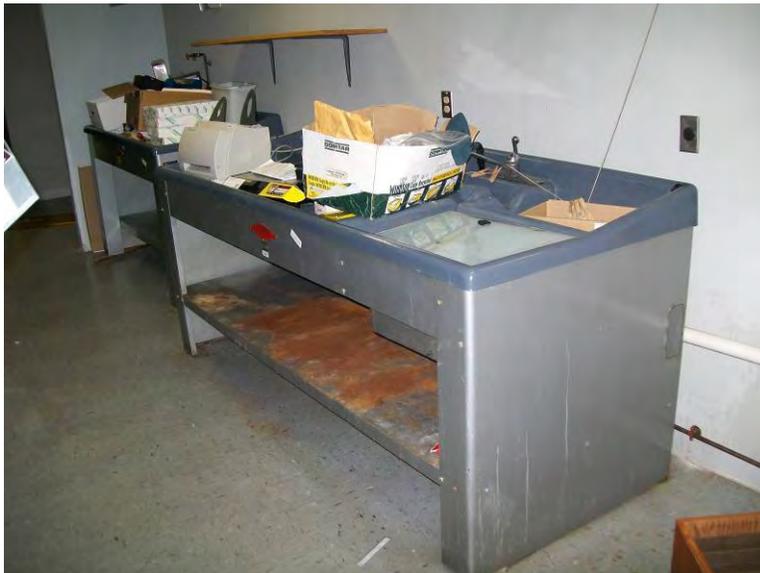
Picture 62.
Interior conditions of the first floor of Building 14—Powell including a work sink.
