Phase I – Environmental Site Assessment

Lakes Region Facility
1 Right Way Path
Laconia, New Hampshire

August 10, 2010

In Reference to:
Project No. 10001086

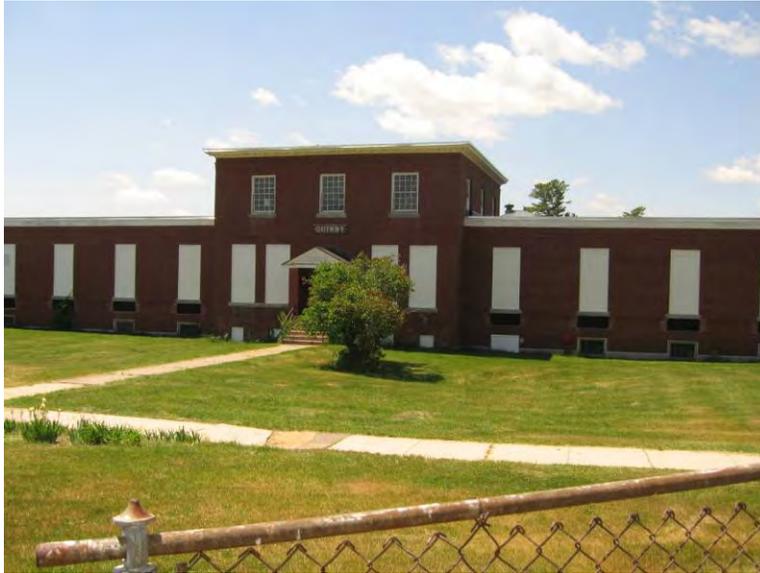
Picture 65.
Representative exterior conditions of
Building 15—Quinby.

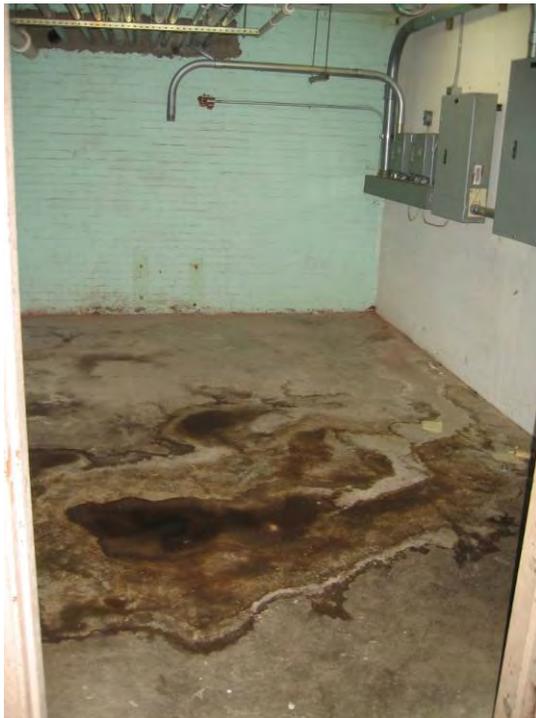
Picture 66.
Staining observed in the
area of former electrical
equipment within the
sub-basement of
Building 15—Quinby.

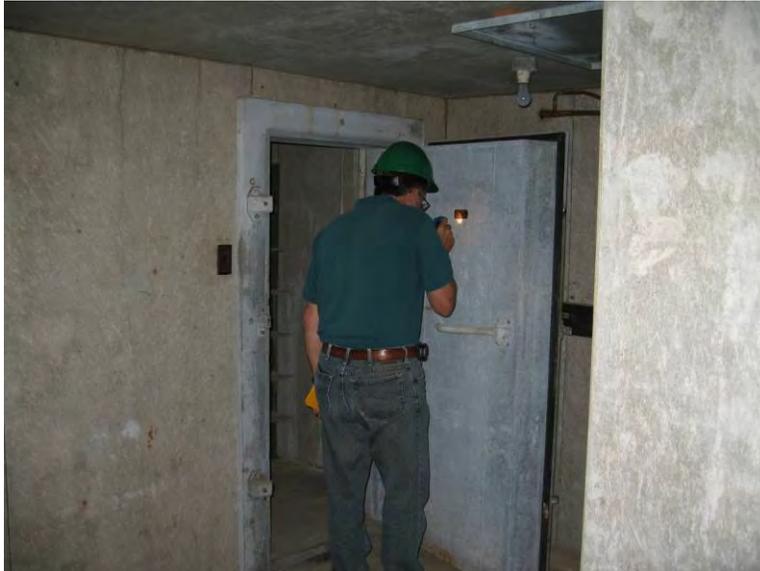
Picture 67.

Coolers located in the sub-basement of Building 15—Quinby. Note: Suspect ACM (Transite)

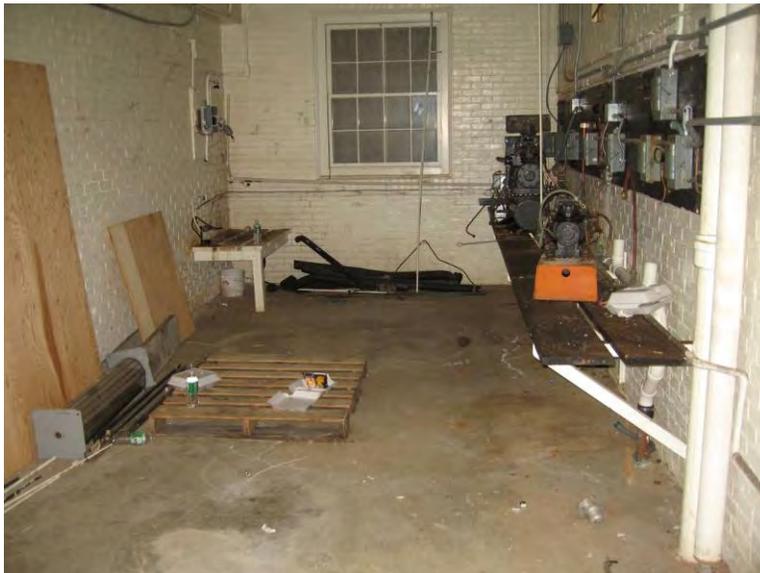
Picture 68.

Compressor room located in the basement of Building 15—Quinby.

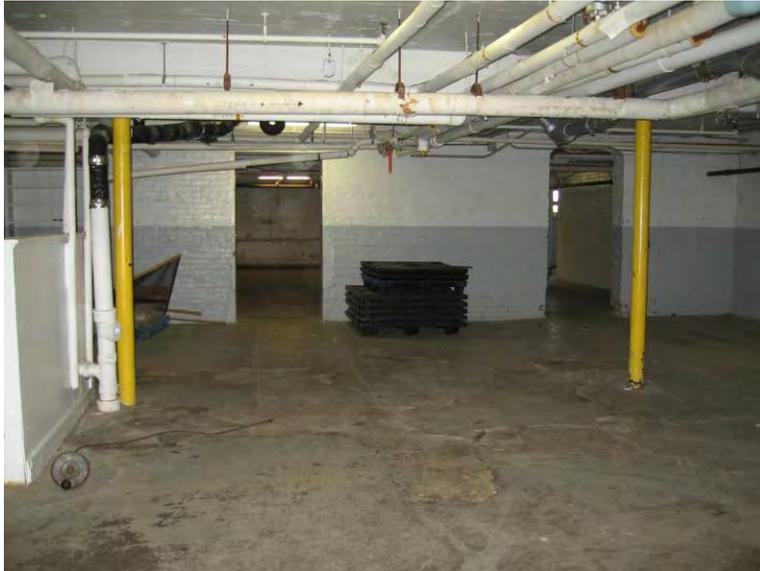
Picture 69.
Representative conditions within the basement of
Building 15—Quinby.

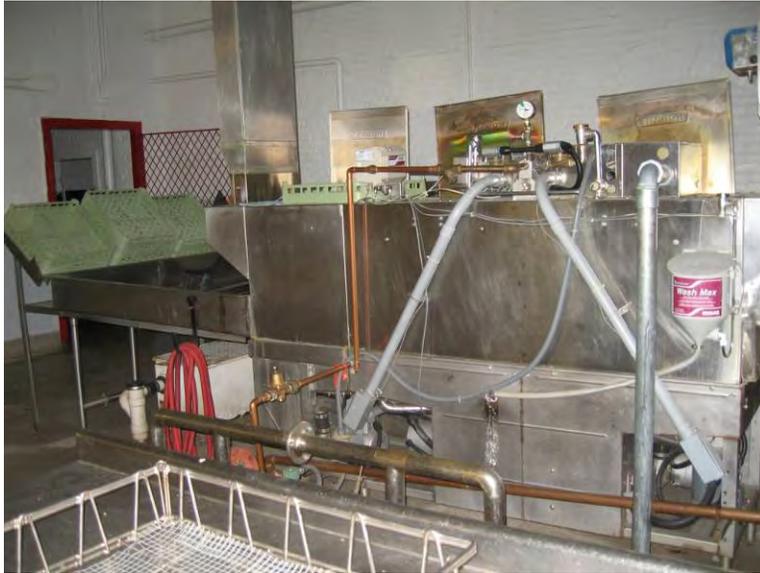
Picture 71.
Representative conditions of the first floor of
Building 15—Quinby.

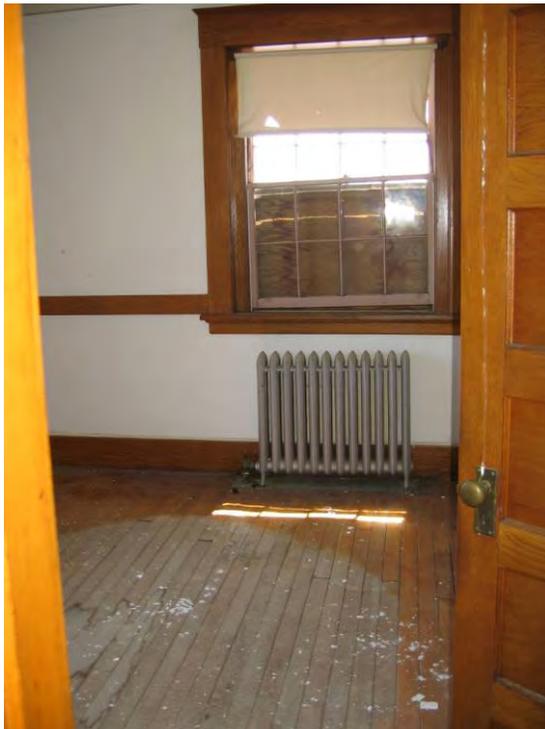
Picture 72.
Representative conditions
of the second floor of
Building 15—Quinby.
Note: Loose and flaking
paint.

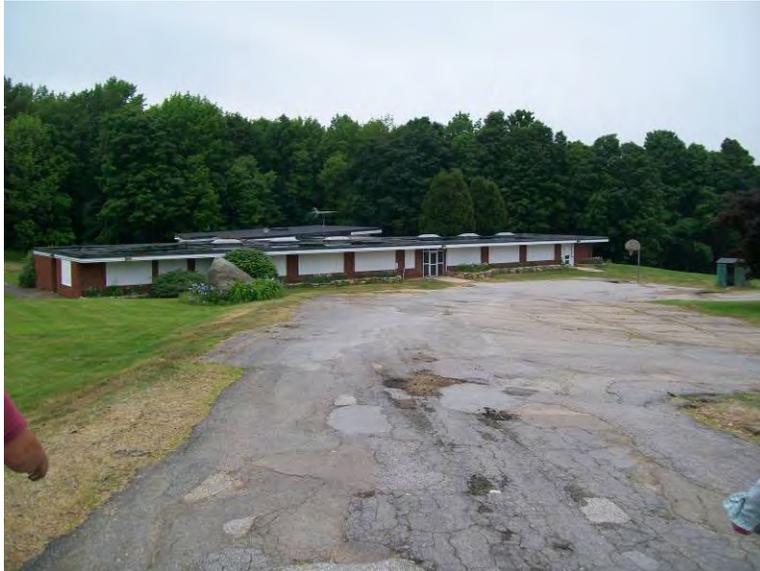
Picture 73.
Representative exterior conditions of Building 16—Rice.

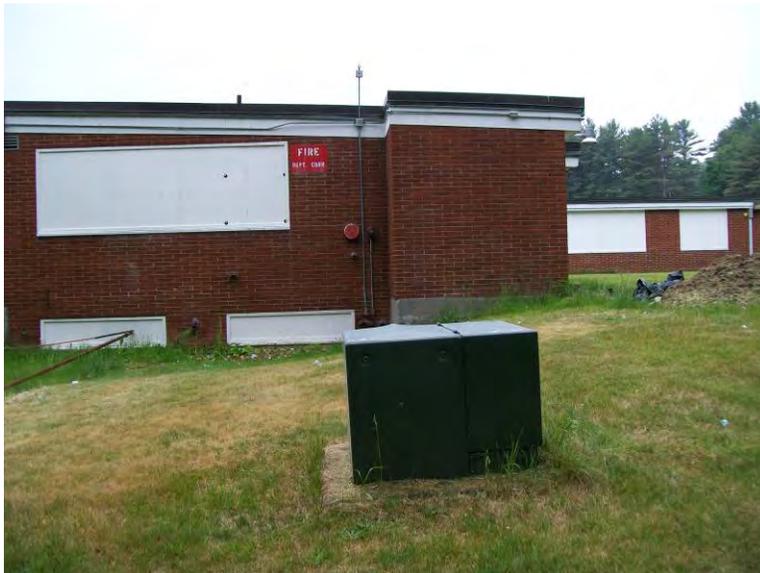
Picture 74. Pad-mounted electrical transformer and reported former location of 1,000-gallon No. 2 fuel oil UST (background) northwest of Building 16—Rice.

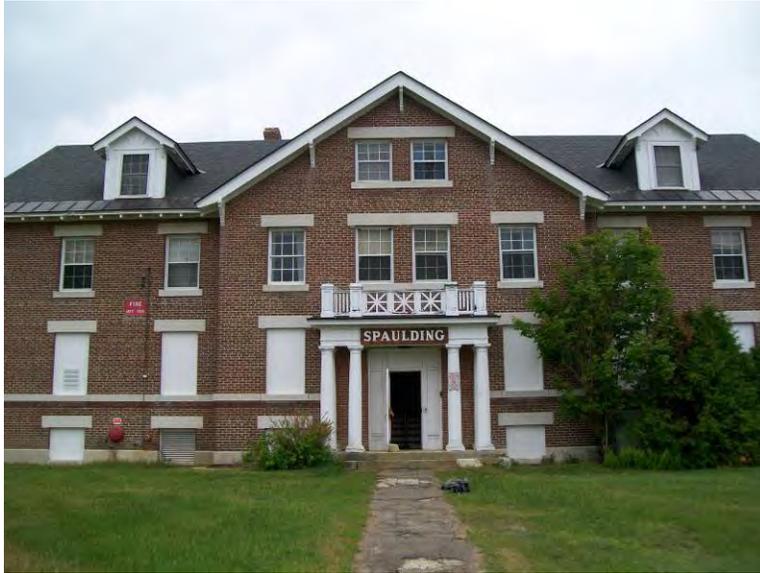
Picture 77.
Representative exterior conditions of
Building 17—Spaulding.

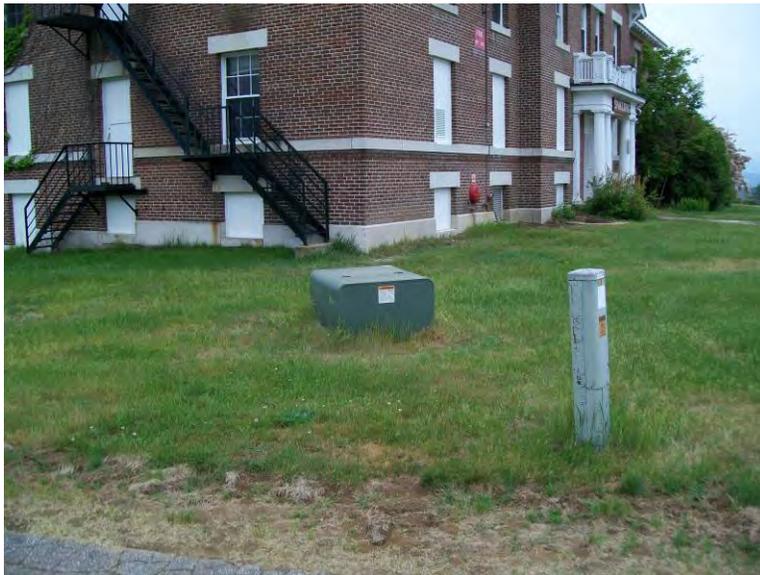
Picture 78.
Pad-mounted electrical transformer located north of
Building 17—Spaulding.

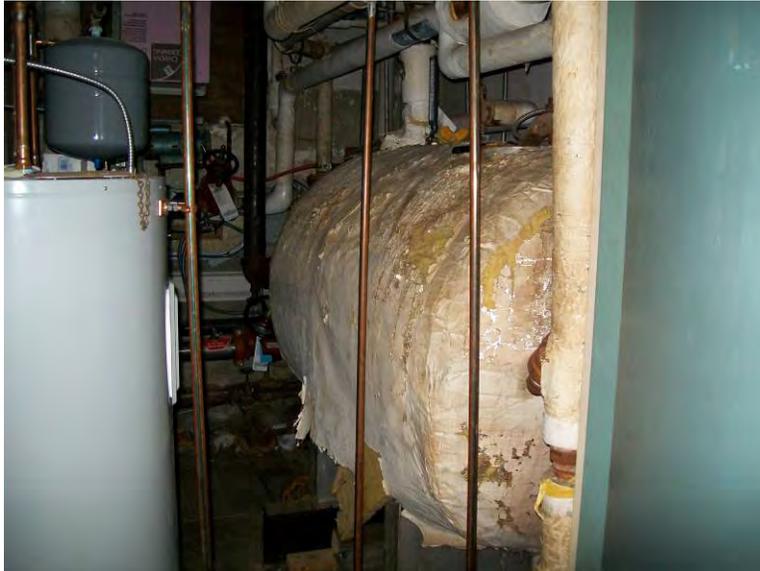
Picture 79. Hot water tank and associated suspect ACM insulating materials located in the basement of Building 17—Spaulding.

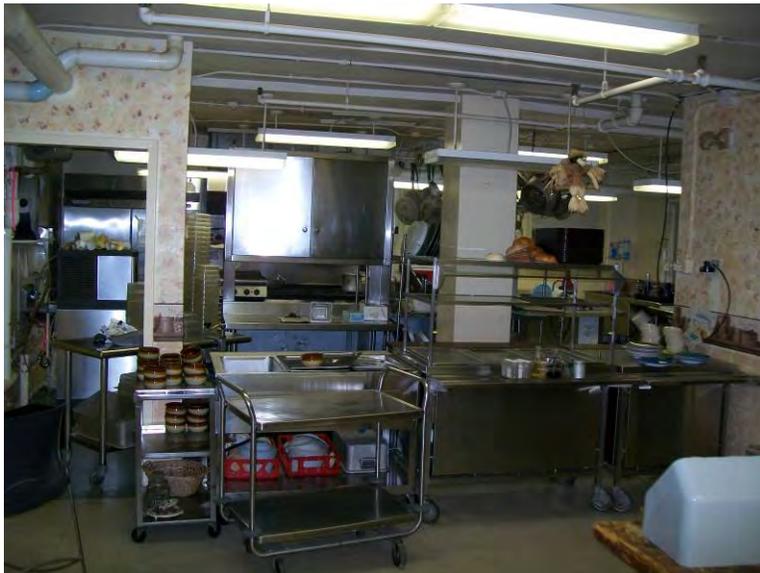
Picture 80.
Food preparation equipment located in the basement of Building 17—Spaulding.

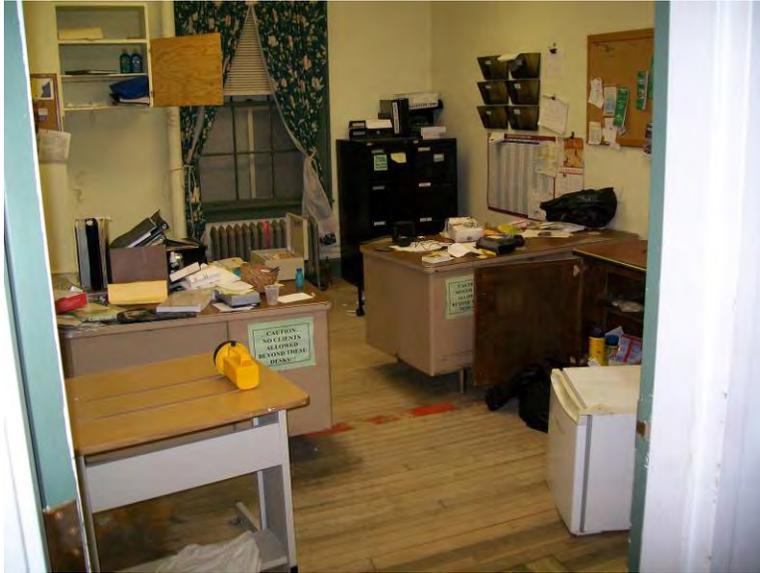
Picture 81.
Representative conditions of the first floor of
Building 17—Spaulding.

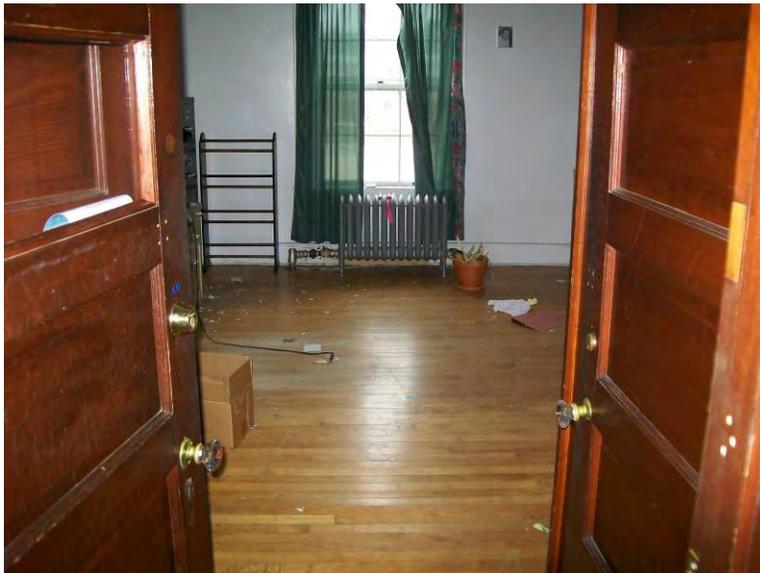
Picture 82.
Representative conditions of the second and third floors of
Building 17—Spaulding.

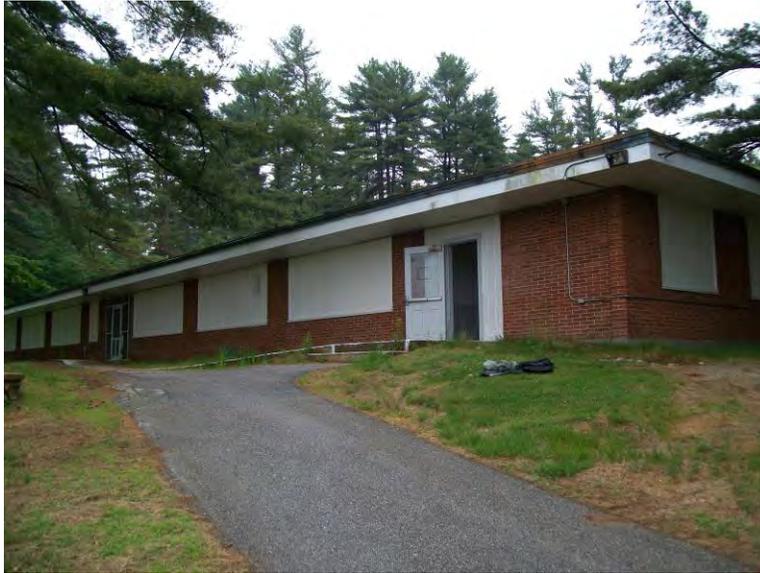
Picture 83.
Representative exterior conditions of
Building 18—Speare.

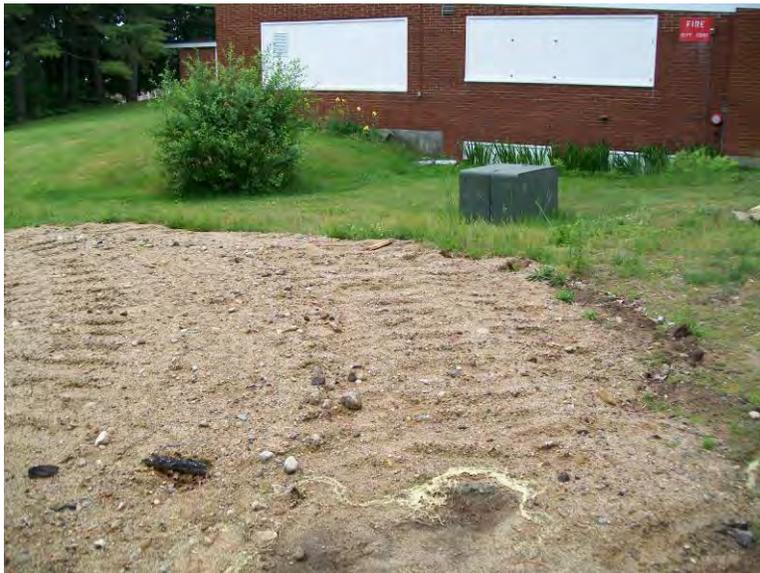
Picture 84. Pad-mounted electrical transformer and
reported former location of 3,000-gallon No. 2 fuel oil
UST (foreground) northeast of Building 18—Speare.

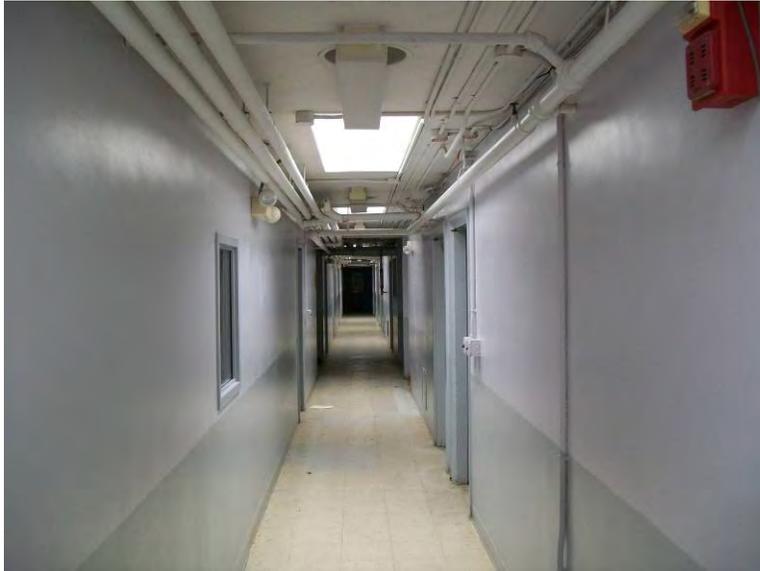
Picture 85.

Representative conditions of the first floor of Building 18—Speare. Note: Suspect ACM floor tiles.

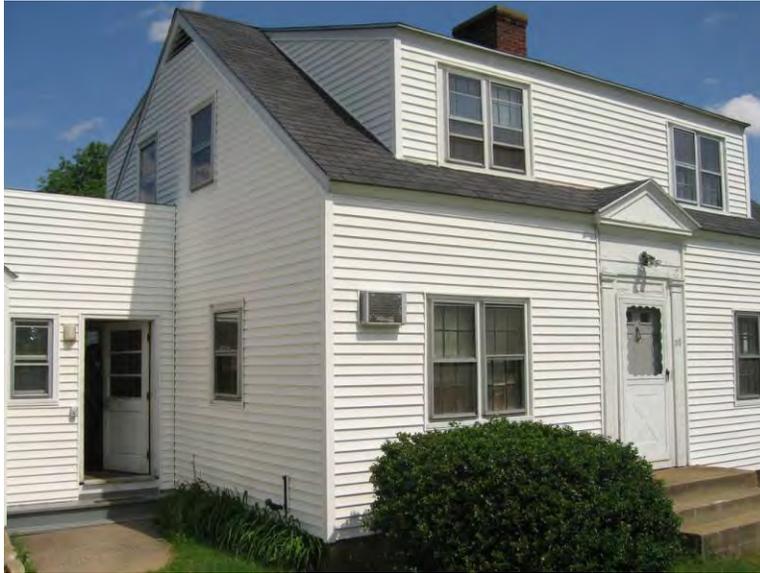
Picture 87.
Representative exterior conditions of
Building 19—Superintendent’s House.

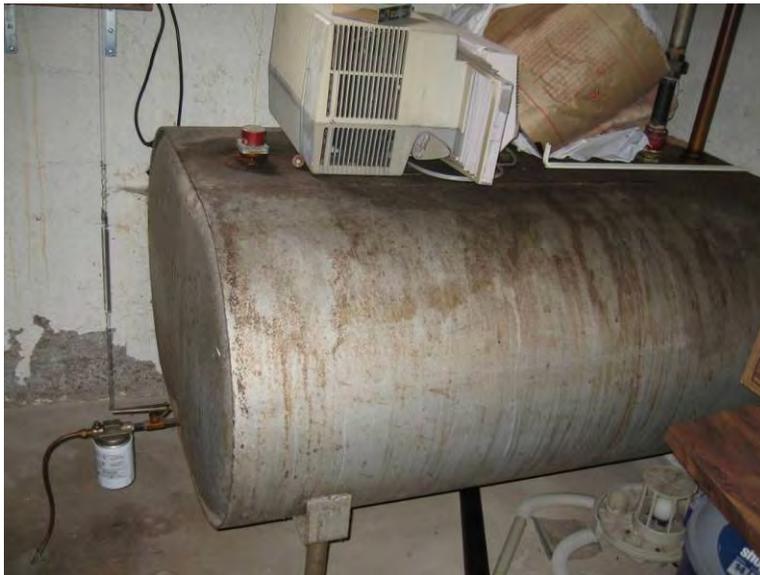
Picture 88.
275-gallon No. 2 fuel oil AST located in the basement of
Building 19—Superintendent’s House.

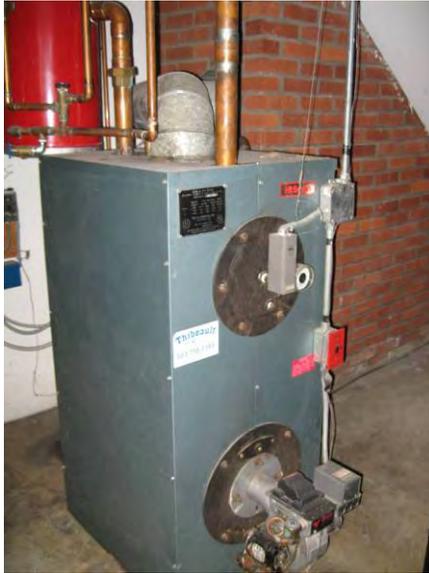
Picture 89.
No. 2 fuel oil-fired boiler located
in the basement of
Building 19—Superintendent’s
House.

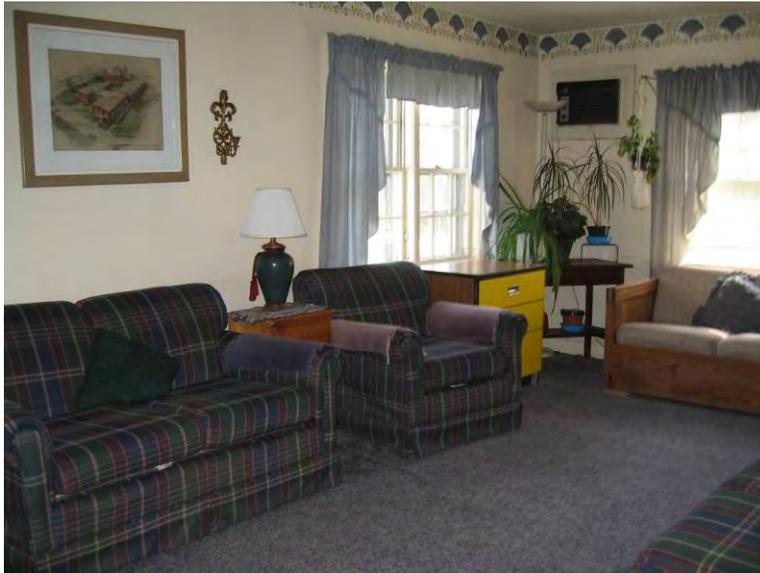
Picture 90.
Conditions of the first floor of
Building 19—Superintendent’s House.

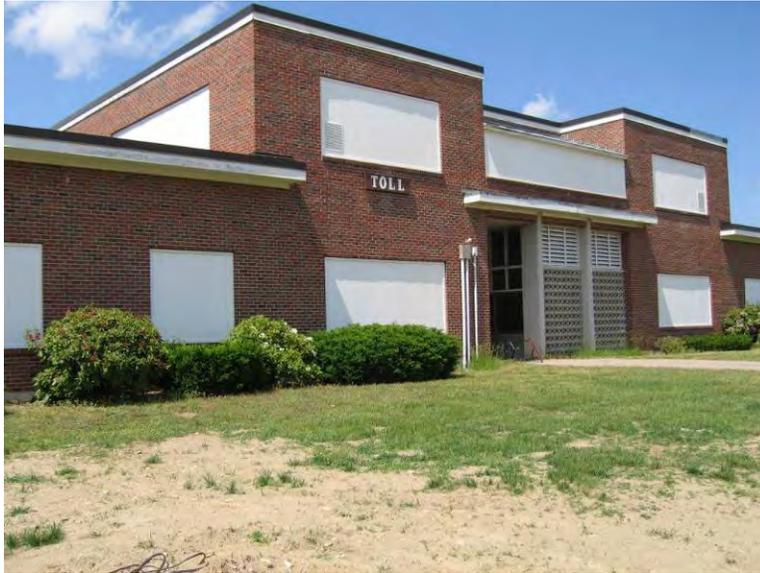
Picture 91.
Representative exterior conditions of Building 20—Toll.

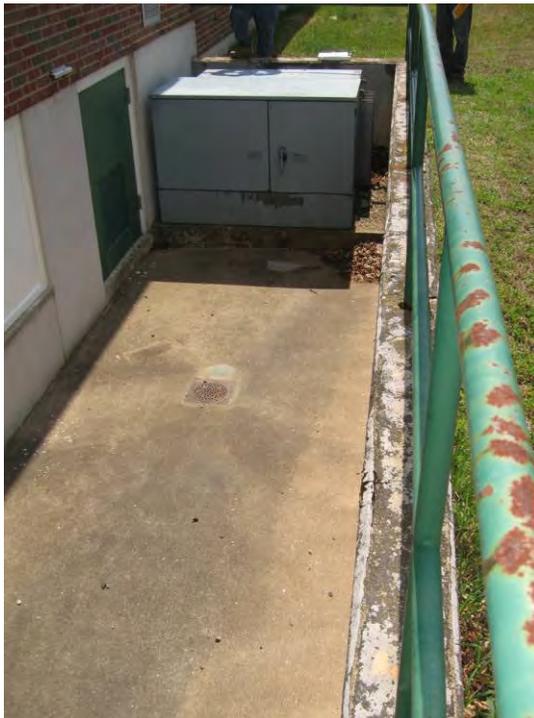
Picture 92. Pad-mounted electrical transformer and drain (foreground) located northeast of Building 20—Toll.

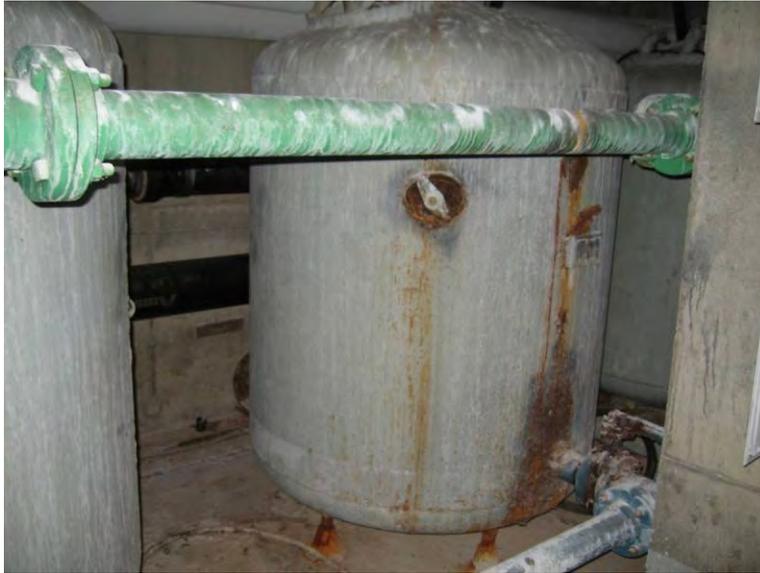
Picture 93.

Pool treatment chemical tanks located in the basement of Building 20—Toll.

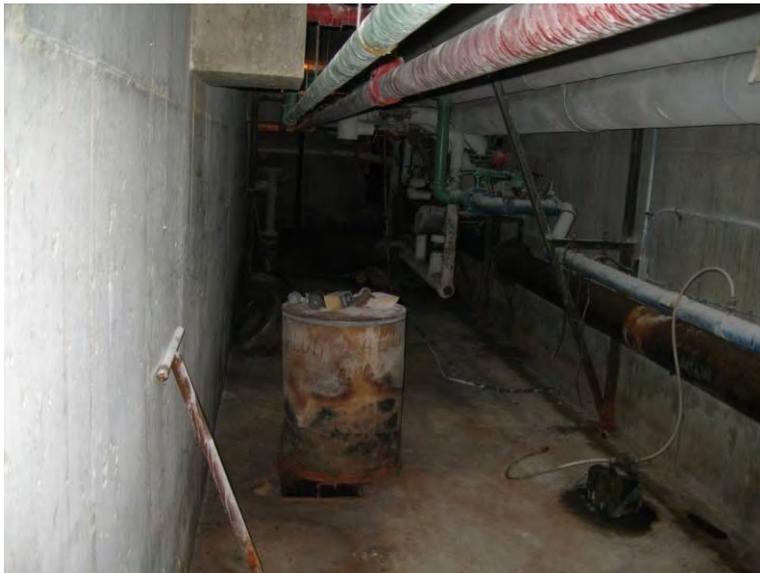
Picture 94.

Compromised pool chemical drum located in the basement of Building 20—Toll. Note: Floor drain.

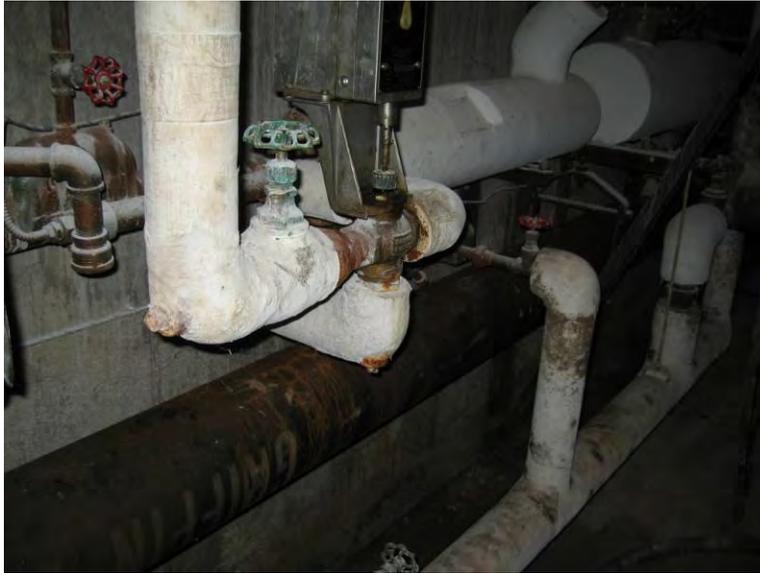
Picture 95.

Suspect insulating material located in the basement of Building 20—Toll.

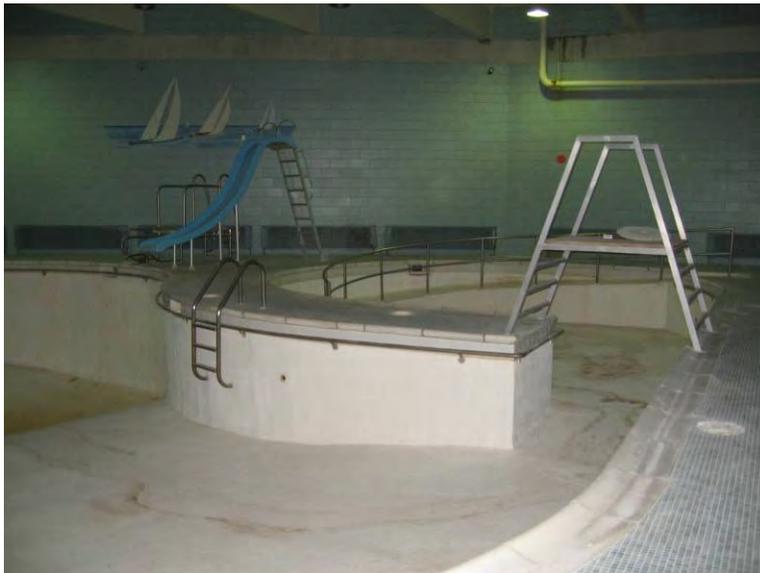
Picture 96.

Pool located on the first floor of Building 20—Toll.

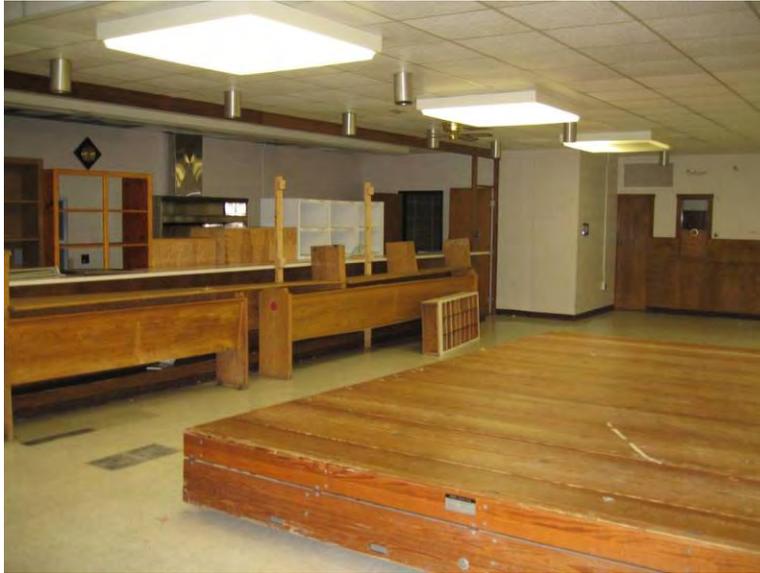
Picture 97.
Representative interior conditions of the first floor of
Building 20—Toll.

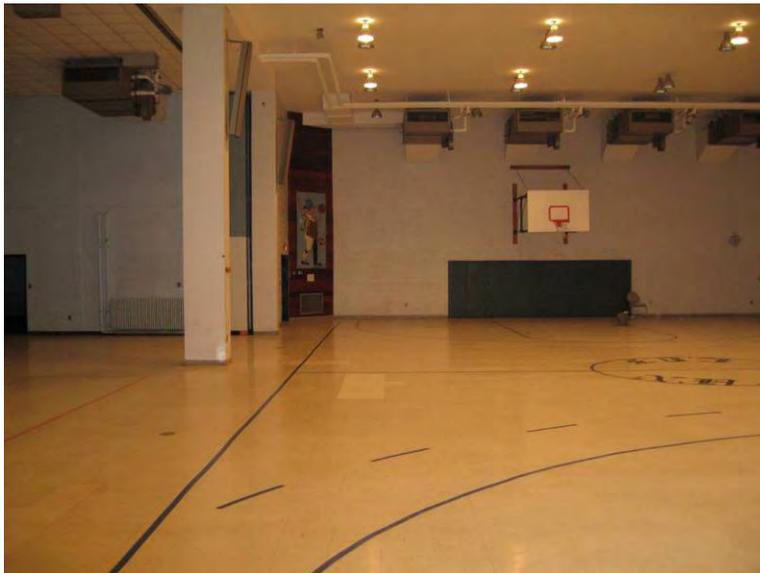
Picture 98.
Gymnasium located on the first floor of
Building 20—Toll.

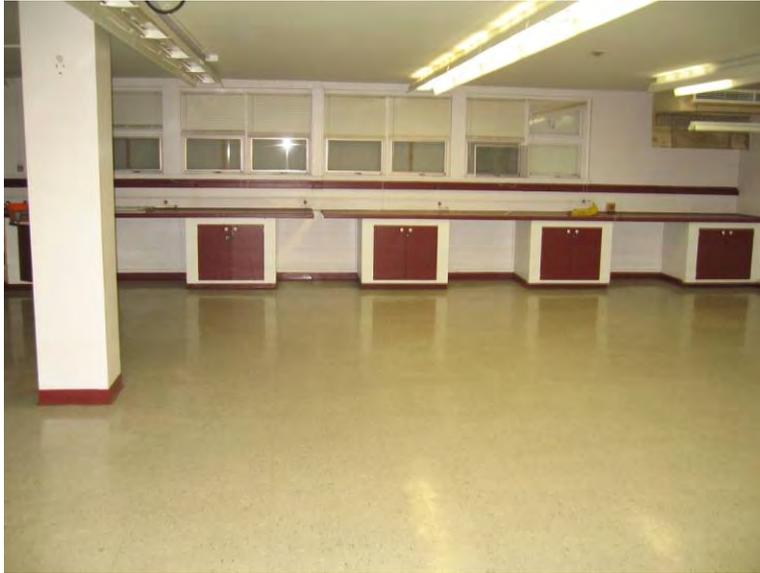
Picture 99.

Representative interior conditions of the second floor of Building 20—Toll. Note: Suspect ACM floor tiles.

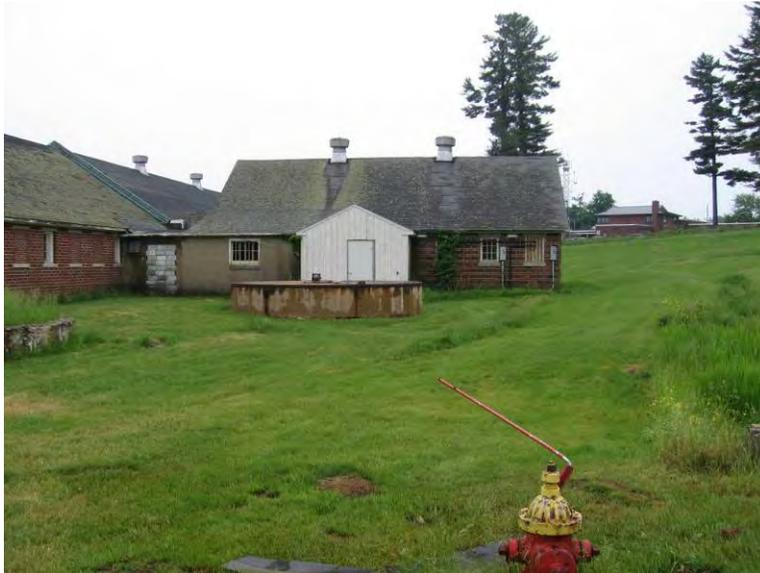
Picture 100.

Representative exterior conditions of Building 21—Warehouse. Note: Former silo pads in foreground.

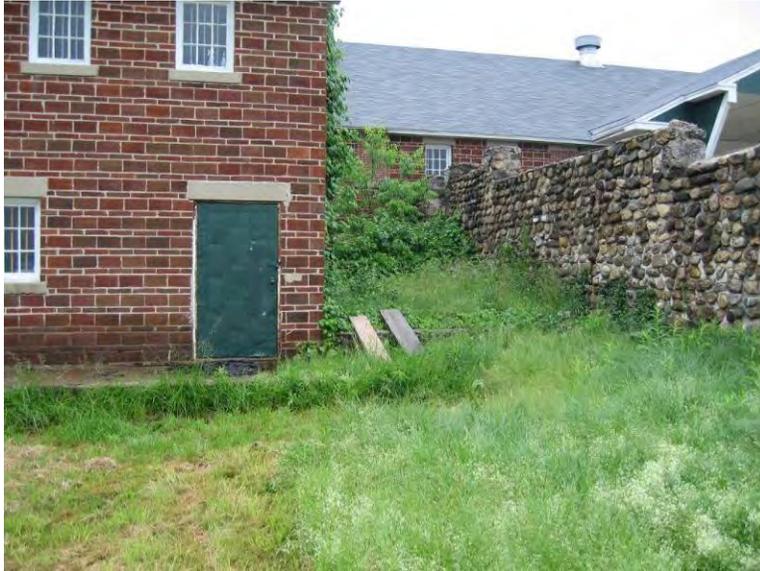
Picture 101. Representative exterior conditions of Building 21—Warehouse including area of suspected former UST or AST.

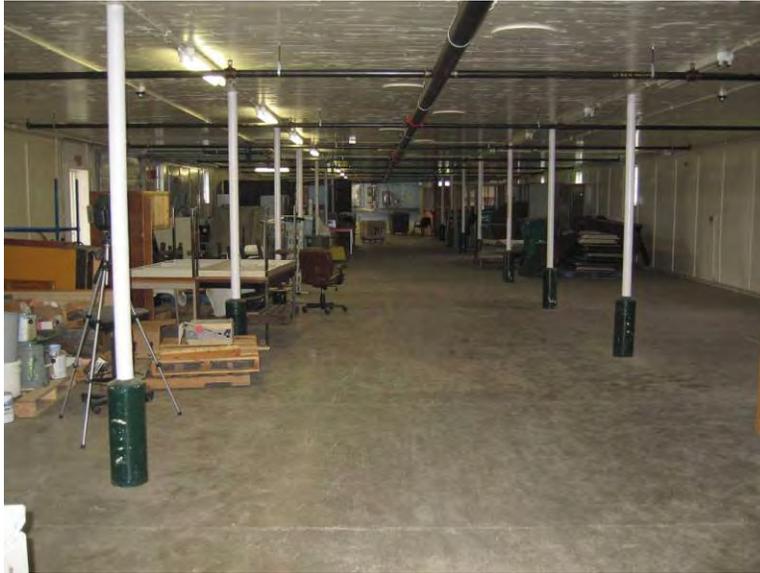
Picture 103.
Representative conditions of the first floor of
Building 21—Warehouse.

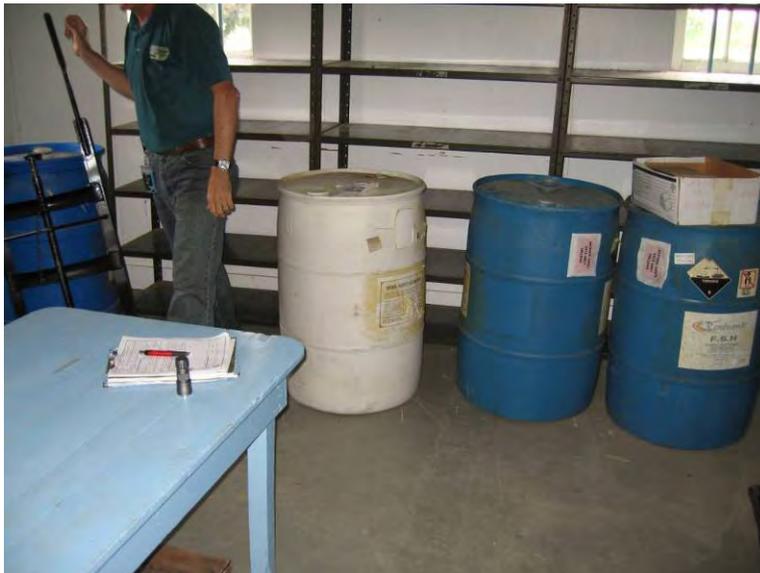
Picture 104.
Bulk containers of laundry detergent located on the first
floor of Building 21—Warehouse.

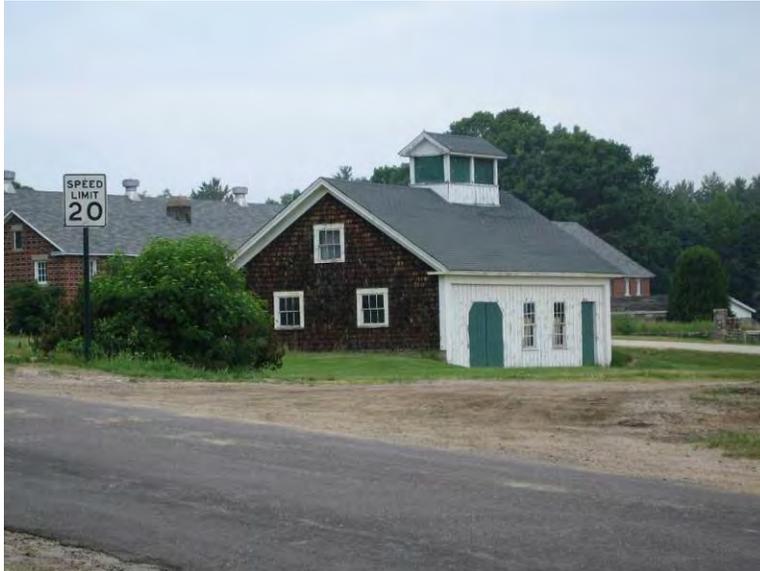
Picture 105. Representative exterior of Building 21— Warehouse accessory building “Sap House” as viewed from the south. Interior portions were not accessible.

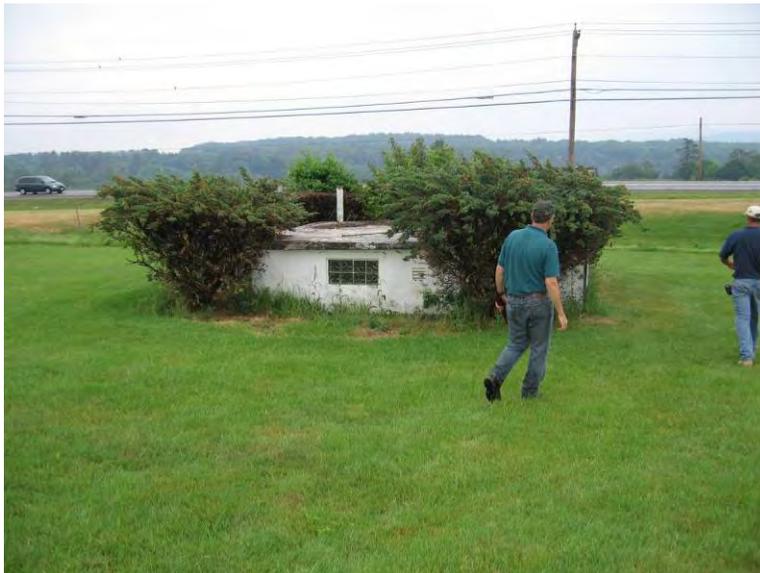
Picture 106. Representative exterior of Building 21— Warehouse accessory building known as “Sewer Pump House” as viewed from the east.

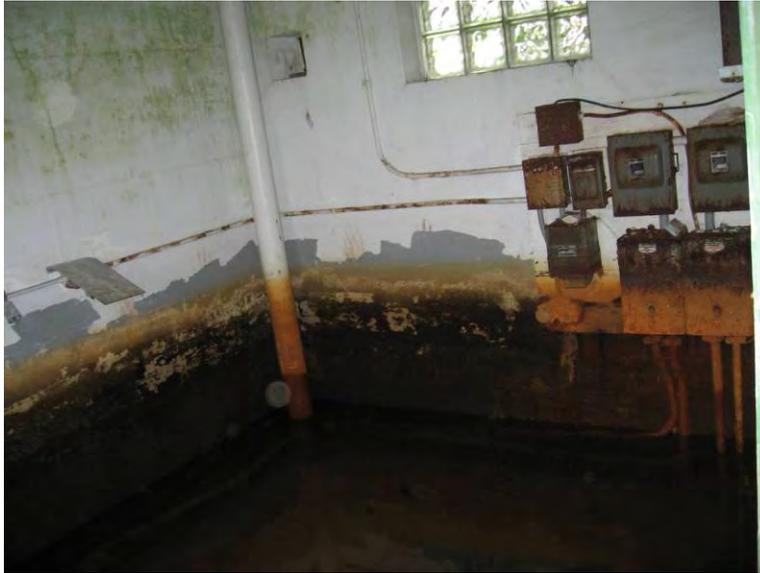
Picture 107. Interior of Building 21—Warehouse accessory building “Sewer Pump House.” Note: Loose and flaking paint, mold, and approximately 2 feet of standing water..

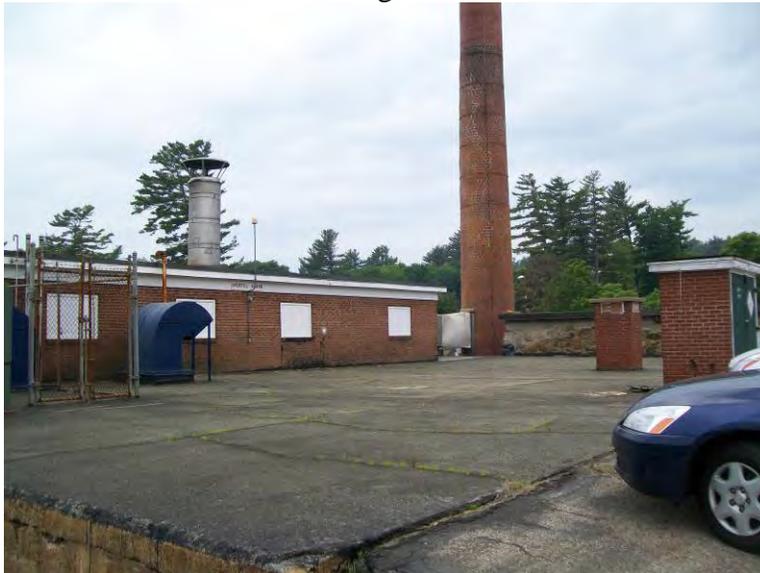
Picture 108. Representative exterior of Building 22—Boiler House including Fuel Bunker section (foreground) and AST filling structures (right).

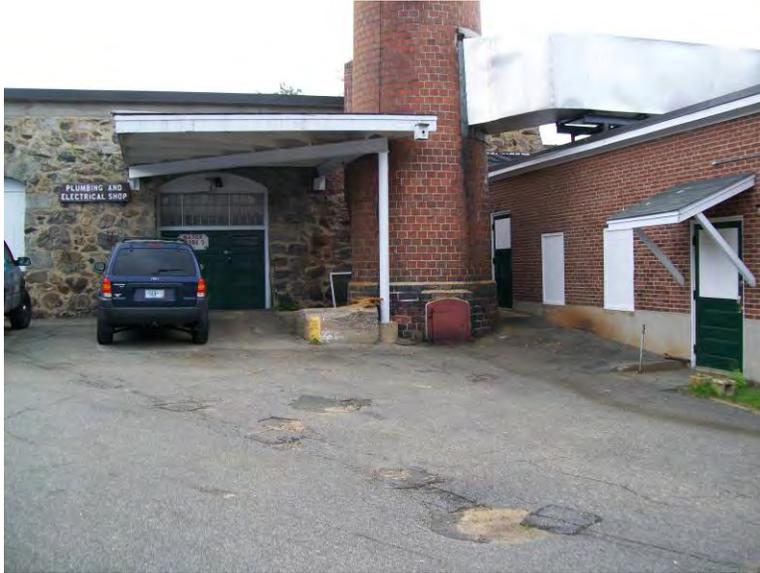
Picture 109. Representative exterior conditions in the area of the Electrical Shop and Plumbing Shop sections of Building 22—Boiler House.

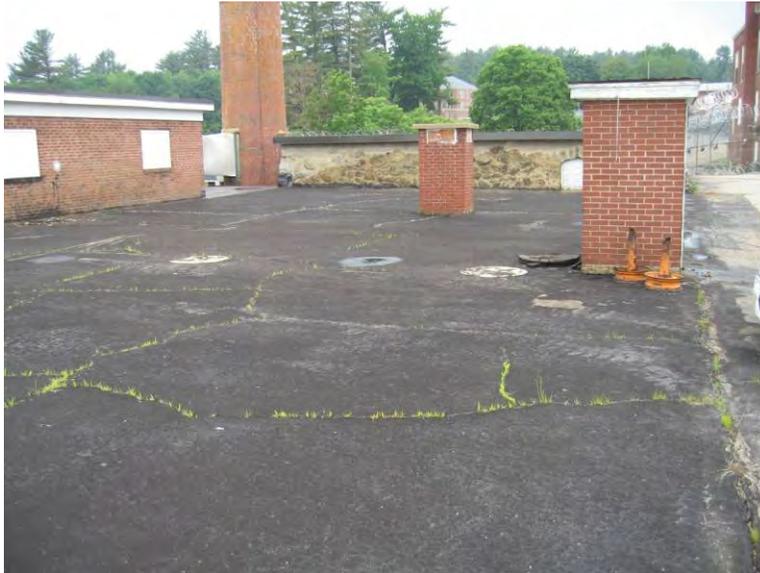
Picture 110. AST filling structures located above the Fuel Bunker section of Building 22—Boiler House.

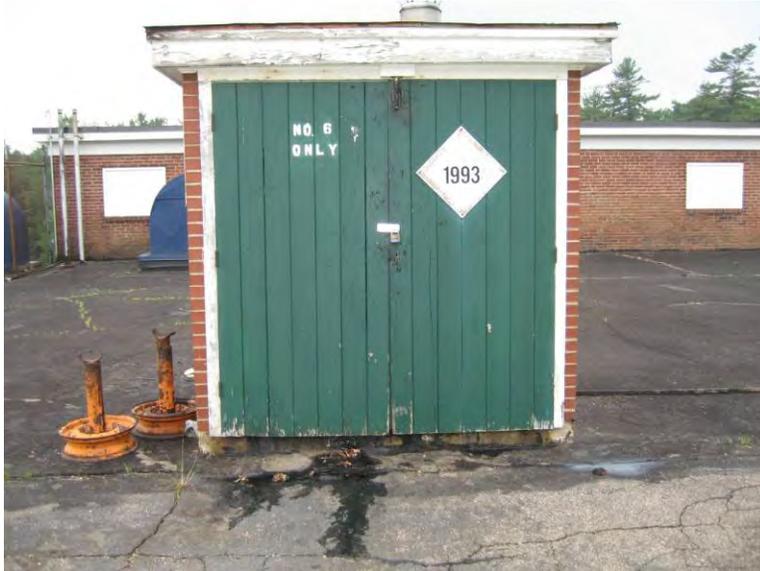
Picture 111. Surficial oil staining observed adjacent to an AST filling structure located atop the fuel storage bunker of Building 22—Boiler House.

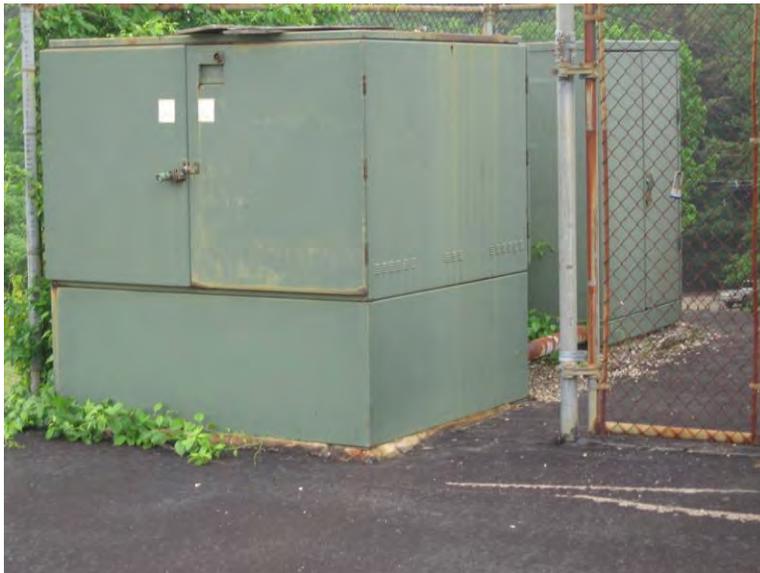
Picture 112. Pad-mounted electrical transformer and associated switchgear located southeast of Building 22—Boiler House.

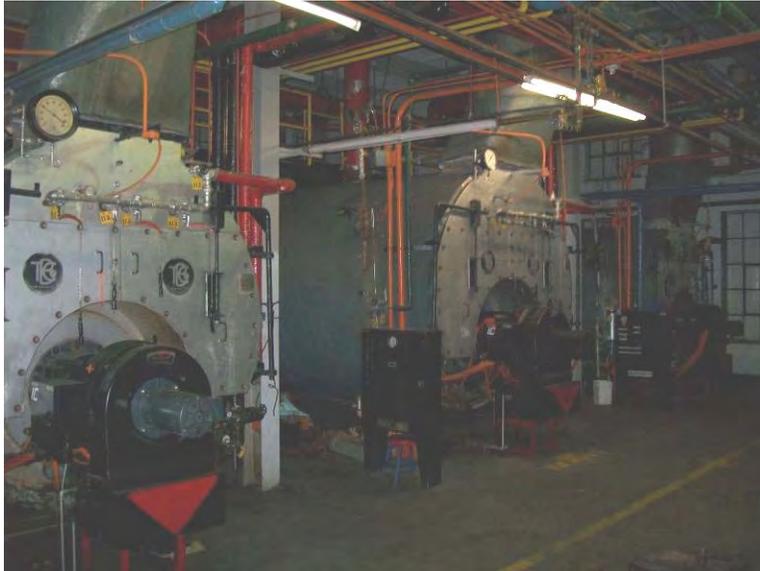
Picture 113. Bigelow steam boilers located in the Boiler Room section of Building 22—Boiler House.
Note: Suspect ACM insulating materials.

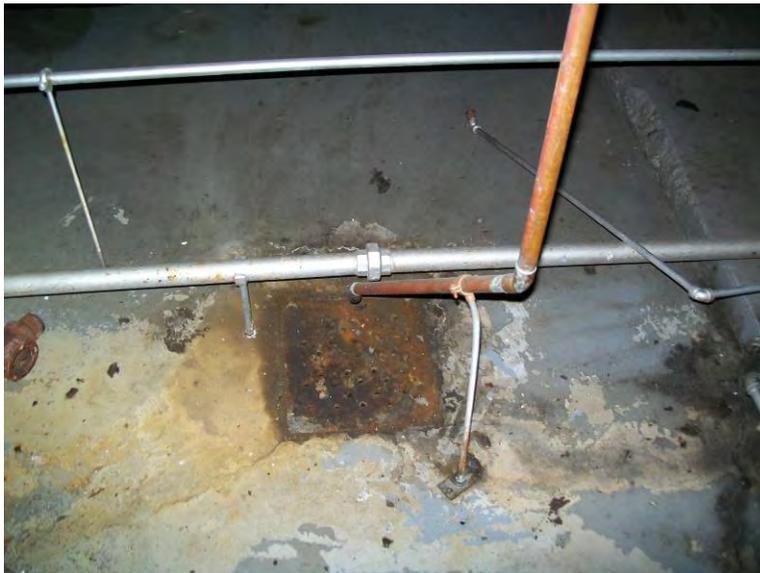
Picture 114. Representative floor drain observed below each steam boiler within the Boiler Room section of Building 22—Boiler House.

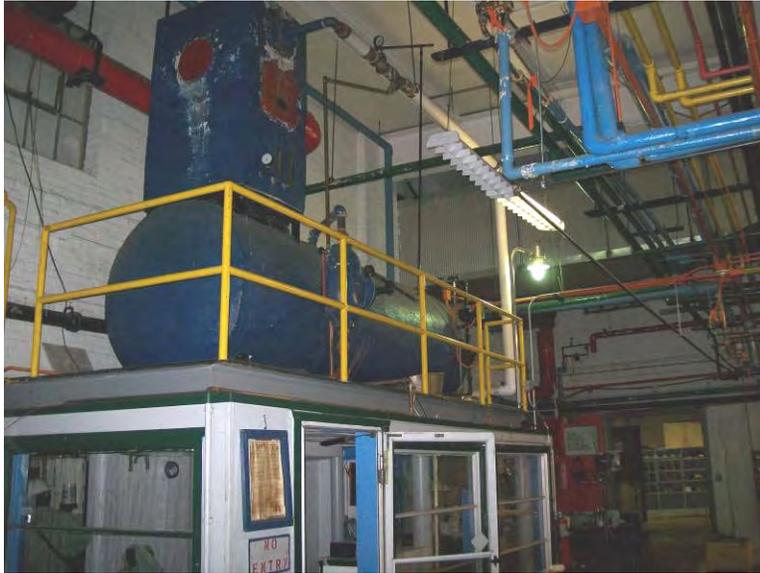
Picture 115. Deairing tank located in the Boiler Room section of Building 22—Boiler House. Note: Suspect ACM insulating materials.

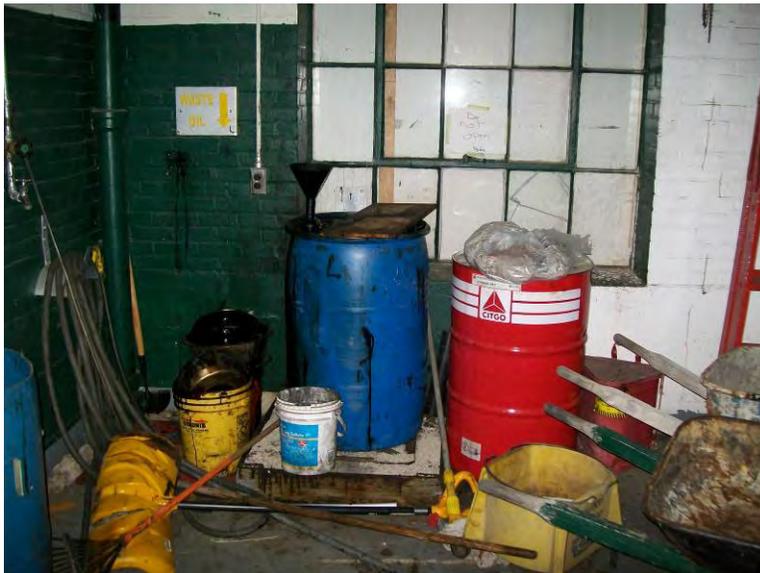
Picture 116. Waste oil accumulation area and associated staining located in the Boiler Room section of Building 22—Boiler House.

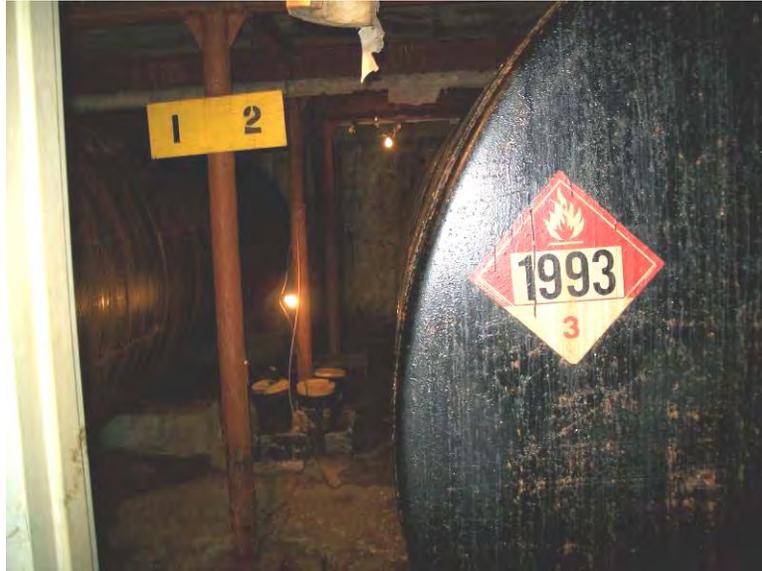
Picture 117. Representative conditions and two empty 12,000-gallon ASTs located within the Fuel Bunker section of Building 22—Boiler House.

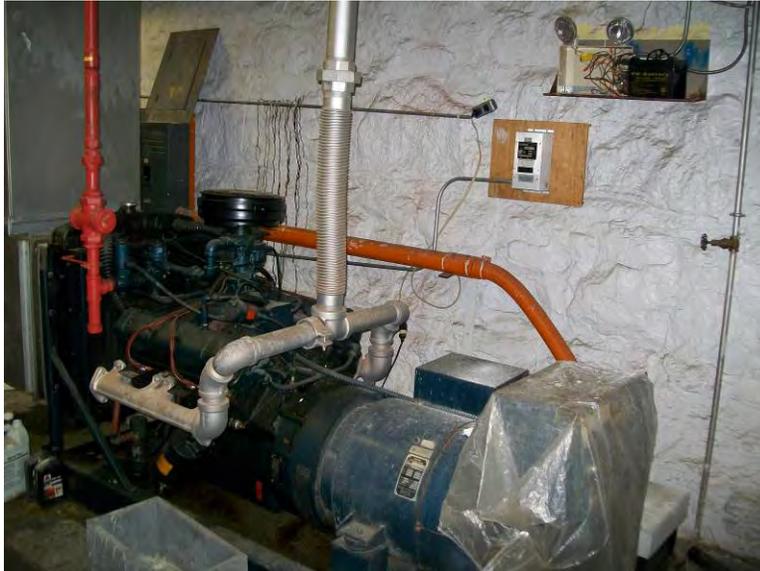
Picture 119. Propane-fired generator and associated floor staining observed within the Electrical Shop section of Building 22—Boiler House.

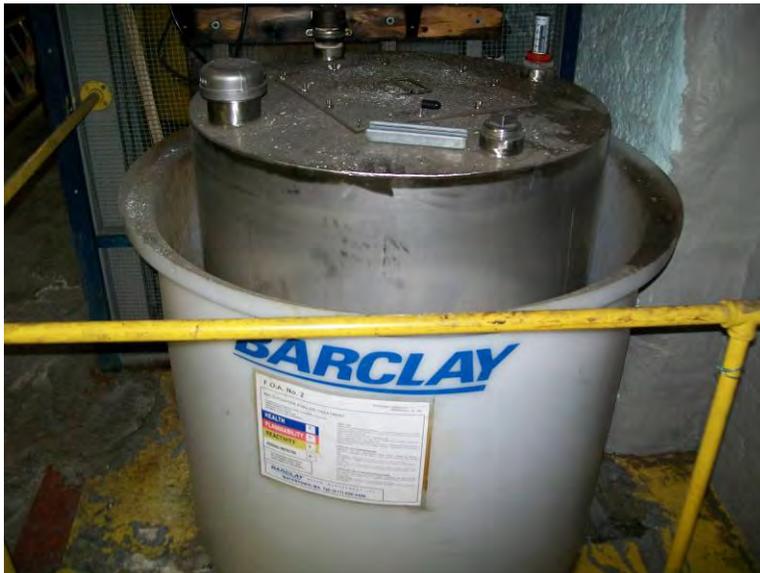
Picture 120. Approximately 80-gallon container of naphthalene stored in the Electrical Shop section of Building 22—Boiler House.
