Phase I – Environmental Site Assessment

Lakes Region Facility
1 Right Way Path
Laconia, New Hampshire

August 10, 2010

In Reference to:
Project No. 10001086

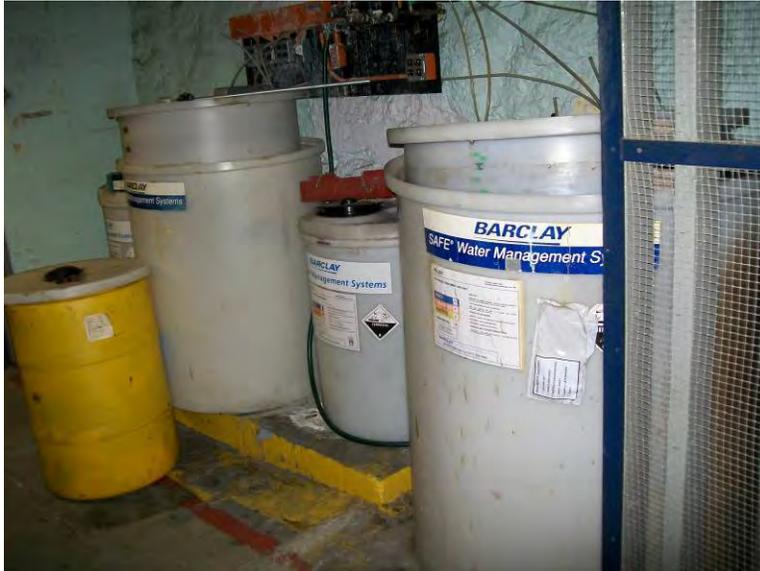
Picture 121. Water treatment chemicals including Volamine stored within the Electrical Shop section of Building 22—Boiler House.

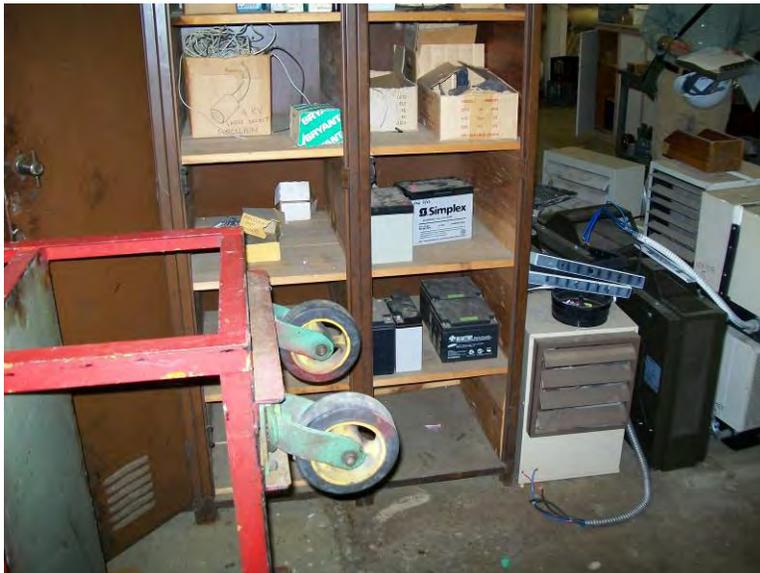
Picture 122. Representative discarded equipment and floor staining observed in the Electrical Shop and Plumbing Shop sections of Building 22—Boiler House.

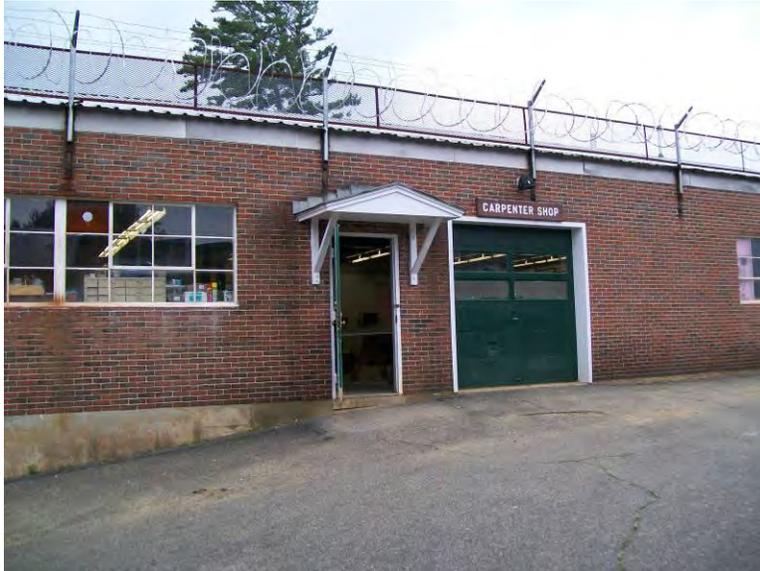
Picture 123.
Representative exterior conditions of
Building 23—Carpenter's Shop.

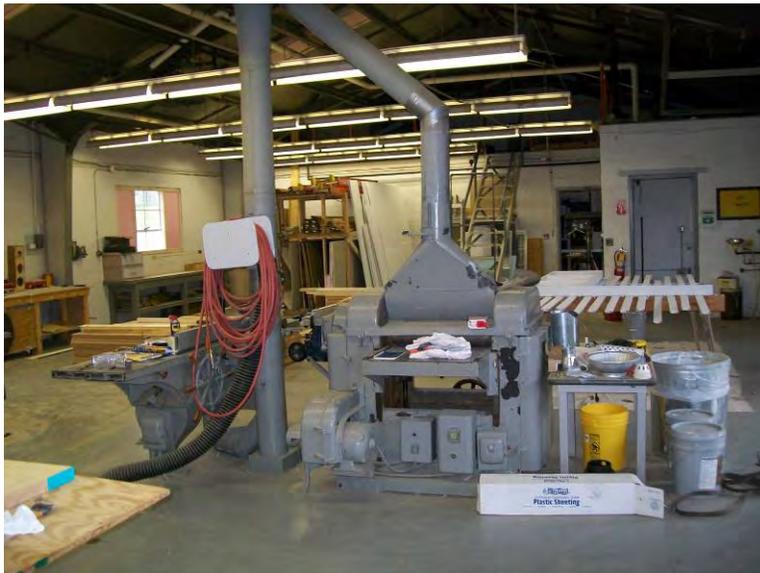
Picture 124.
Representative interior conditions of
Building 23—Carpenter's Shop.

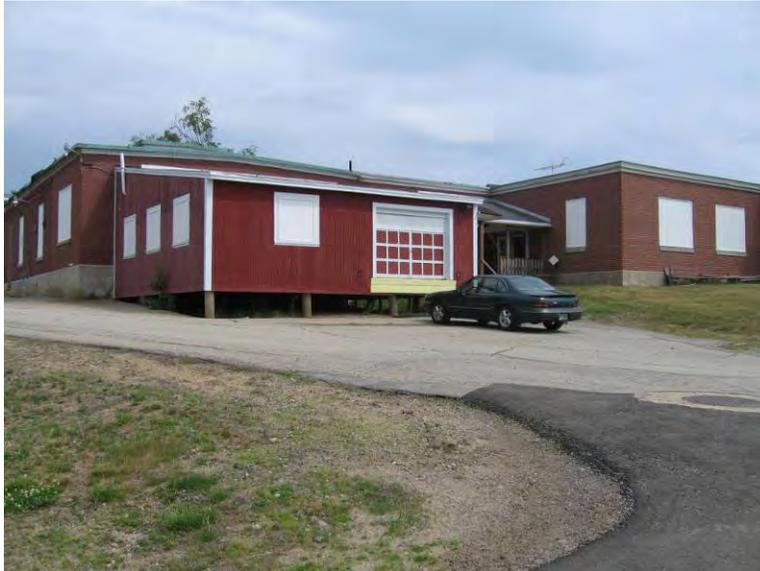
Picture 125.
Representative exterior conditions of
Building 24—Laundry.

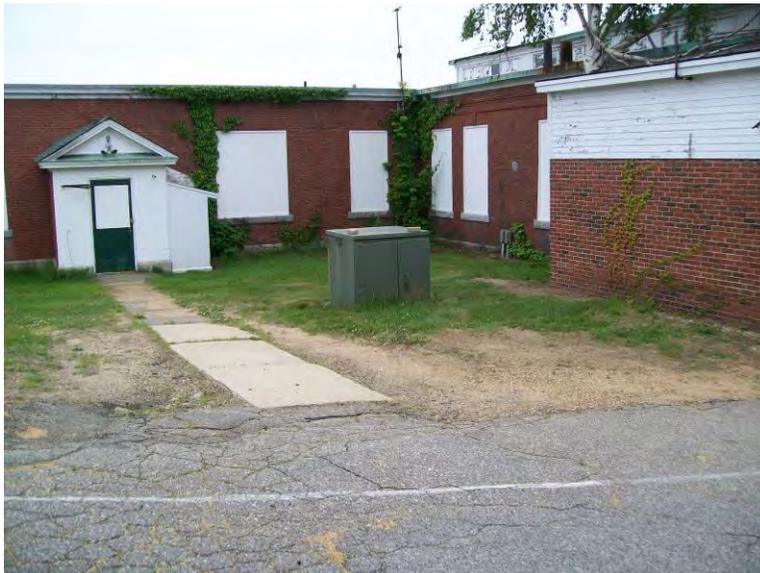
Picture 126.
Pad-mounted electrical transformer located north of
Building 24—Laundry.

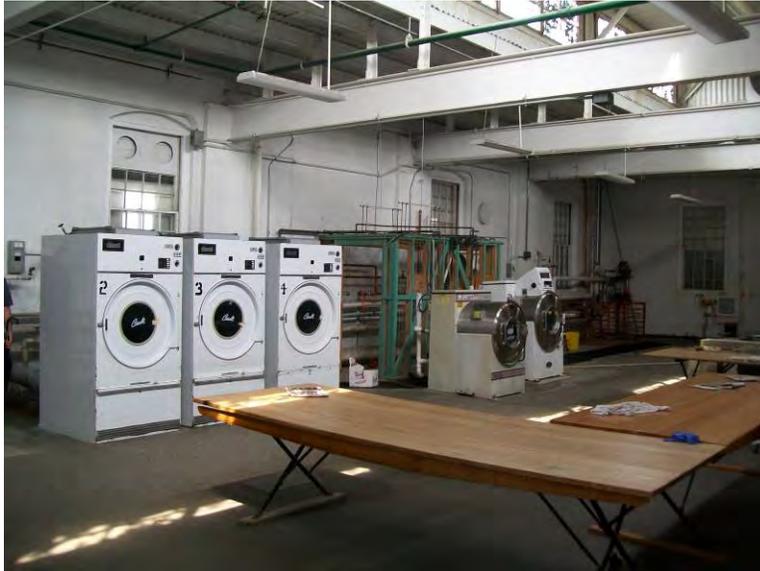
Picture 127.
Representative laundry facility conditions within
Building 24—Laundry.

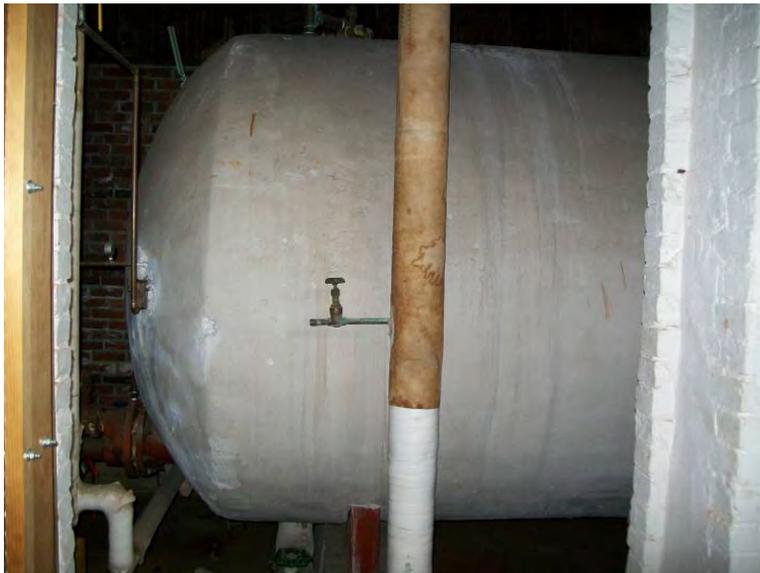
Picture 128.
Hot water tank and associated suspect ACM wrap ob-
served within Building 24—Laundry.

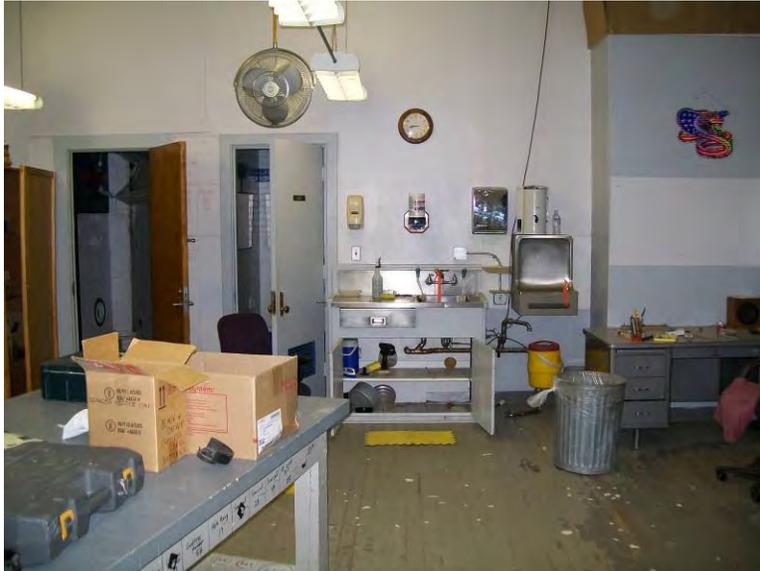
Picture 129.
Representative conditions within the office area of
Building 24—Laundry.

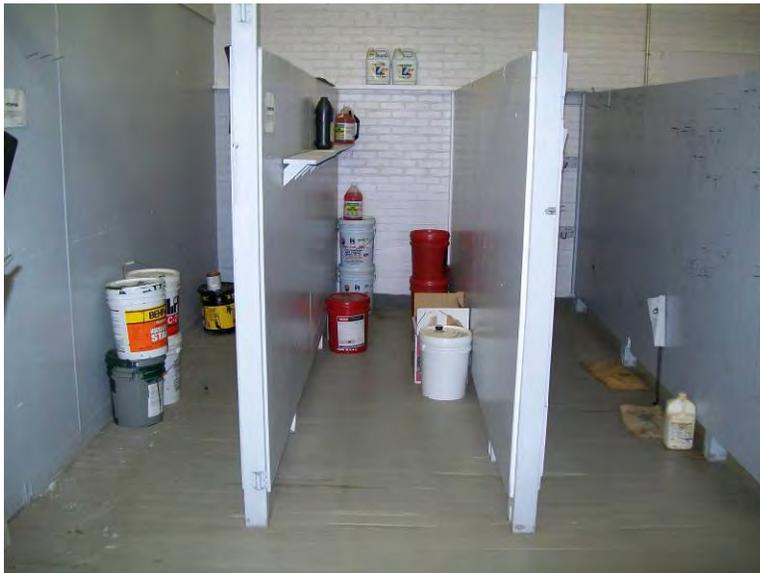
Picture 130.
Representative conditions within the paint room of
Building 24—Laundry.

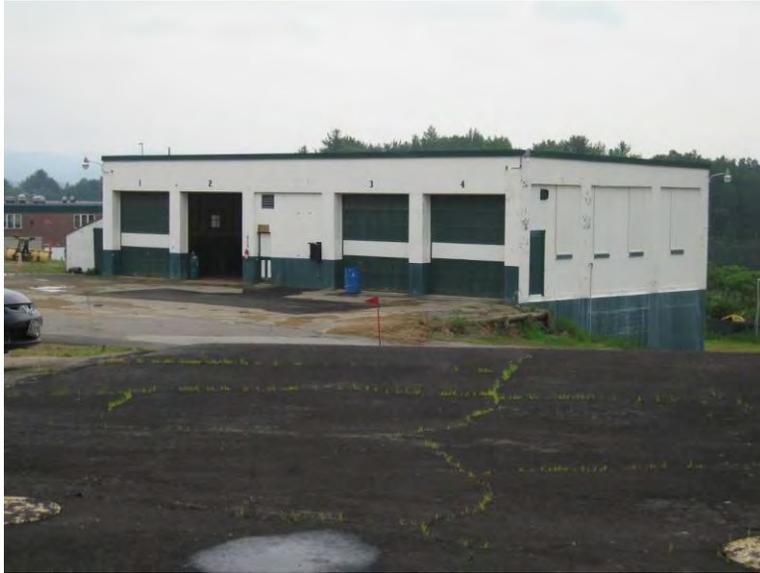
Picture 131.
Representative exterior conditions of
Building 25—Garage as viewed from the north.

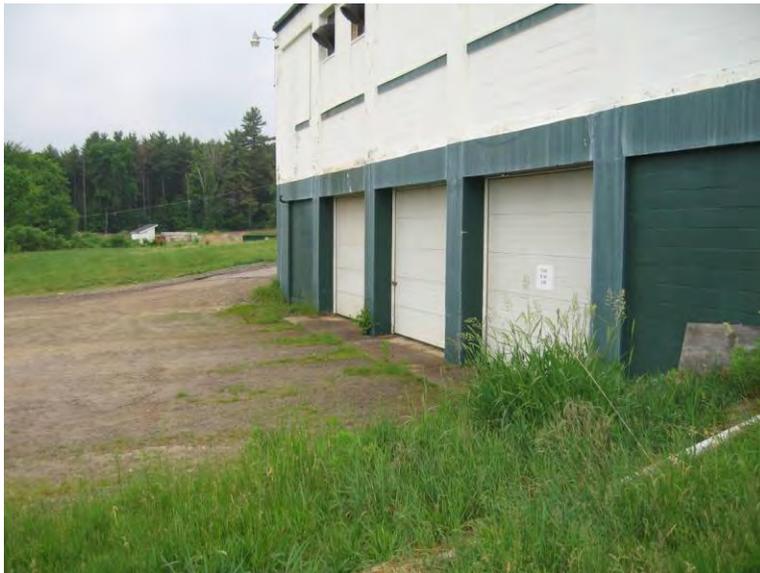
Picture 132. Building 25—Garage as viewed from the
southeast. Note: Paint spray booth exhaust structures at
top center and generator exhaust pipe at middle center.

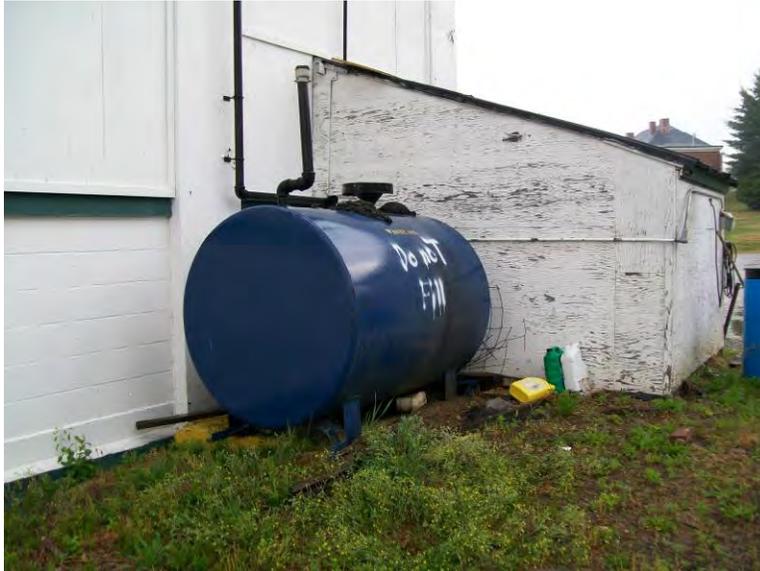
Picture 133.

330-gallon waste oil AST located adjacent to the southeast exterior wall of Building 25—Garage.

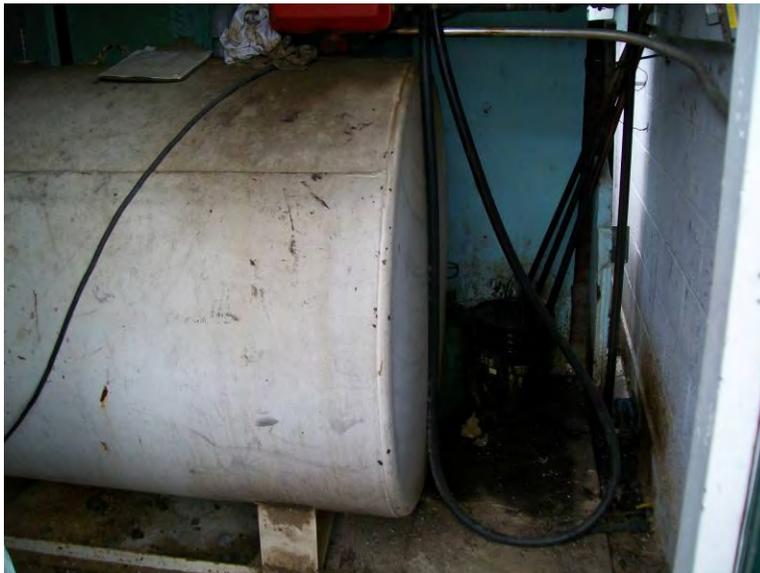
Picture 134.

330-gallon diesel AST located adjacent to the southeast exterior wall of Building 25—Garage.

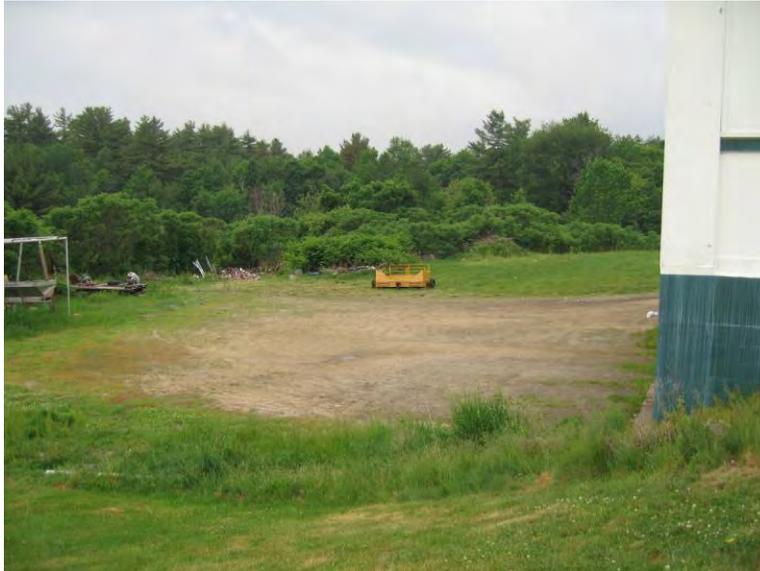
Picture 135.
Miscellaneous waste items observed south of
Building 25—Garage.

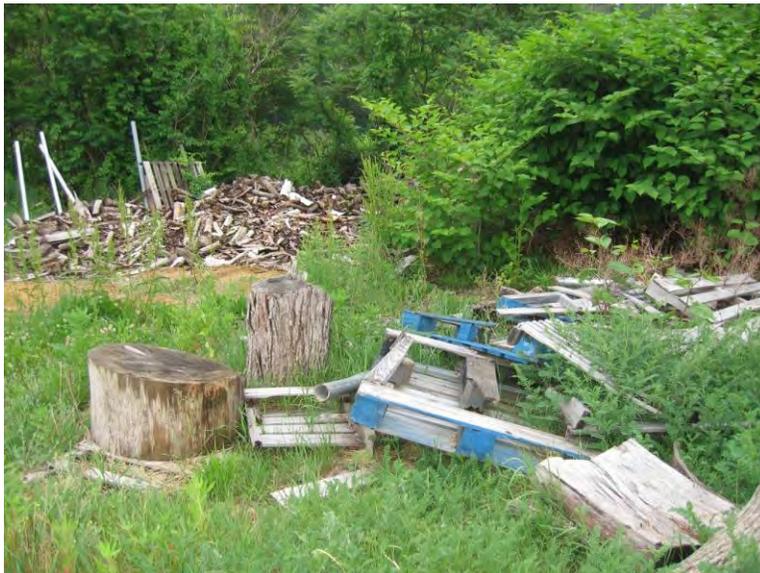
Picture 136.
Miscellaneous waste items observed south of
Building 25—Garage.

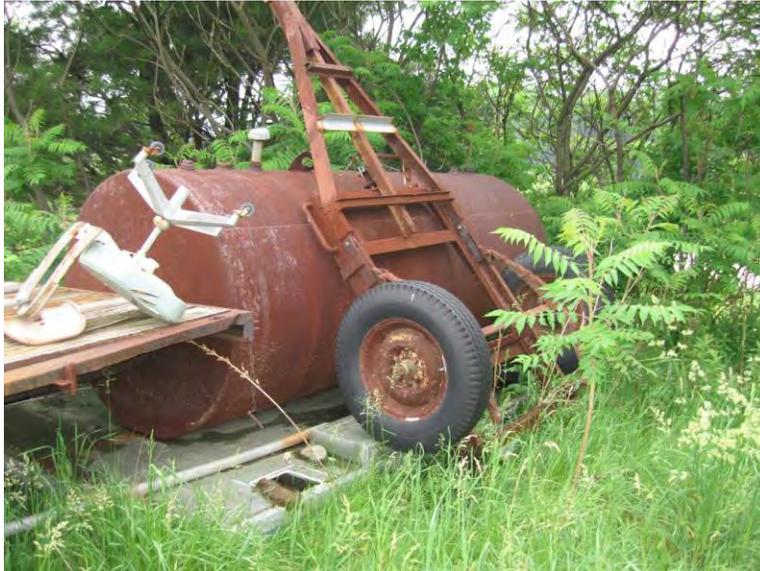
Picture 137. Miscellaneous waste items including one approximately 1,000-gallon storage tank observed south of Building 25—Garage.

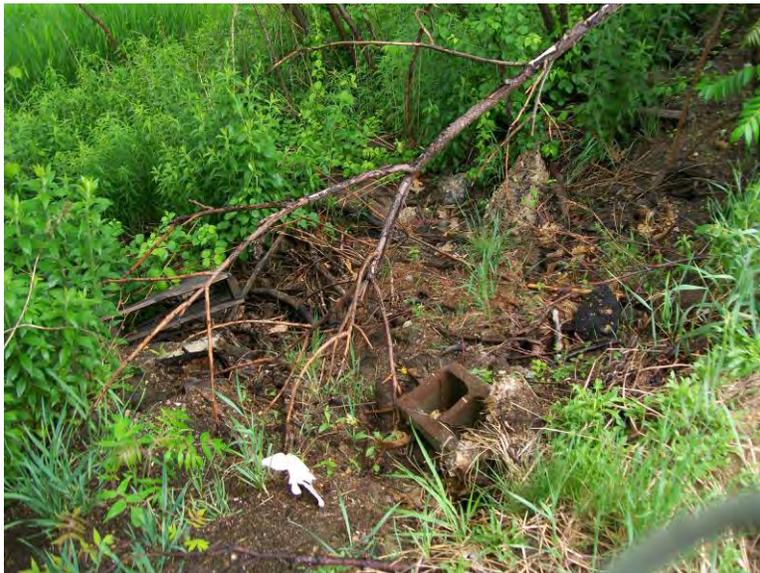
Picture 138.
Miscellaneous waste items observed south of Building 25—Garage.

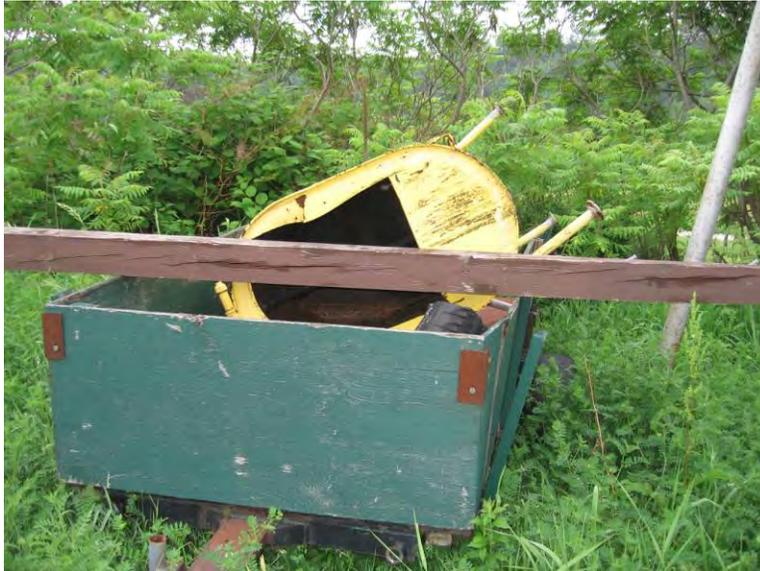
Picture 139. Miscellaneous waste items including one discarded AST observed south of Building 25—Garage.

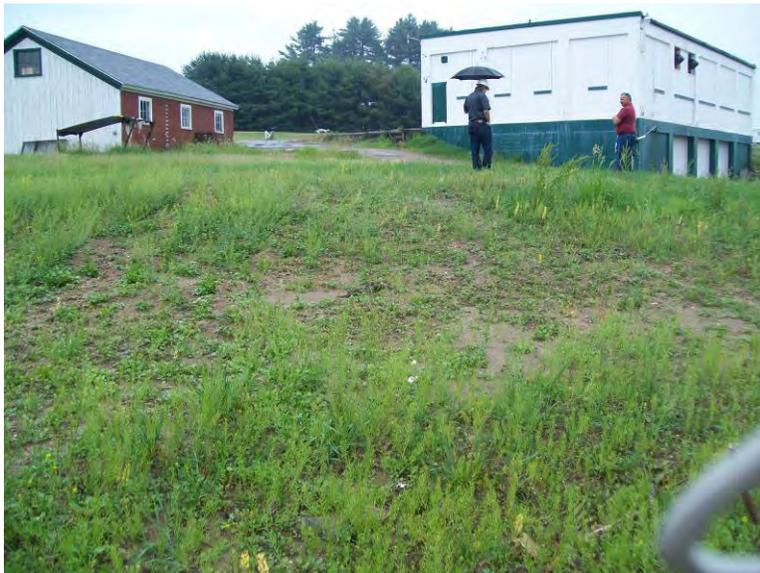
Picture 140.
Area of potential coal ash disposal observed southwest of Building 25—Garage.

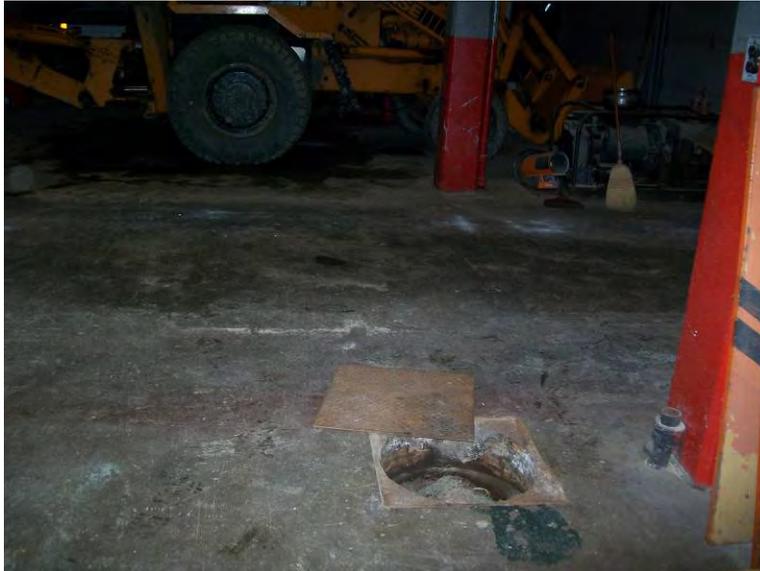
Picture 143.

Representative conditions and sealed floor drain observed in the basement of Building 25—Garage.

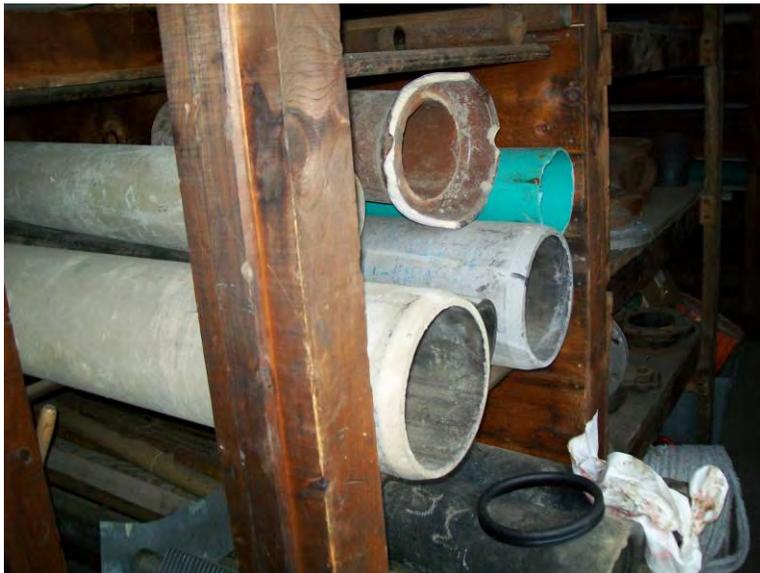
Picture 146. Interior of Building 25—Garage accessory building known as “Plumbing Storage Shed.”
Note: Suspect ACM piping.

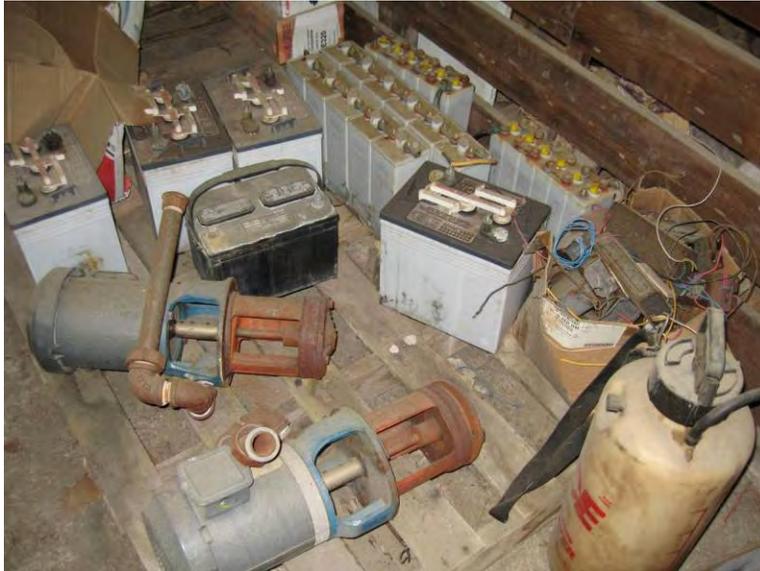
Picture 149. Representative waste items observed within Building 26—Lumber Storage including batteries, spray cans, pumps, etcetera.

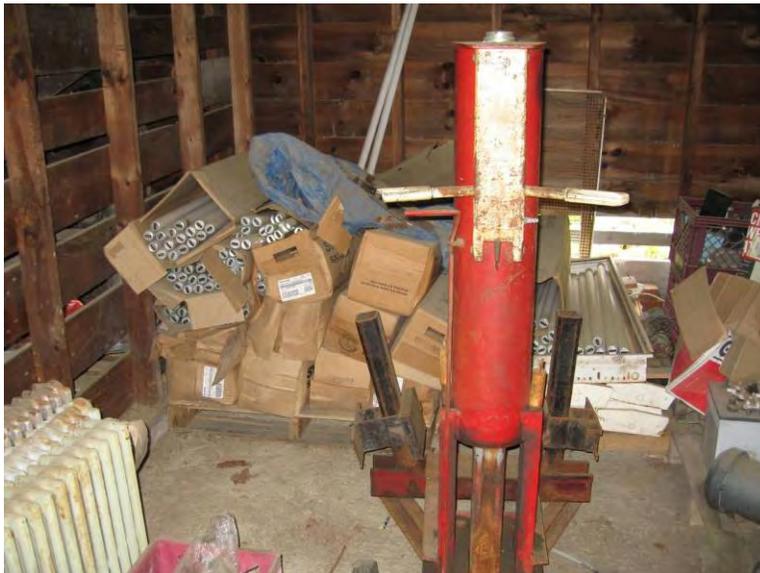
Picture 150. Representative waste items observed within Building 26—Lumber Storage including fluorescent light bulbs, hydraulic lift, steam radiators, etcetera.

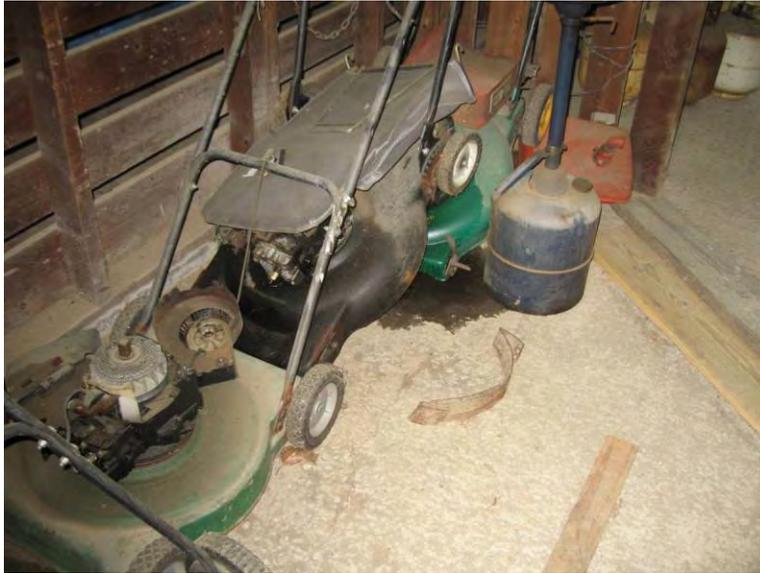
Picture 151.
Oil staining observed within
Building 26—Lumber Storage.

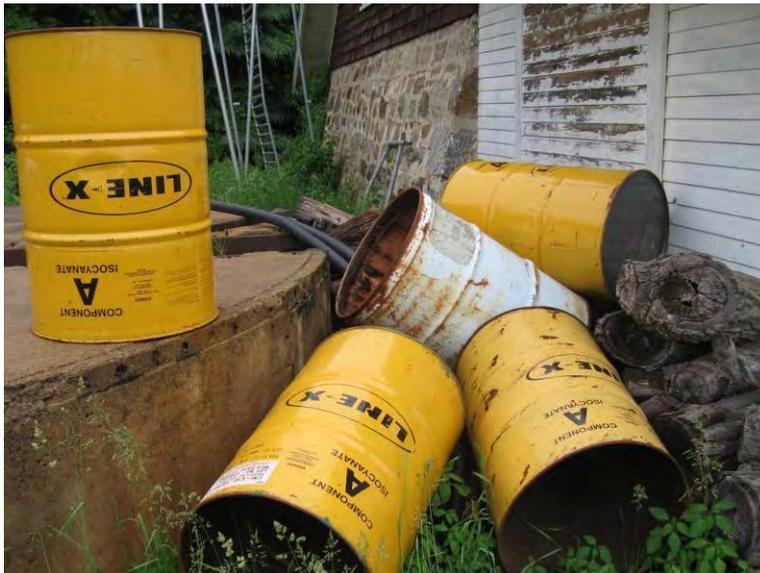
Picture 156.
Empty drums observed adjacent to
Building 27—Pig House.

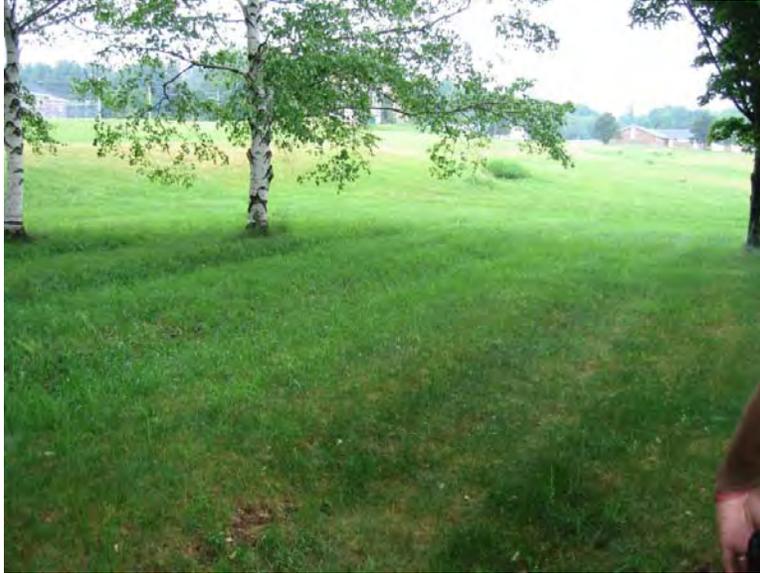
Picture 159.
Uneven ground located north of
Building 28—Greenhouse.

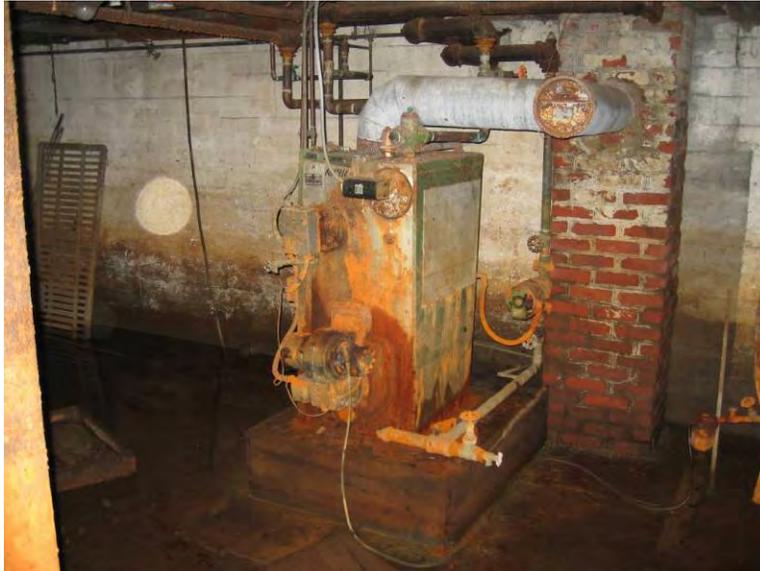
Picture 161. Former No. 2 fuel oil-fired boiler observed within the basement of Building 28—Greenhouse. Note: Water staining above basement floor elevation.

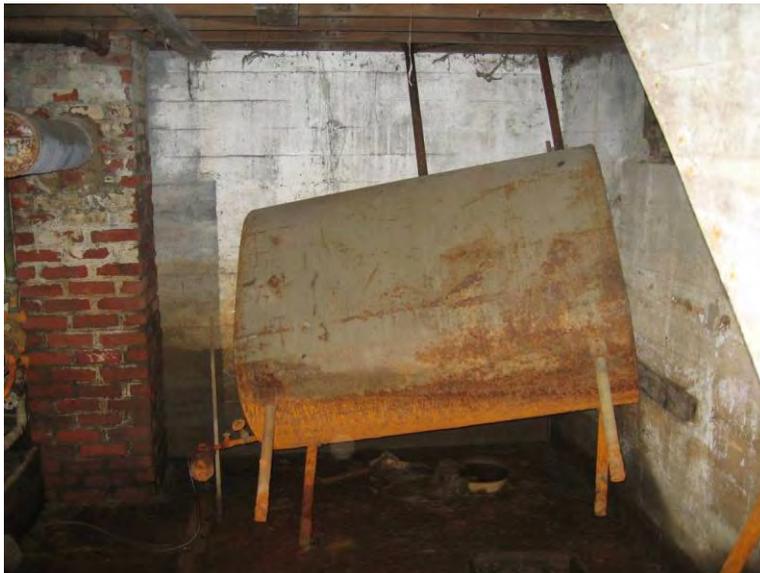
Picture 162. Discarded No. 2 fuel oil AST observed within the basement of Building 28—Greenhouse.

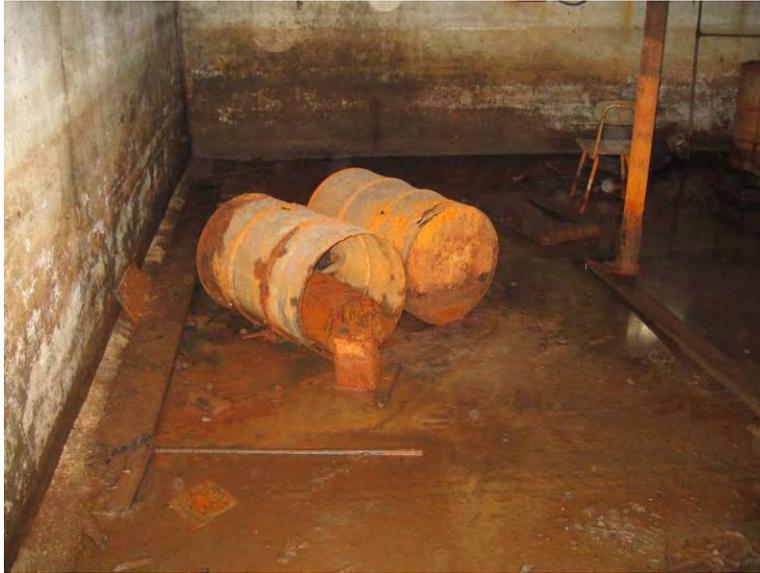
Picture 163.
Empty drums observed within the basement of
Building 28—Greenhouse.

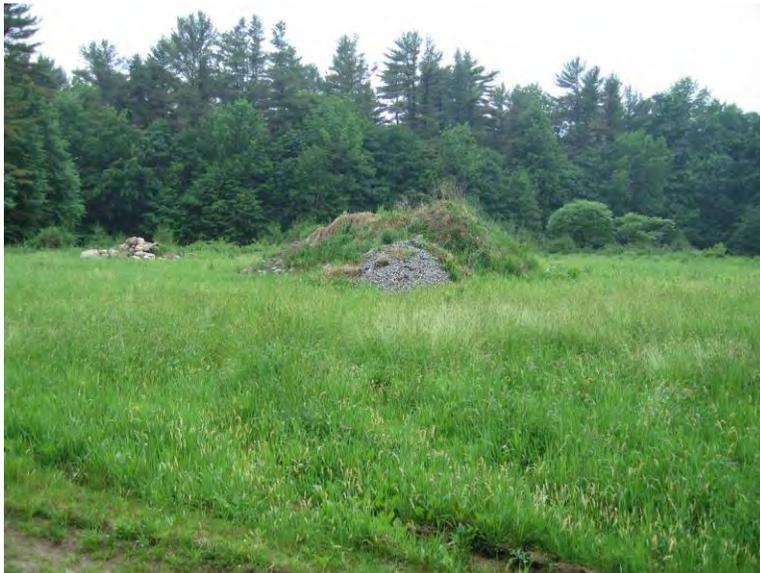
Picture 169.

Area of reported waste burial and NHDES investigation located west of Building 30—Poultry Houses.

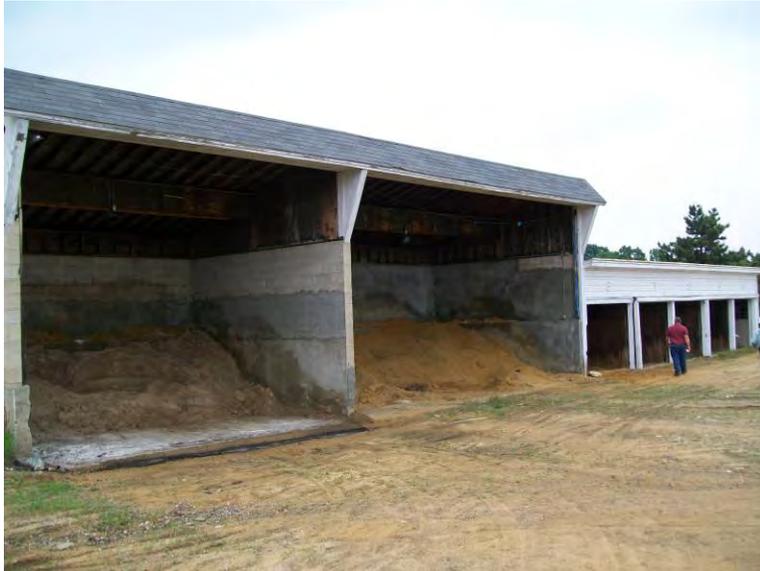
Picture 172.
Interior of Building 31—North Barns. Note: Suspect
ACM building materials at right.

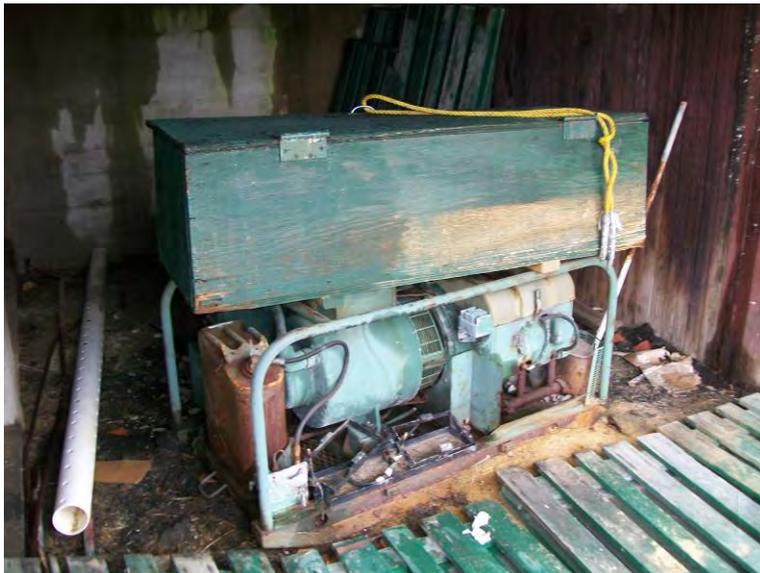
Picture 174. Portable generator stored within accessory building located adjacent to Building 31—North Barns. Soil adjacent to this generator reportedly exhibited a petroleum odor.
